An Archaeological Building Recording at Whirlow Hall Farm, Sheffield

ARS Ltd Report 2011/59
May 2011

ARS Ltd Report 2011/59

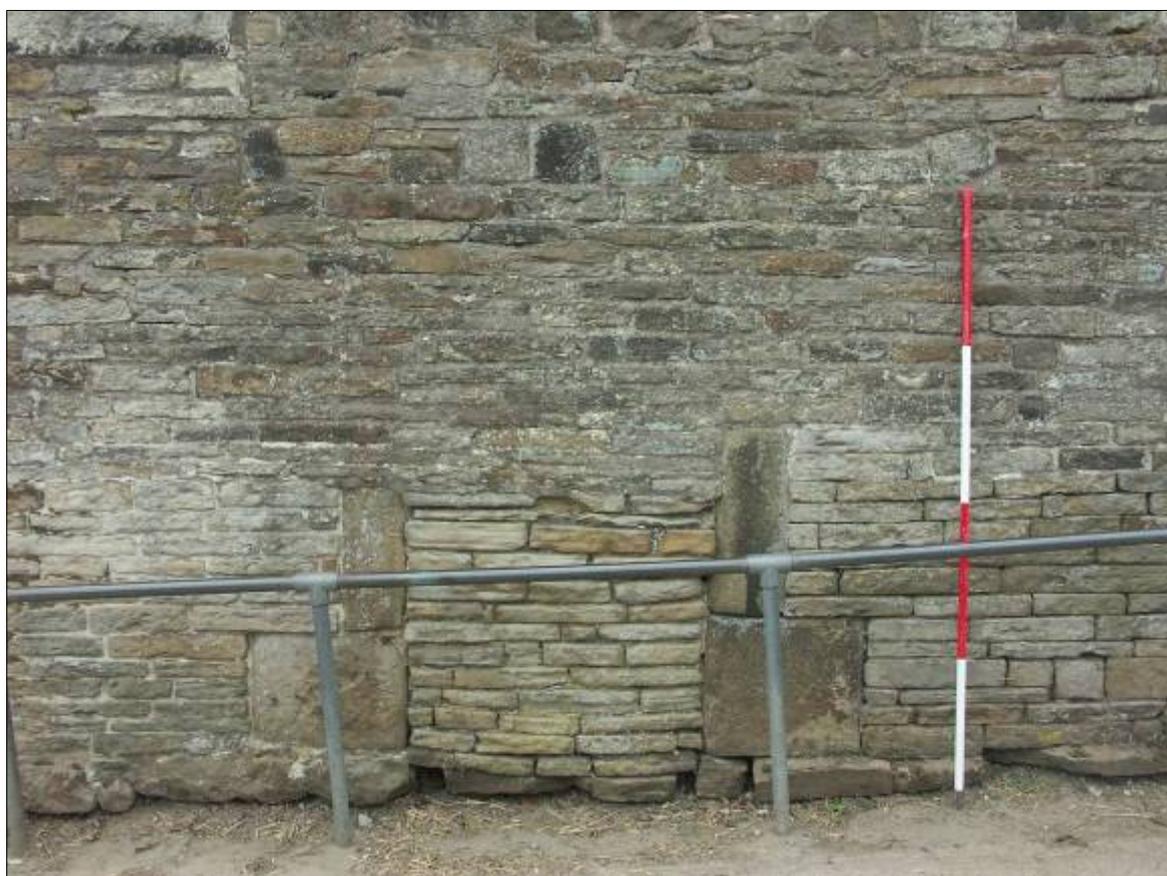
Plate 18. Detail of blocked and truncated doorway in the north wall of Building G.

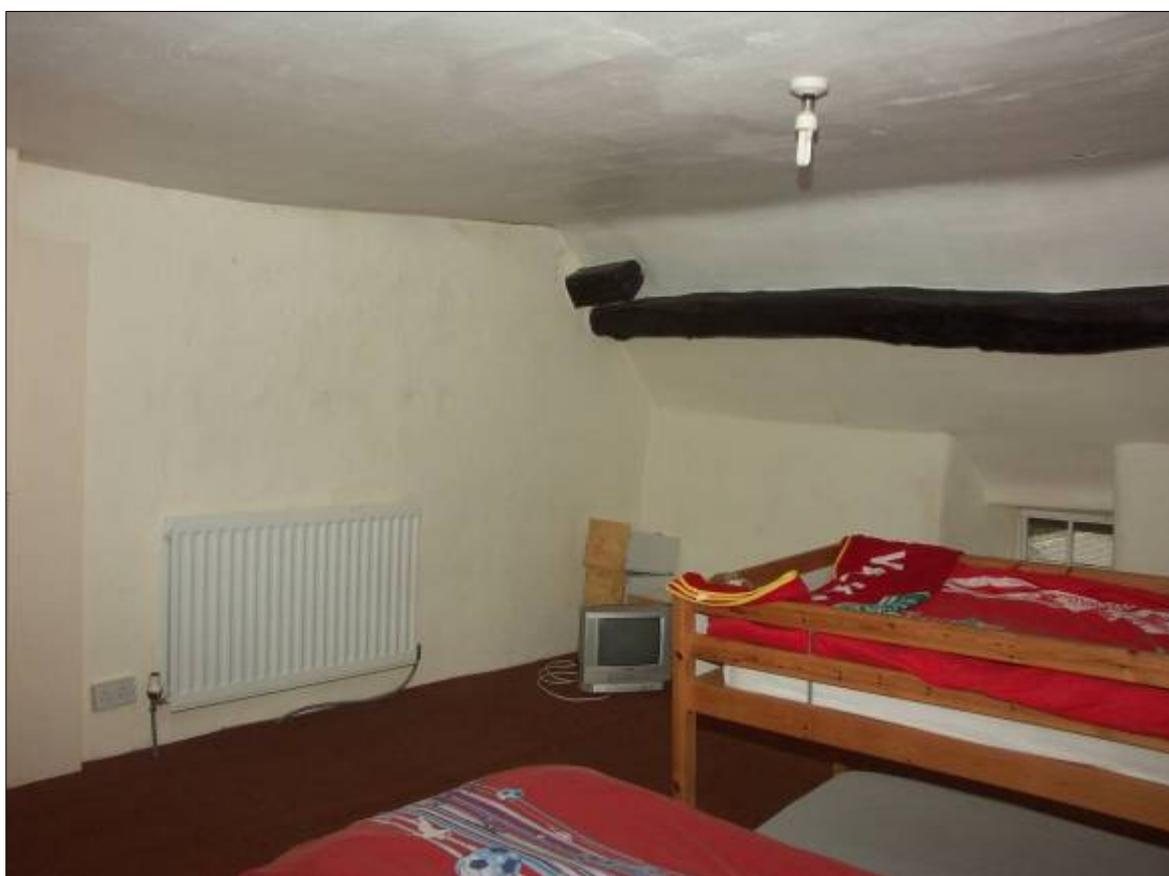
Plate 20. Attic Level of Building F. Interior north wall showing side purlin leading to the now demolished northern half of the building.

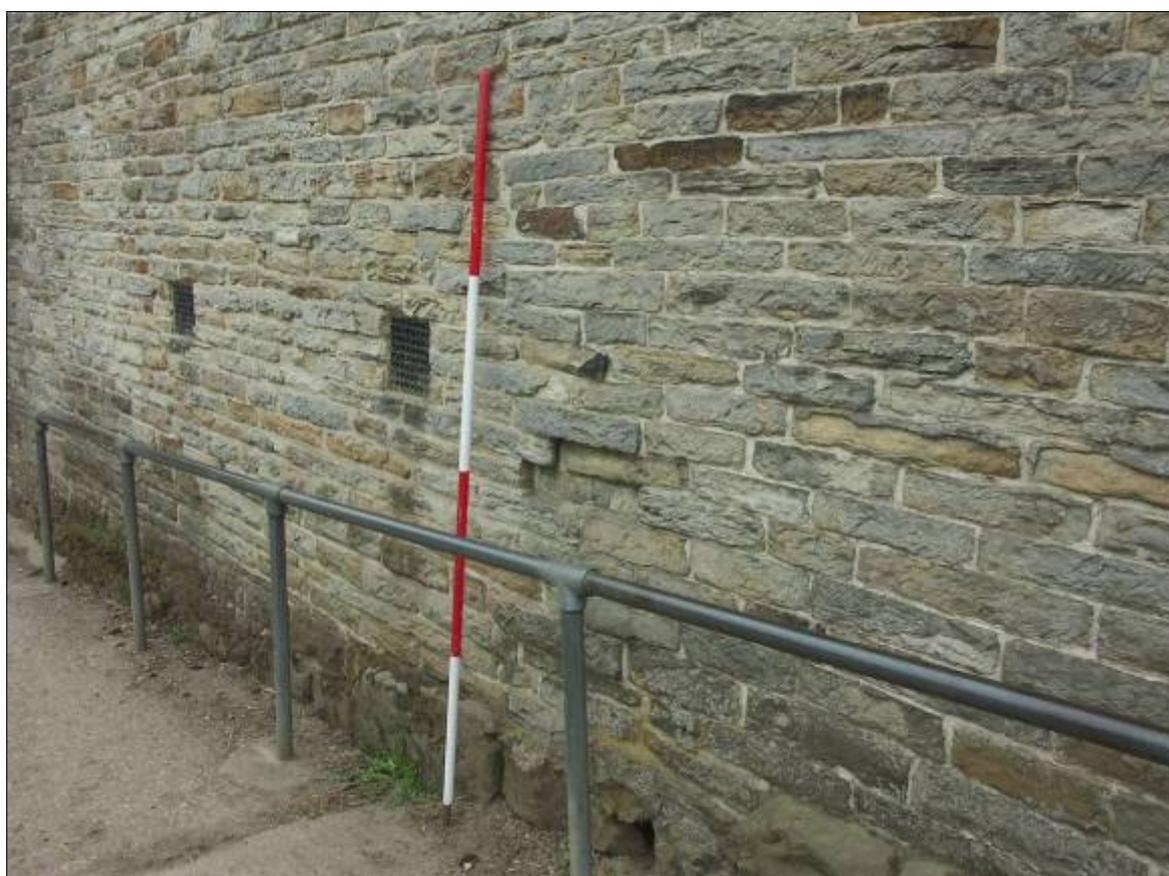
Plate 29. Detail of a possible scar associated with the location of a, now removed, cruck frame in the north wall of Building H.

- Cracking and disturbance has also been noted on the north elevation of building H (see Section 4.50, Plate 29) and is interpreted as the possible location of another cruck frame that has since been removed. This means that the cruck frame building was originally larger than the current extent of Building I.

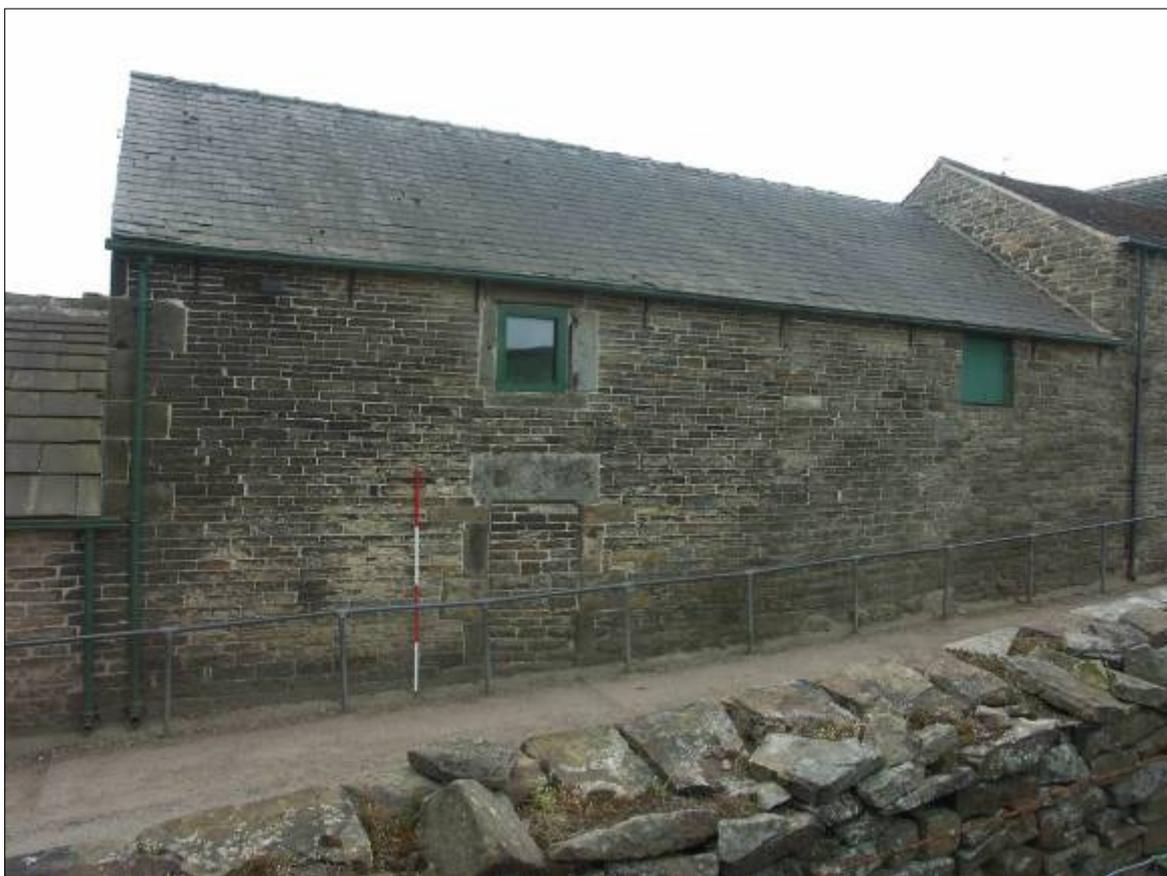
- The surviving frame sits in the centre of Building I and has been encased with stone at a later date and the stresses placed by the frame onto the stone walls have created some cracking. This is evident on the north elevation, at the location of the surviving frame (Plate 36) and on the south elevation where sections of the encasing wall have fallen away to reveal the cruck blade and its stylobate (Plate 37). There is significant cracking above this.

Plate 36. North elevation of Building I, showing crack associated with the location of a cruck frame.

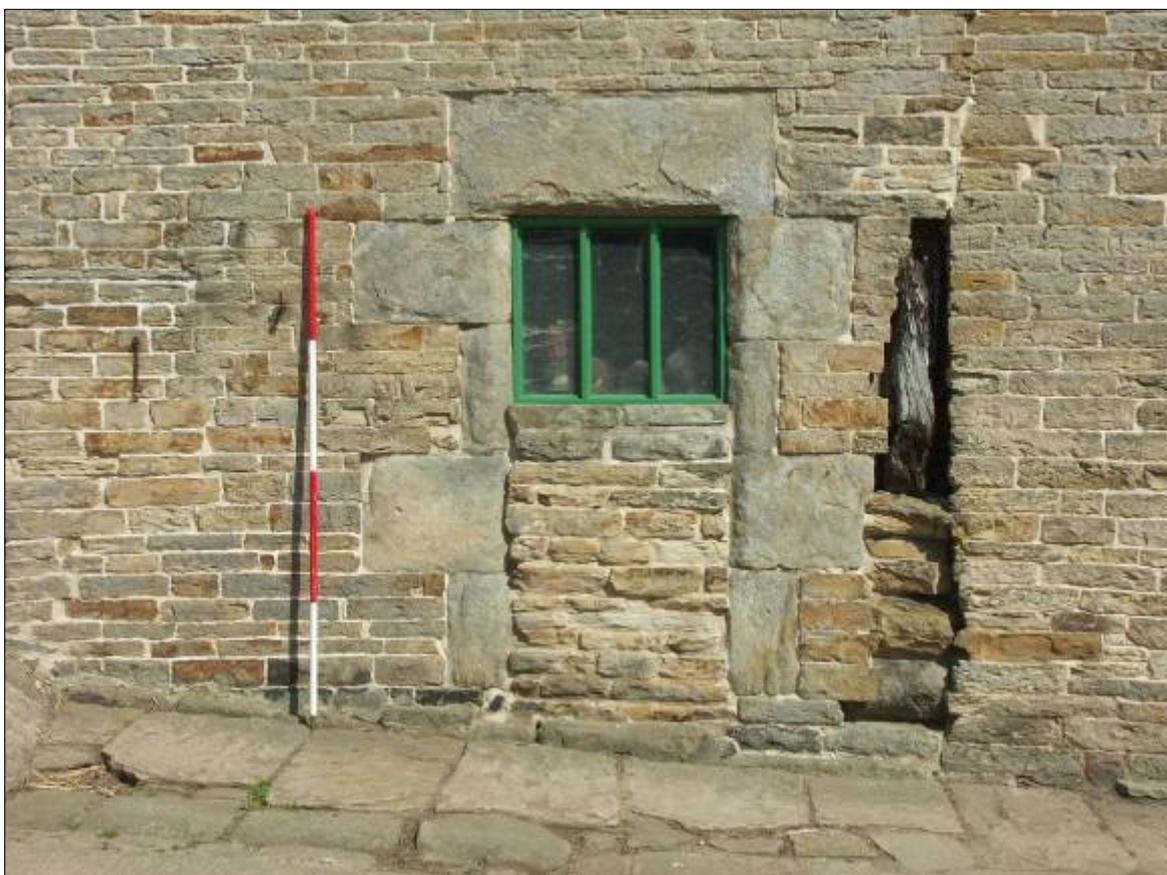
Plate 37. Detail of exposed cruck blade and stylobate beside a partially blocked doorway in the south wall of Building I.

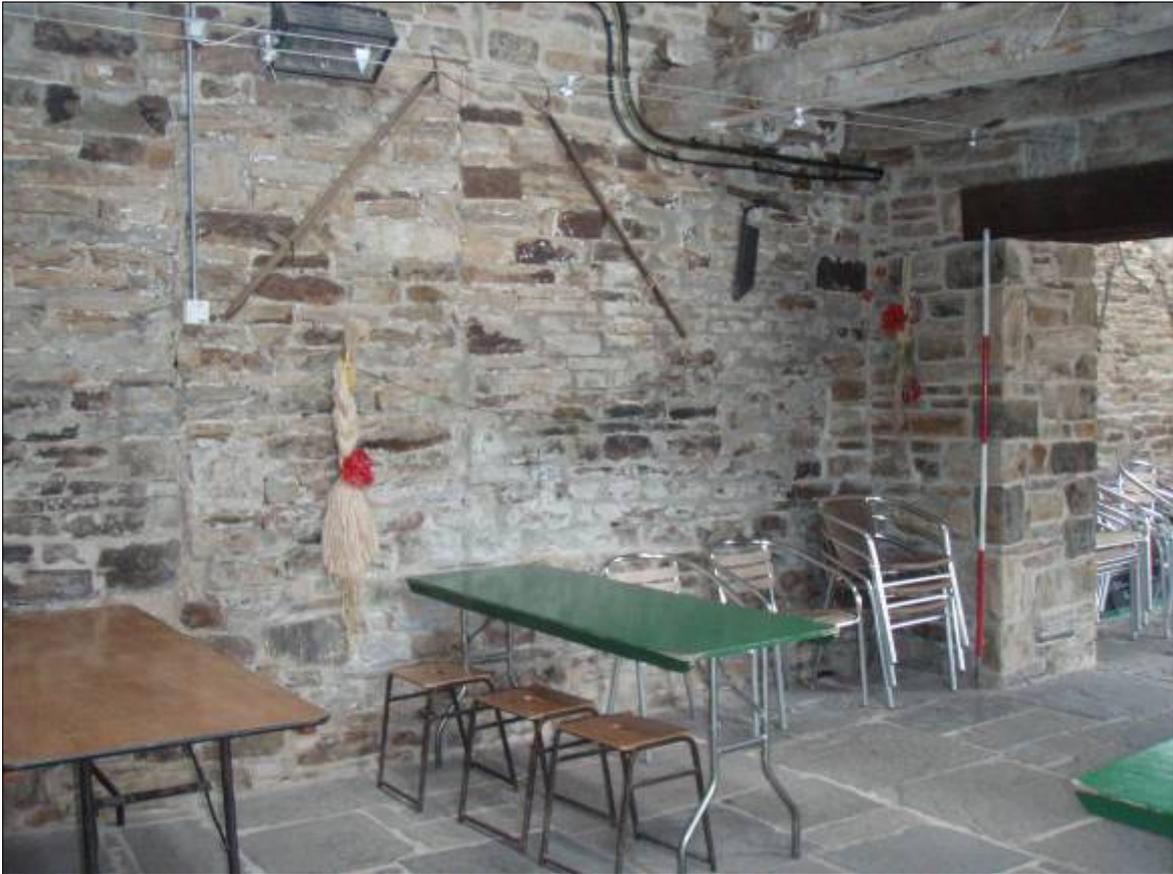
- In the east wall of the current Building I there is a scar on the interior of the north east corner that terminates at the same height above ground level as the stylobate of the surviving cruck visible in the east wall (Plate 38). This suggests that scarring marks the location of a cruck blade that was encased in stone, then removed, and the walling patched up above the stylobate. In the south east corner at the same location there is cracking and discontinuity of coursing at the base of the wall, suggesting again that a stylobate has been retained in this location.

Plate 38. Interior of Building I facing northeast, showing scar of a cruck blade in the northeast corner.

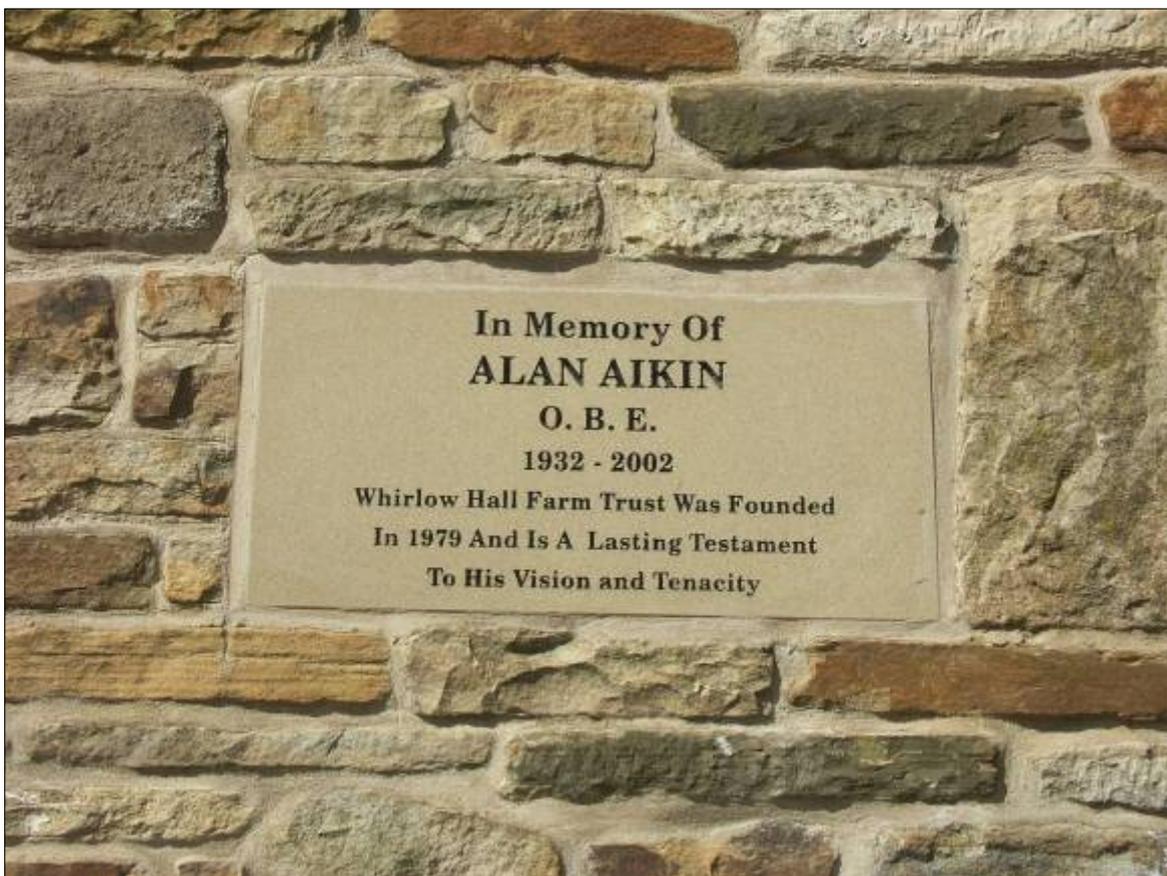
- 4.69 The east elevation contains a date stone of 2002, which may date the repairs to the structure (Plate 48-49). The earliest depiction of this building is on the Ordnance Survey map of 1893 (Sheppy 2011, 31); it does not appear on the 1850 map.

Plate 49. Detail of the date stone of the east elevation of Building J.

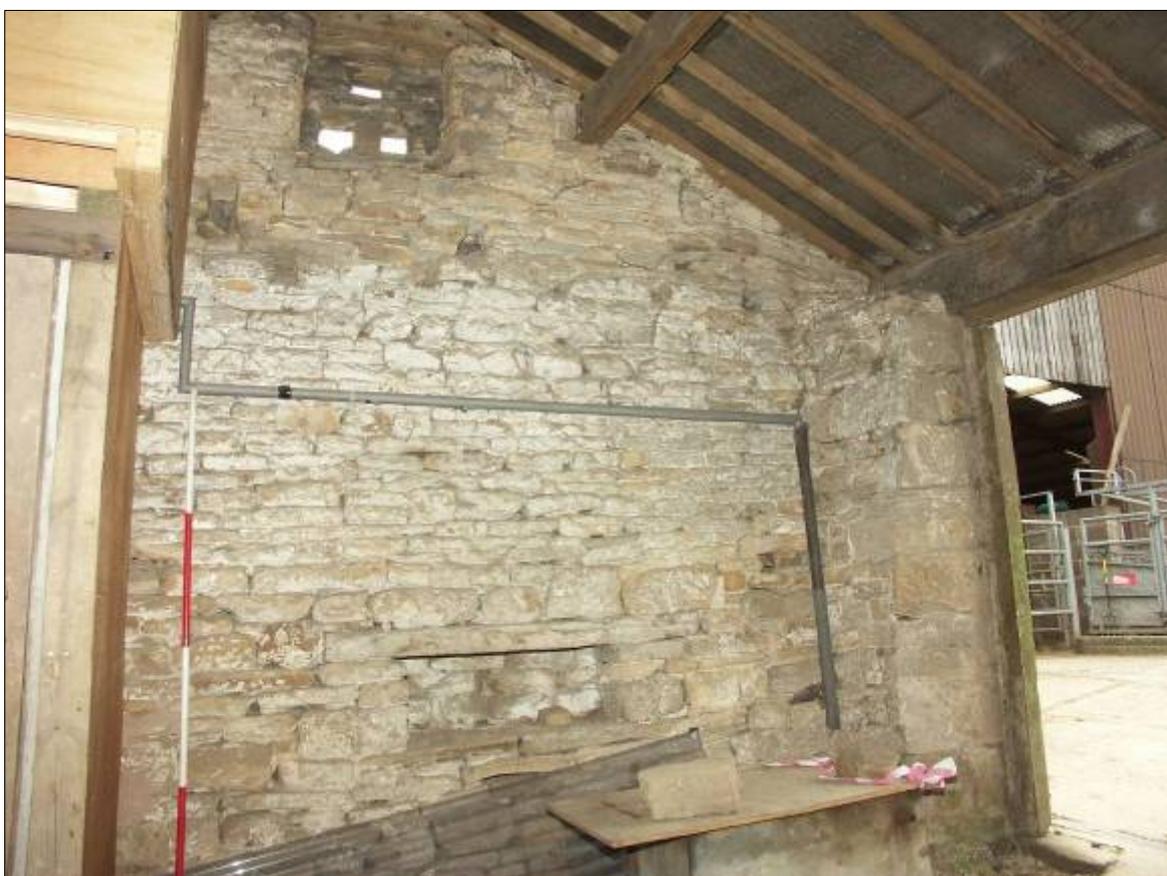
- 4.84 The south wall of this building contains five small openings in the gable end, each with a short projecting platform externally (Plate 60 and 65). This has led to this building being interpreted as a dovecot (Frost 1970, 24), but this is only a secondary function for the building and was certainly not its original purpose. Purpose-built dovecots would have several more external openings and the internal walls would be entirely covered with small stone-built nesting boxes (Brunskill 2007, 82-89).

Plate 65. Interior of Building N. South wall showing adaptation as a dovecot.

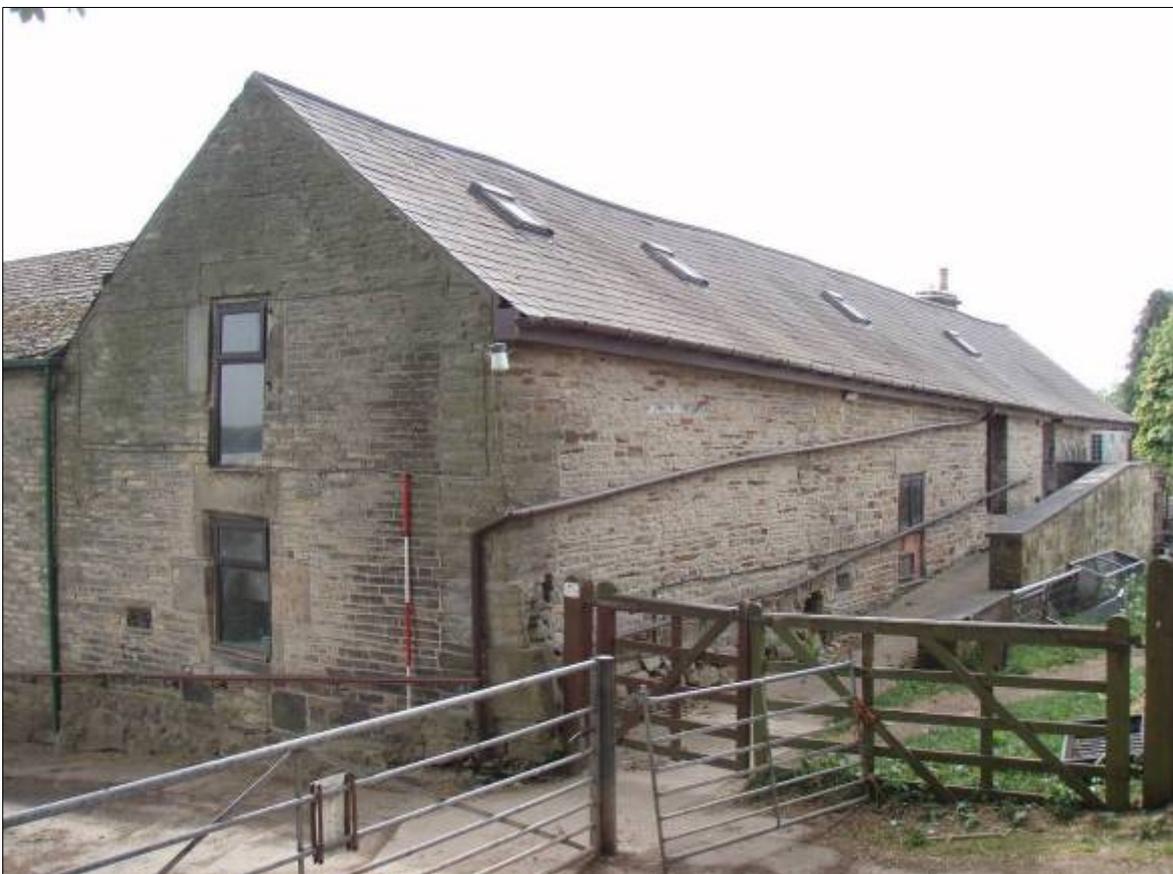
Plate 71. Building O from the northwest showing the scar in the northwest corner.

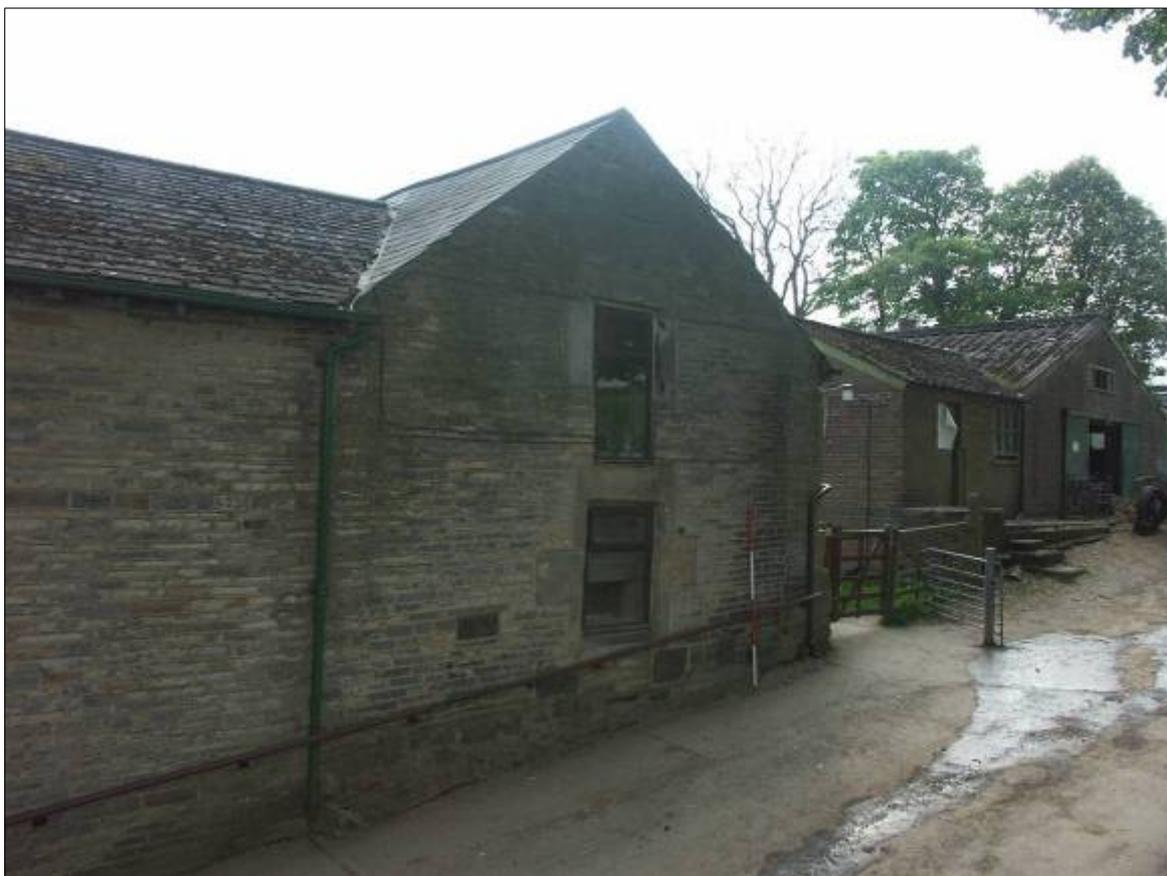
- 4.91 The north elevation contains a ground-floor doorway with dressed-stone surround that has been partially blocked to create a window (Plate 72). Above the doorway a pitching eye has been extended downwards to create a doorway-sized opening which is now glazed. This may have been done in the historic period to adapt the building for use as a granary. There are exposed foundation stones visible on this end of the

Plate 72. North elevation of Building O.

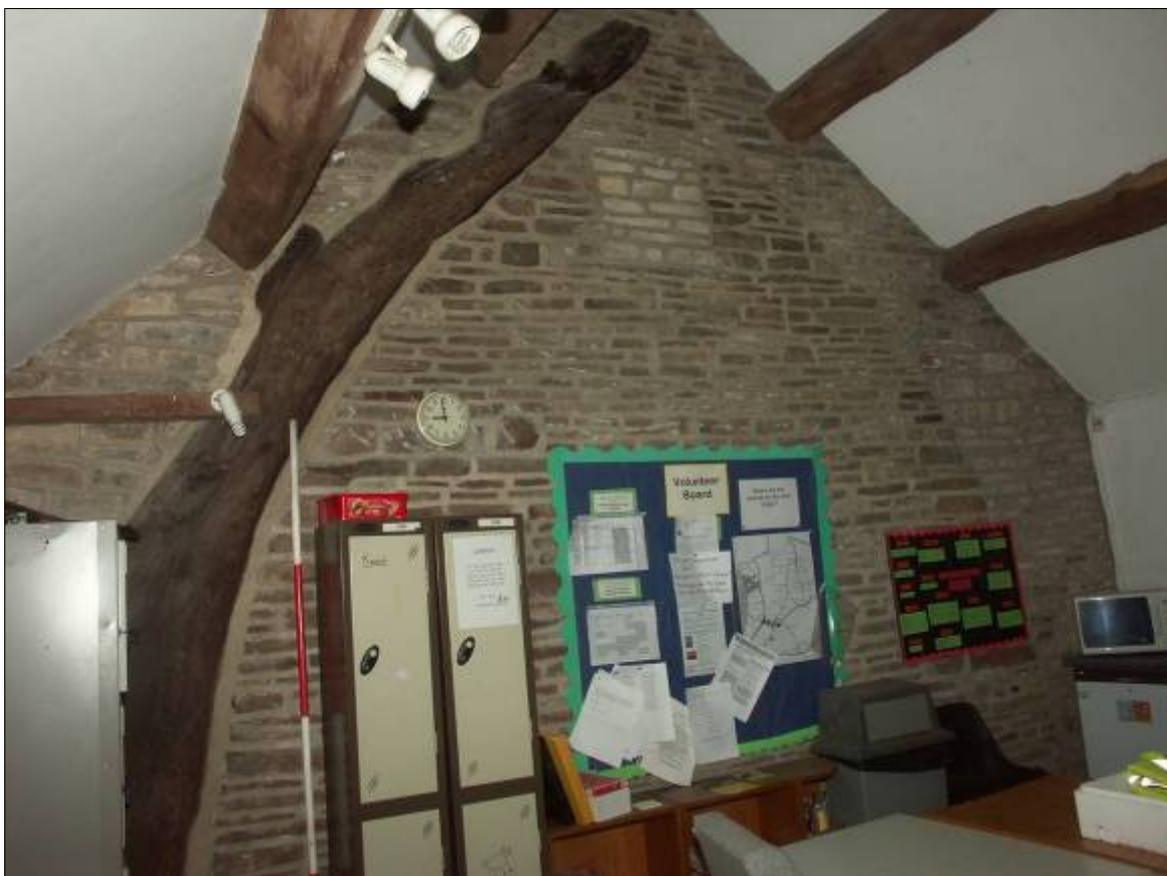
Plate 73. First Floor of Building O. Interior of the south wall showing surviving cruck blade and the scar of its matching pair.

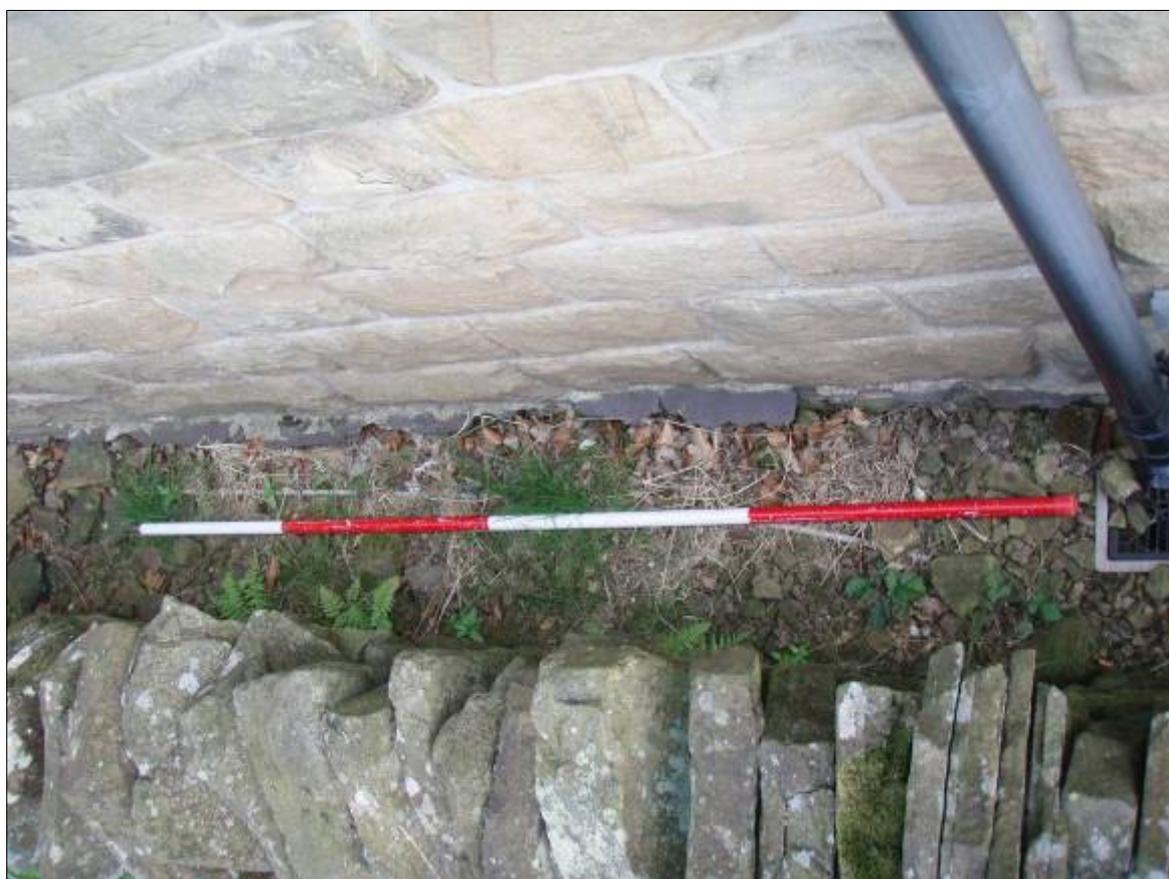
Plate 91. Detail of slate damp-proof course on the northwest wall of Building S.

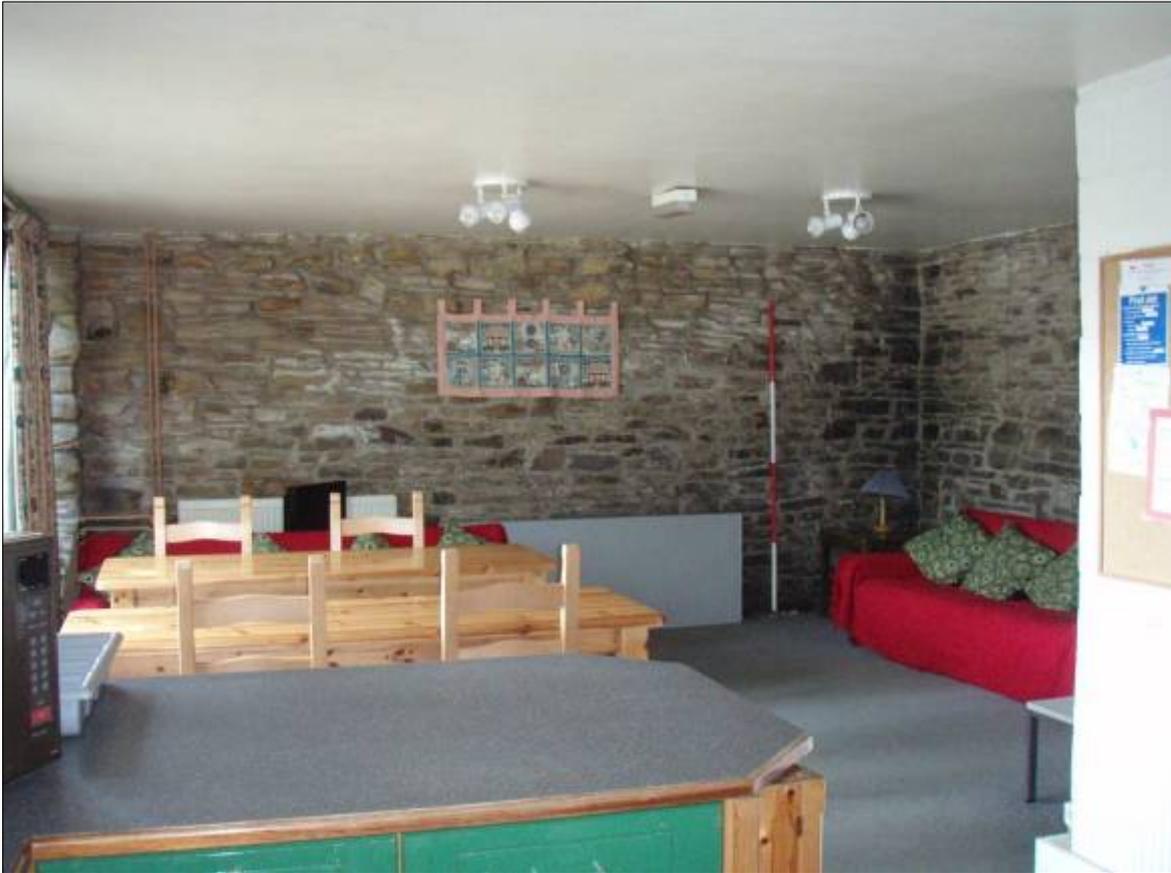
Plate 92. Ground floor of Building S. Interior facing southwest showing fire blackening in the west corner.

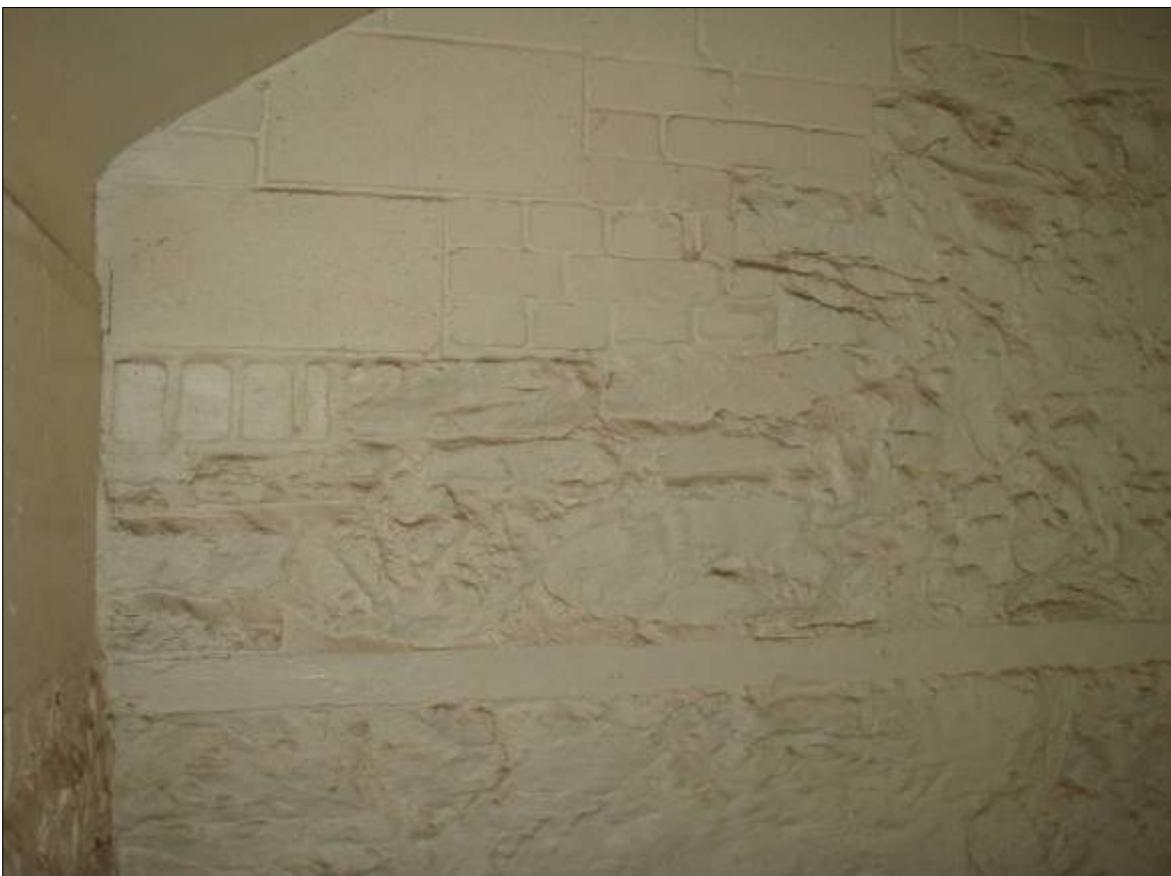
Plate 93. First Floor of Building S. Interior showing modern brick and concrete heightening of the side walls and gable end. The slender tie-beam of a previous roof structure is also visible embedded in the wall.
