# Archaeological Excavation and Survey of Scheduled Coastal Alum Working Sites at Boulby, Kettleless, Sandsend and Saltwick, North Yorkshire

ARS Ltd Report No-2015/42  
OASIS No: archaeo15-208500

Compiled By:  
Samantha Bax, Rupert Lotherington PCIfA and Dr Gillian  
Scott  
Archaeological Research Services Ltd  
The Eco Centre  
Windmill Way  
Hebburn  
Tyne and Wear  
NE31 1SR

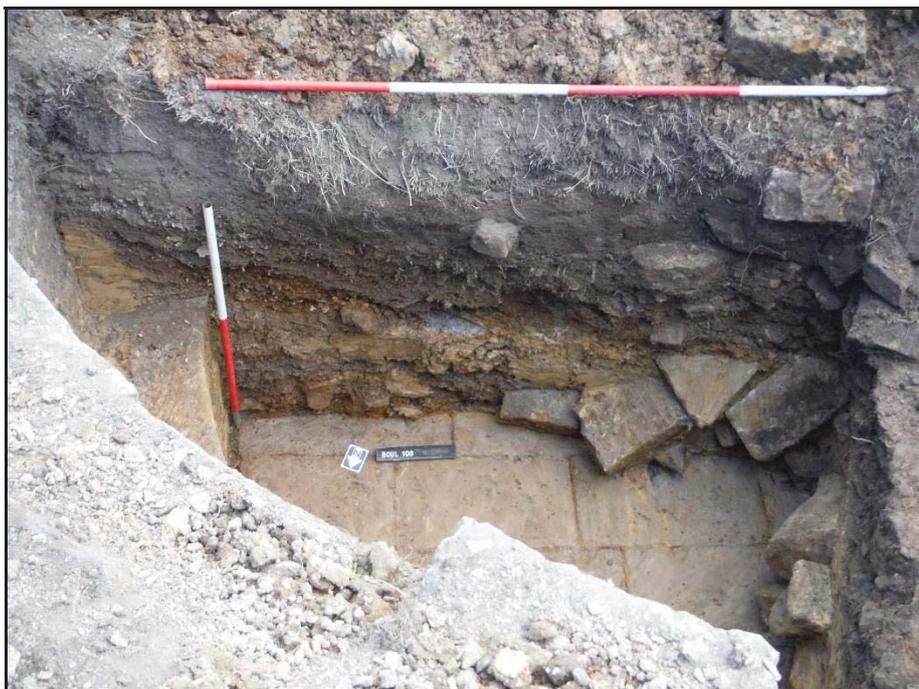
Figure 1- Post-excitation photograph of Trench 1. Note the south-western cistern (106) in the foreground and the north-eastern cistern (322) in the background. (Scale- 2 x 2m & 2 x 1m)

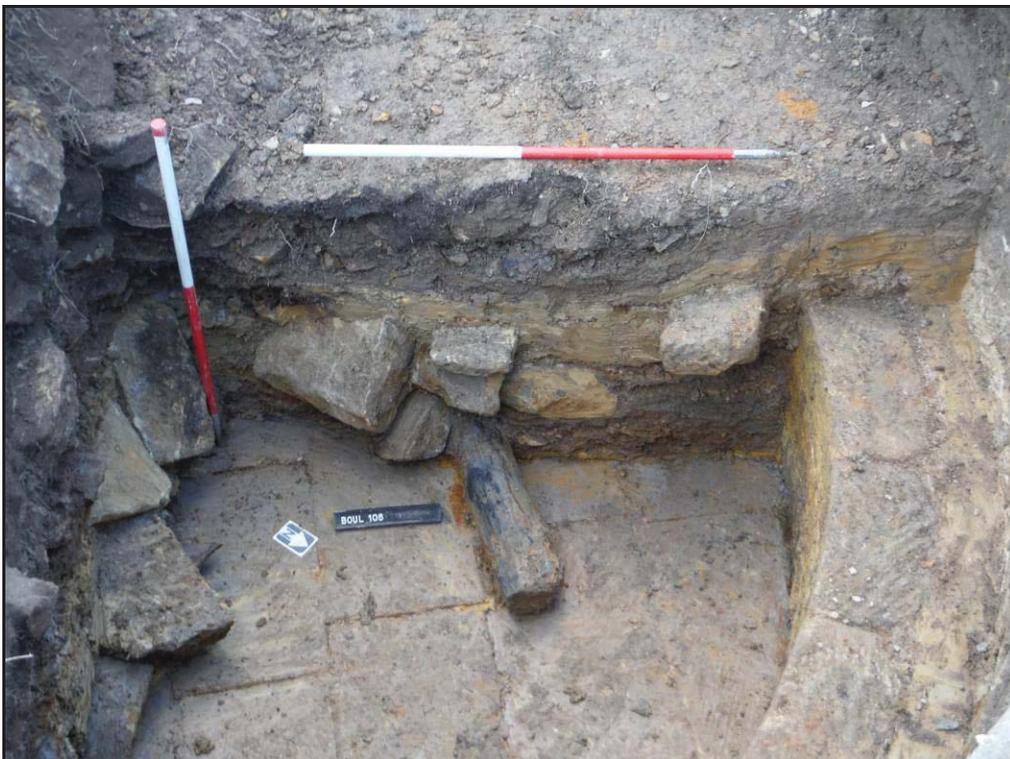
Figure 3 – NW-facing section through south-western cistern (106). Note clay seal (105) between walls (106) and (116) (Scale- 2 x 1m)

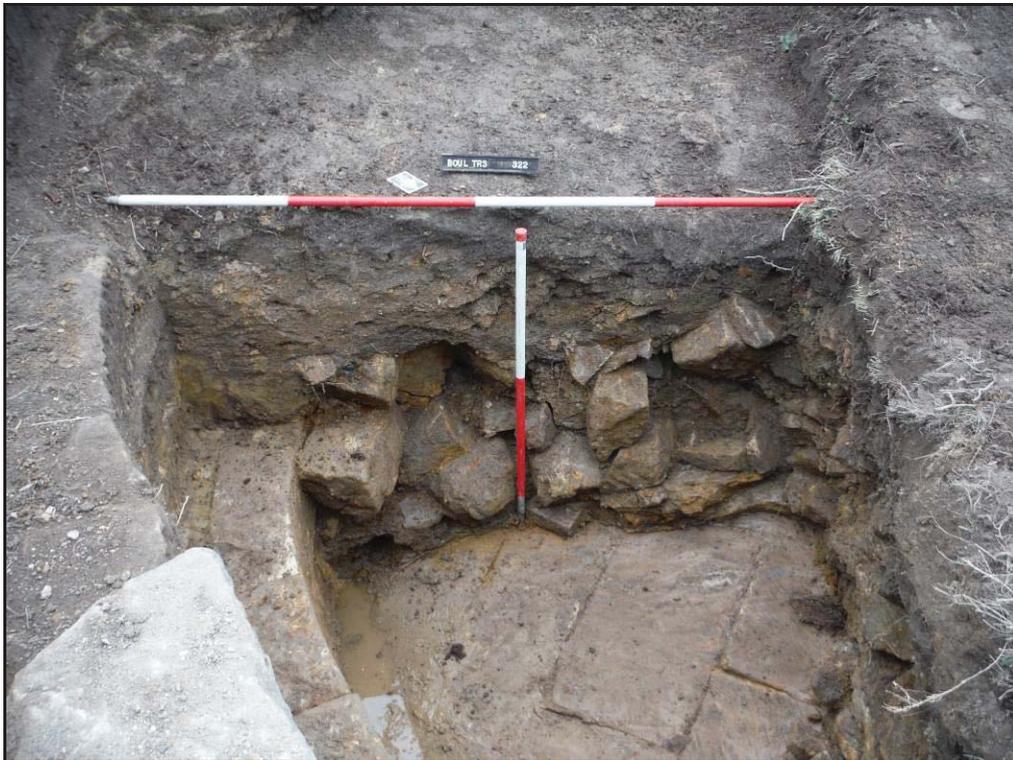
to be an intended structural design and was likely caused by erosion to the cliffs edge which resulted in progressive subsidence to cistern (322).

Figure 4- NE-facing section through cistern (322) displaying collapse deposit (114) (Scale- 2m + 1m)

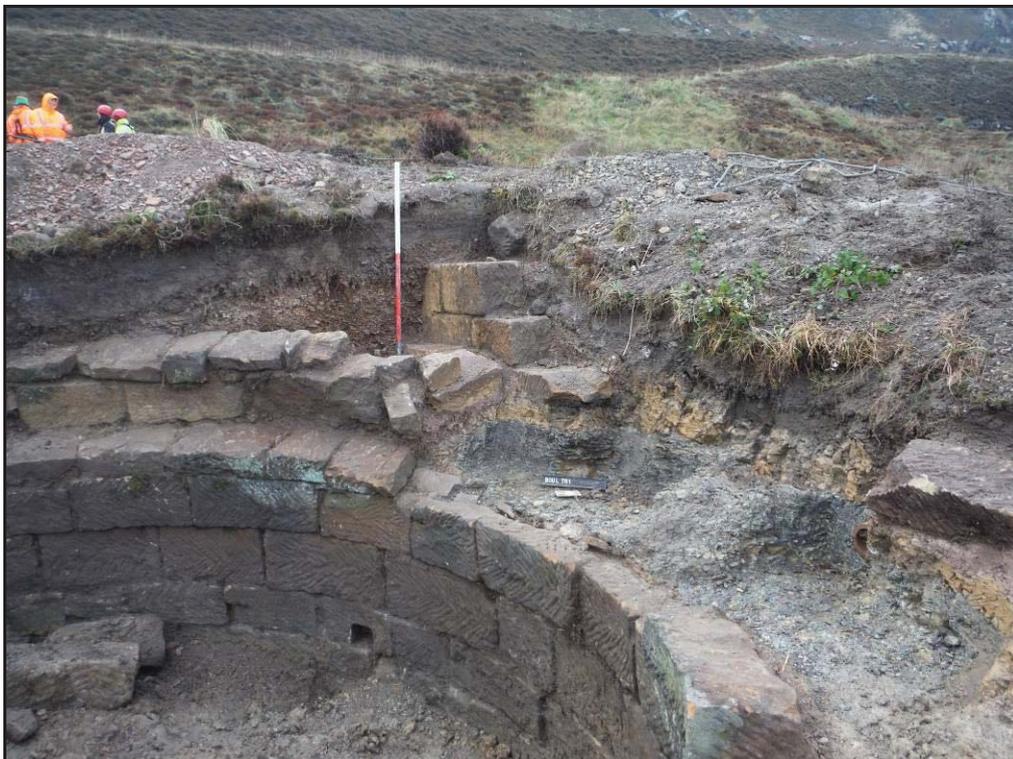
Figure 5- West facing oblique view of structure (118). Note also the socket hole within the wall of the cistern (106), interpreted as a socket for a planked lid on the cistern. (Scale 1 x 1m)

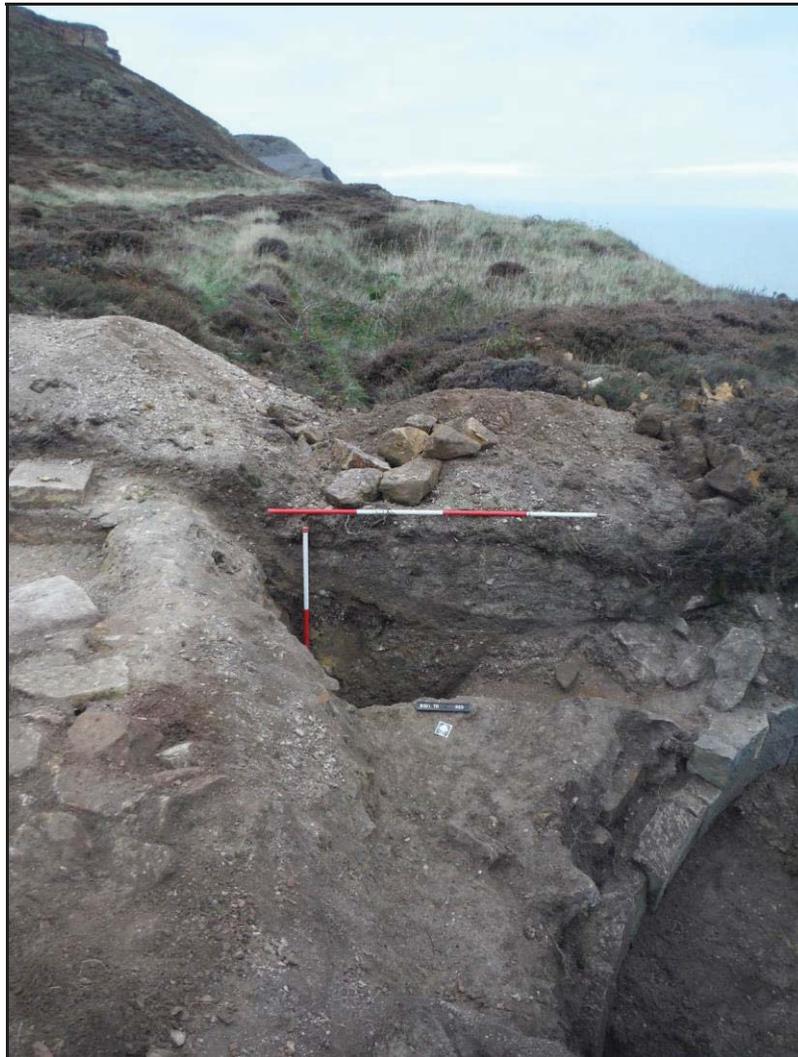
Figure 7- SE-facing section through potential liquor trough F.131. Note continuation of linear depression demarcating the route of the trough north of Trench 1. (Scale- 1 x 1m & 1 x 2m)

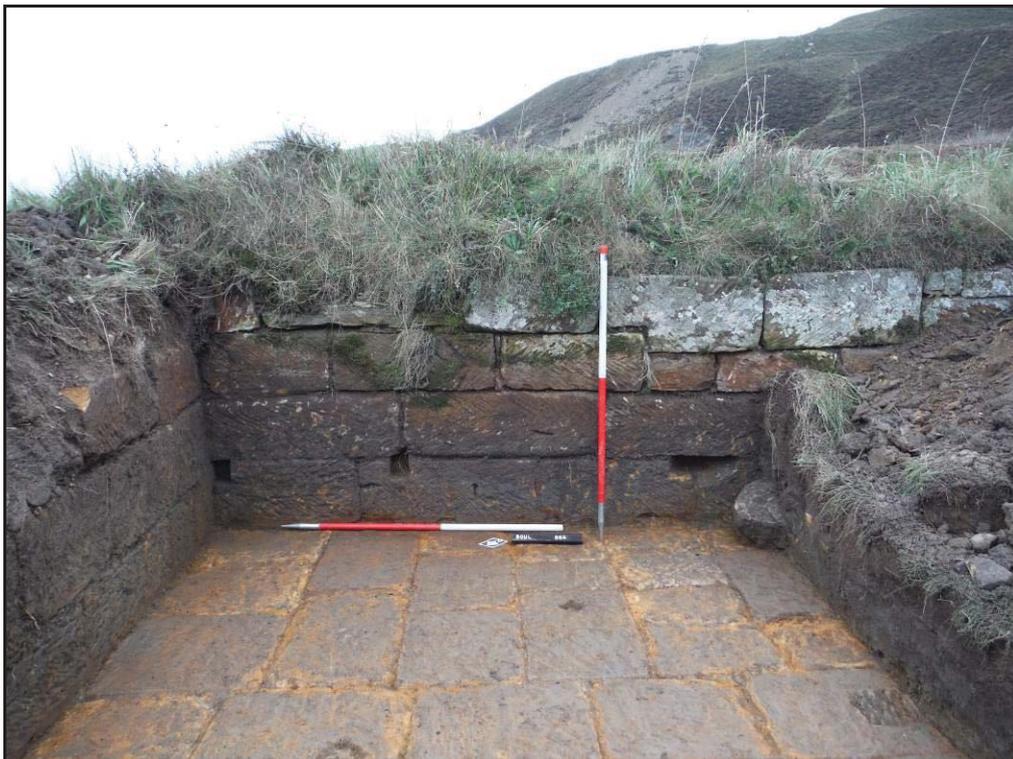
deposit (302). Additionally, socket [309] showed evidence of damage to its borders and displayed traces of brownish-red, oxidised metal adhering to the rear interior face. Consequently, [307], [309] and [311] were interpreted as potential machine sockets or facets for metal structural beams. As previously mentioned, deposits (301), (302), (303) and (312) abutted wall (304) at its eastern and northern extents. Wall (304) was also abutted by flagged sandstone surface (305) (Figure 12-14 & 113).

Figure 13- SE facing view of wall (304). Note sockets [307], [309] and [311]. (Scale- 2 x 1m)

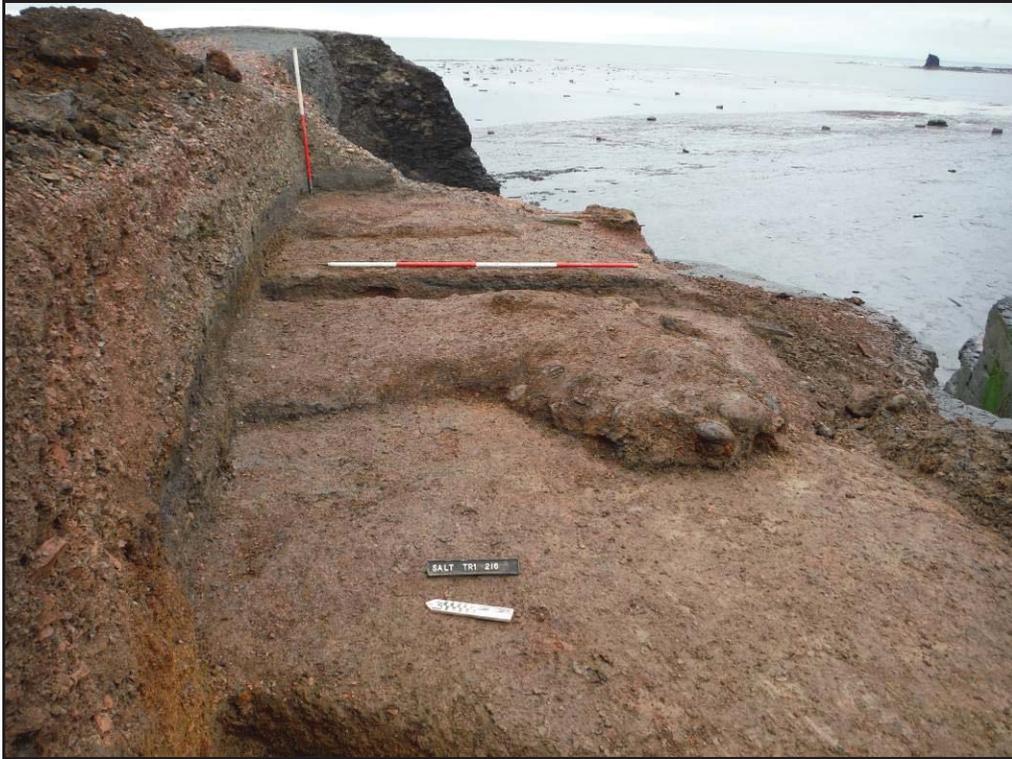
Figure 25- ENE facing view of Trench 1 displaying compacted working surfaces (216) and 219) Note the breach in the unquarried shale bank within the background (Scale- 1 x 1m & 1 x 2m)

2.3.7 It was noted that an unquarried bank of natural shale remained in situ at the seaward extent of the quarry (Figure 25). Although the bank of shale remained outside of excavation Trench 1 its presence was considered significant as an intended sea break created in order to protect the quarry floor from seaward impact. It was hypothesised that the erosion scar upon which Trench 1 was targeted, had been created by a breach within the shale bank. Additional breaches to the shale bank were also identified, across the seaward extent of the unexcavated quarry, north of Trench 1.

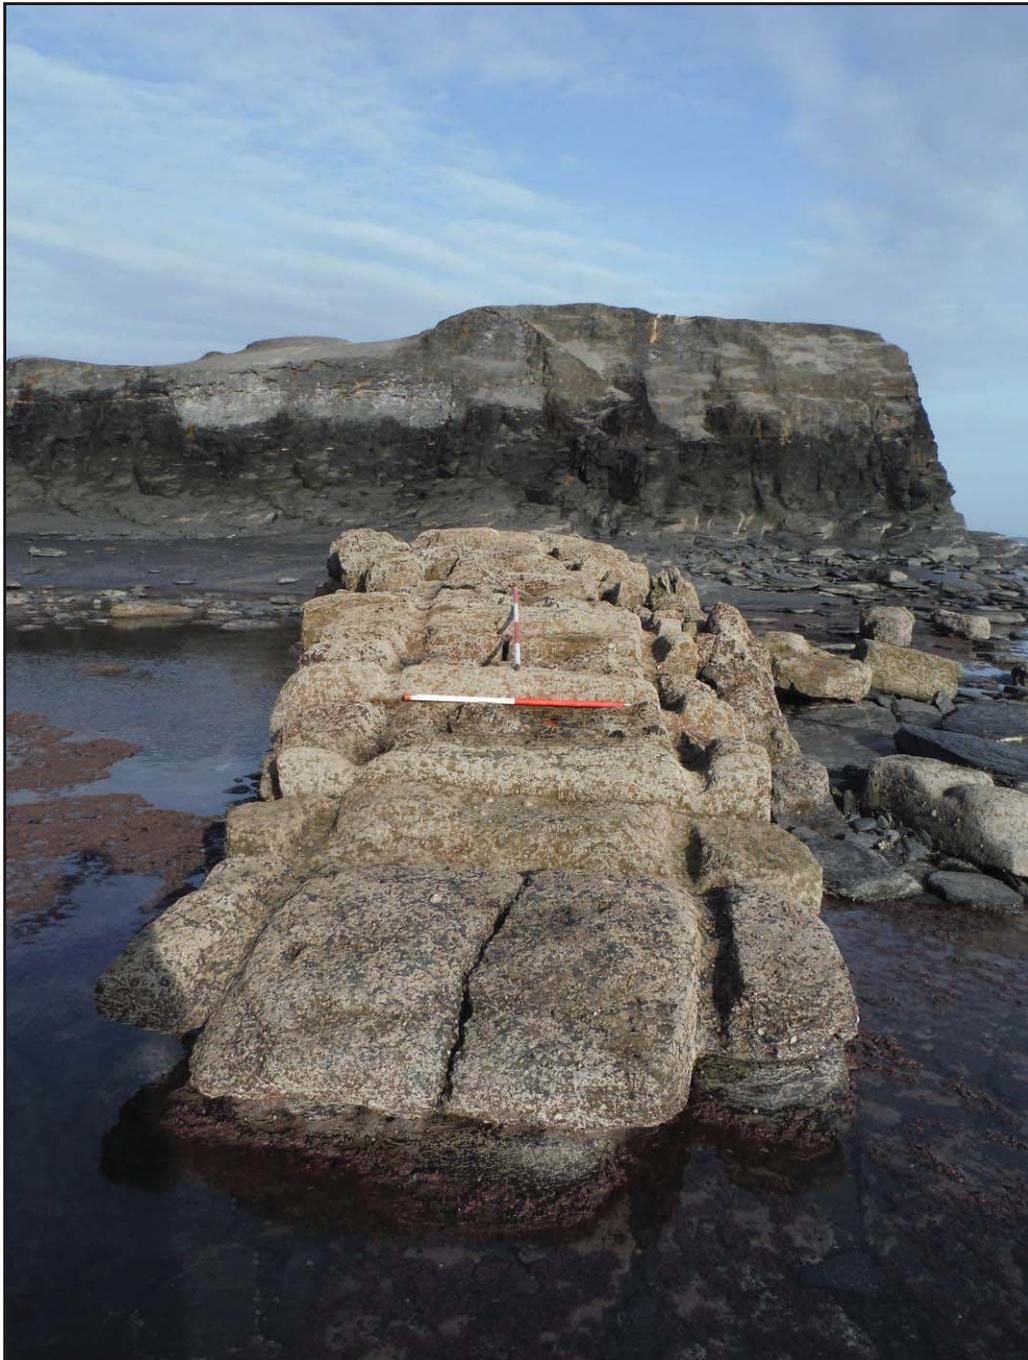
Figure 29- NNW facing view of the slipway at Saltwick. Note the two parallel grooves/tracks within the superior surface of the stonework. (Scale- 1 x 1m & 1 x 2m)

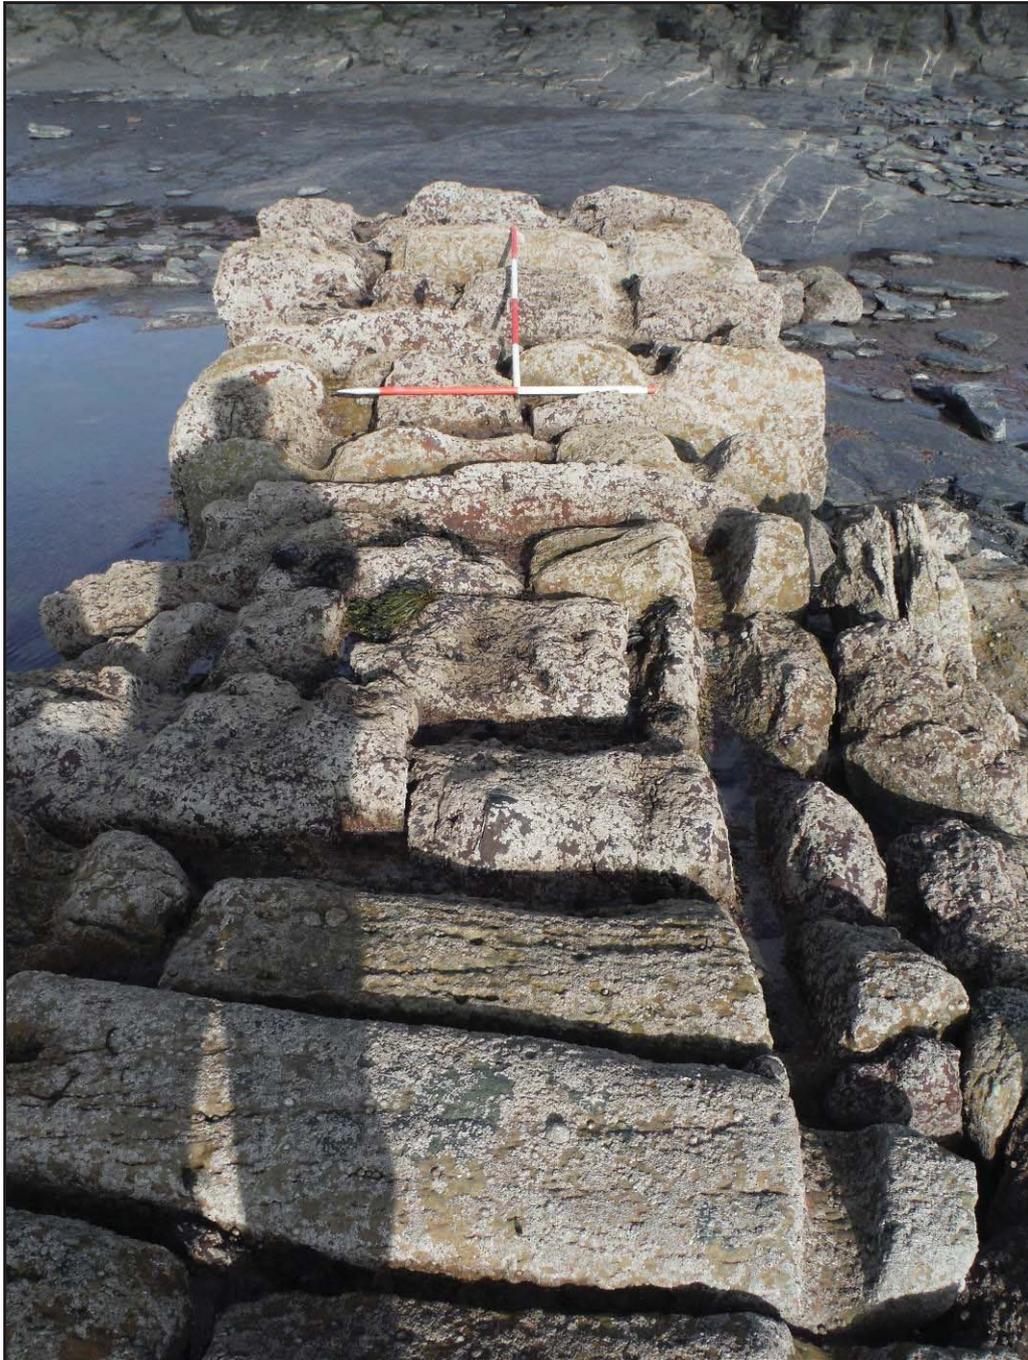
Figure 30 –NNW facing view of the slipway at Saltwick displaying the grooves/tracks cut into the superior surface of the stonework. (Scale- 1 x 1m & 1 x 2m).

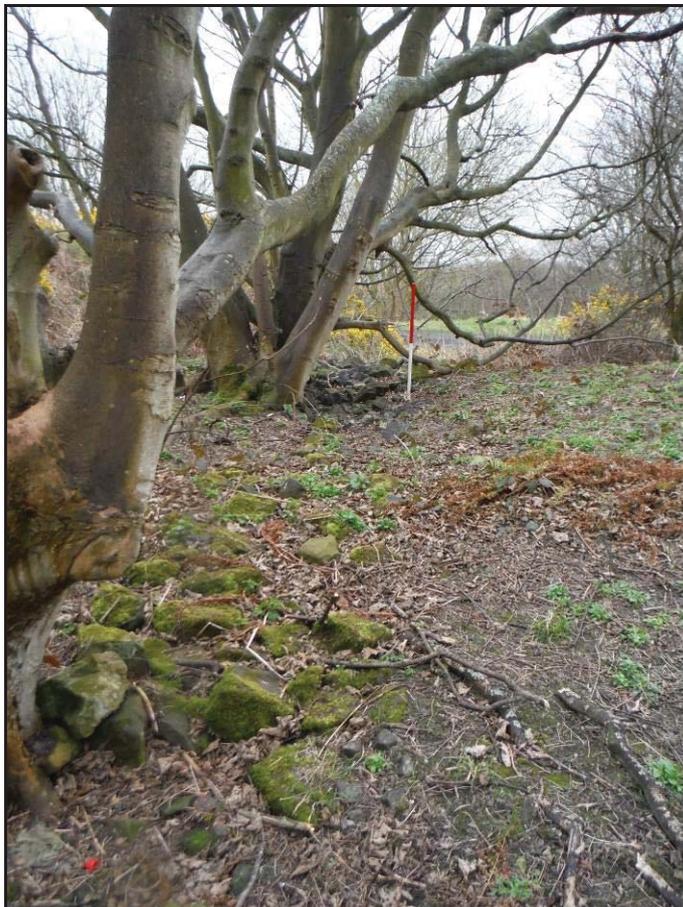
2.4.16.4 **Feature 18** was noted throughout Sandsend Quarries and records the presence of various French drains across the site which appear generally to have been used to drain the quarry floors. The French drains are c.0.5m wide and are variously filled with loose sandstone rubble and/or slag (Figure 37). The drains most likely relate to works undertaken as part of the construction of the Whitby, Redcar and Middlesbrough Railway (**Feature 4**). One such French drain was recorded as a ditch on the aerial photography and Lidar transcription, whilst an adjacent drain was added to the interpretative plan of the site in order to represent their spacing across the Scheduled area. French drains are generally considered to be a trench filled with gravel or rock, or sometimes containing a perforated pipe, that redirects surface water and groundwater away from a certain area.

Figure 37- French drain within the quarry floor at Gaytress Quarry, looking south-east. The drain is filled with sandstone rubble in the foreground and slag material in the background.

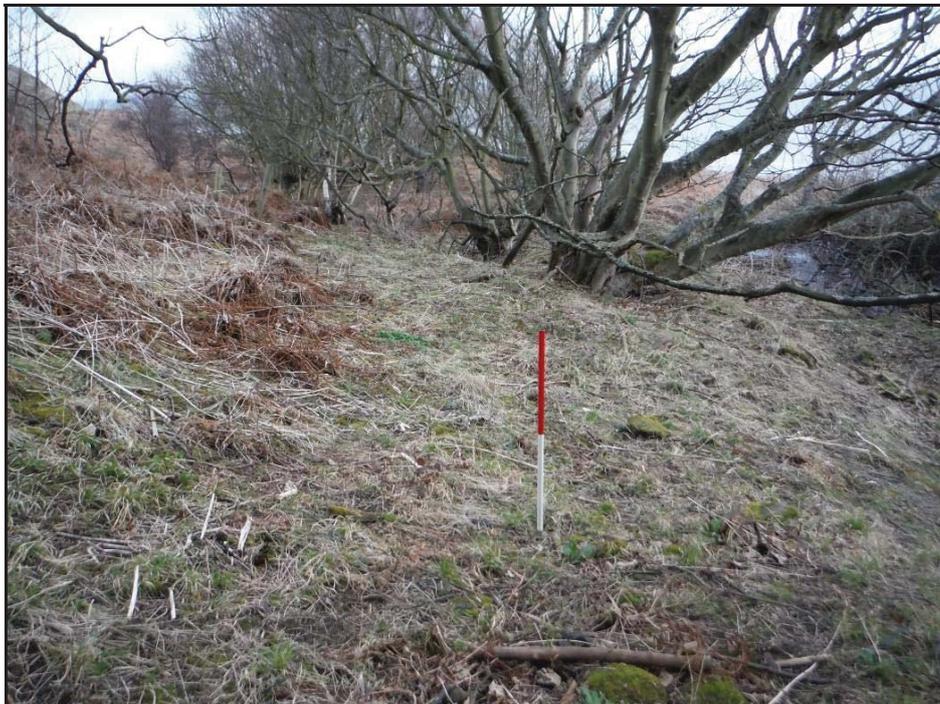
of subsidence or deliberate removal of the former route of the railway was noted (**Feature 22**) alongside a possibly associated dump of slag (**Feature 23**) to the east of the track within a lower quarry floor on this side (Figure 39). The dump of slag may be material derived from the dismantled section of the railway line.

Figure 39- Area to the east of the Whitby, Redcar and Middlesbrough Railway, looking north, showing a dump of slag material sloping down from the left of the photograph onto the quarry floor (Scale- 1 x 1m).

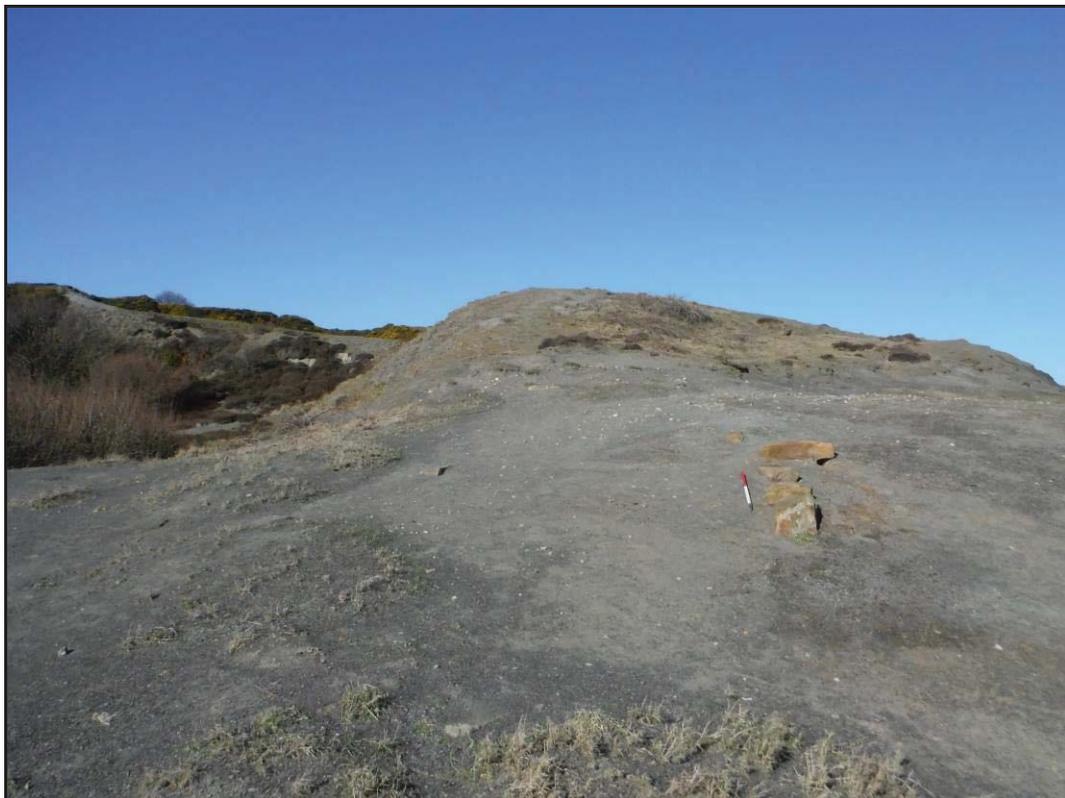
2.4.17.10 Towards the south-eastern extent of **Feature 10**, there are structural remains (**Feature 28**) protruding from loose shale deposits. These take the form of short, single leaf, alignments of dressed sandstone blocks (Figures 70 and 71). The remains appear to be contained within a cut into natural unquarried shale deposits. The structural remains may represent three walls of a building, however, too little was exposed to confirm this. A building in this location may have been related to processes taking place in the adjacent steeping pits (**Feature 8**). The remains appear to pre-date **Feature 10**, however excavation would be needed to confirm this relationship.

Figure 70- Structural remains at the south-eastern end of Feature 10, looking north-west (Scale- 1 x 1m).

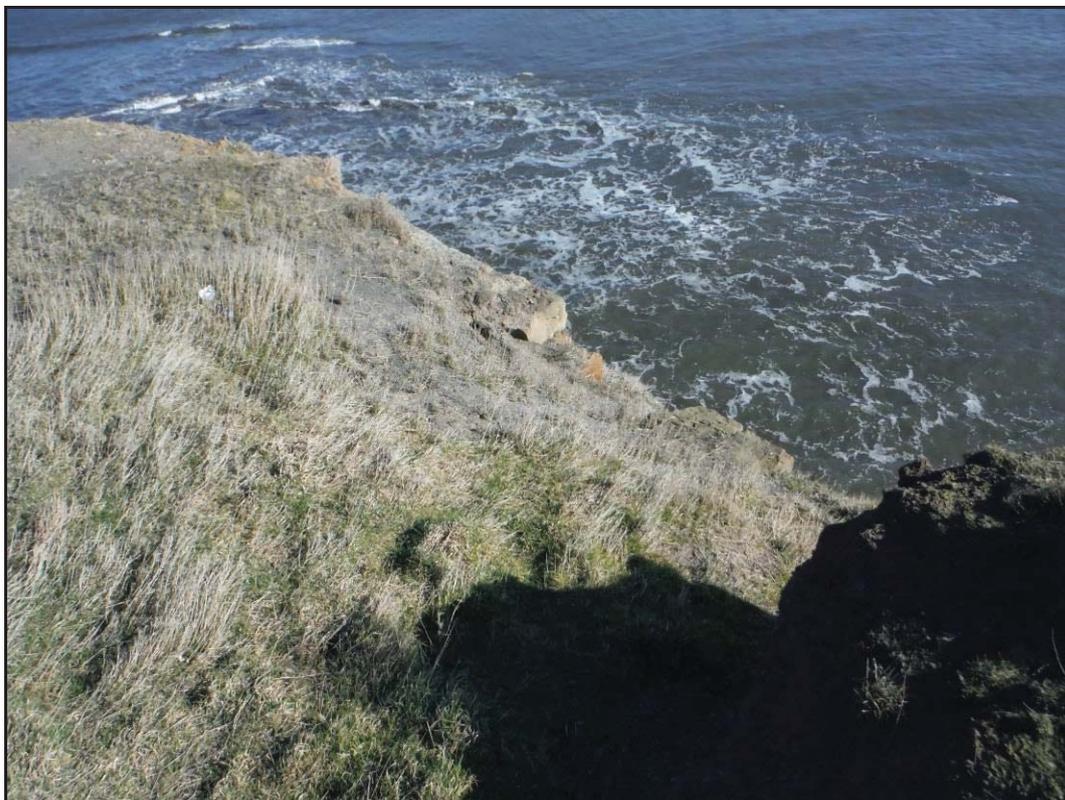
2.4.17.11 Further structural remains were also noted eroding out of the cliff to the east of **Feature 28** (Figure 72). These are likely to be part of a separate structure, however, there was no surface evidence of this feature.

Figure 72- Structural remains eroding from the cliff face within Ness End Quarry, looking north.

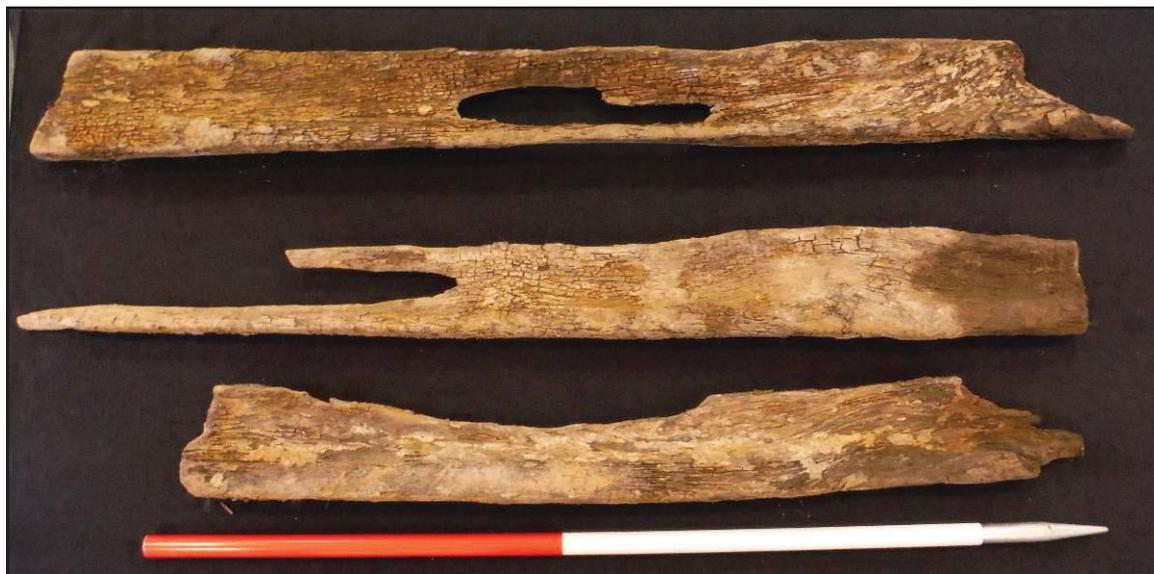
3.1.1 Three wooden planks were recovered from the upper part of a fragmentary working/ floor surface [216] within Trench 1 at Saltwick Nab Alum Quarry. The planks are all in average condition with all three heavily abraded/worn and only partially surviving.

Figure 92- Vertical view of wooden planks (Scale- 1 x 1m).
