An Archaeological Evaluation at London Road, Hazel Grove Stockport.

ARS Ltd Report 2008/36

An Archaeological Evaluation at Hazel Grove, Stockport .

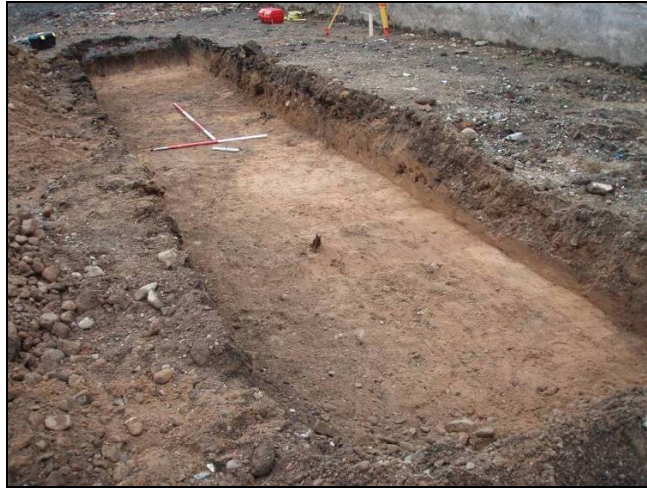
Fig. 2 Trench 1, facing west. (Scale: 2m)

- 2.2.1 Trench 1 was located along the north wall bounding of the site close to the Conservative club and measured 10.23m x 2m (Fig. 2). The stratigraphy of the trench consisted of a made ground/topsoil (001), identified across the site, existing to a depth of up to 0.7m in places. The topsoil (001) was predominately made up of a dark brown soil with brick, stone and gravel inclusions together with some modern waste. The deposit directly overlay a natural orange sand substratum (002), found across the site at varying depths.

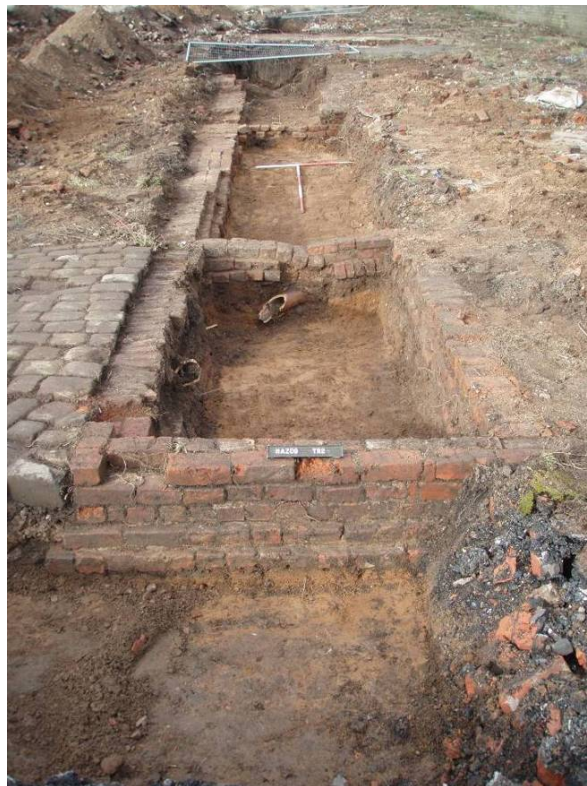
Fig. 3 Trench 2, facing north east. (Scale: 2m)

- 2.3.1 Trench 2 was located along the north east wall close to the car wash and London Road. The trench was placed with the aim of targeting the building shown on the 1813 enclosure map (Fig. 3). The building would have originally fronted on to 'Shady Lane' which now lies below the northern site boundary.

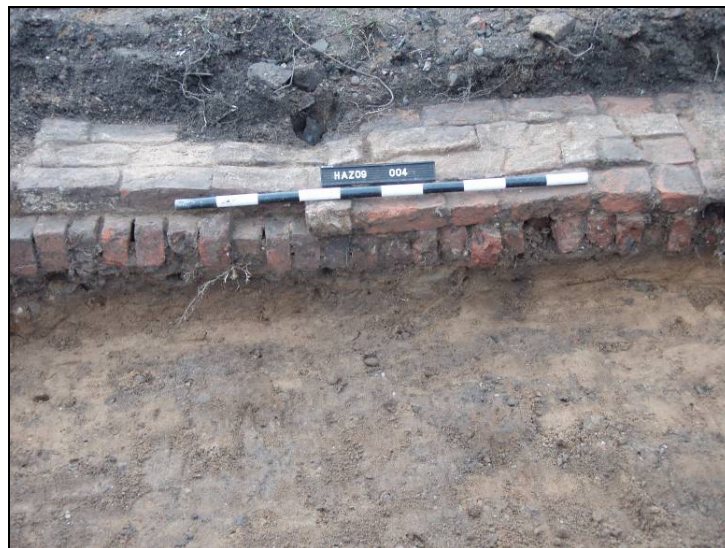
Fig. 4 Building 1: View of brick wall (004), facing west. (Scale: 1m)

- 2.3.3 The first phase of the building was a substantial brick wall (004) in the south east end of the trench (Fig. 4). The wall ran on a roughly north-west south-east alignment with two returns running to the north east towards Shady Lane. The wall comprised of a single skin and at least three courses above a stepped foundation layer of two courses with a double skin (004). The wall at its maximum measured 0.5m across, while the bricks were largely uniform in size, measuring 0.22m x 0.11m x 0.08m, and were bonded with a loose, sandy mortar.

- 2.3.4 The bricks were laid in a header bond along the long section of wall that formed the back edge of the trench with the exception of a 2m section where a stretcher bond was used with the foundation layers bedded on their side (Fig. 20, Appendix II). This may represent an original entranceway, as it was too low in the wall to represent a separate phase of building such as a later infilling (Fig. 4).

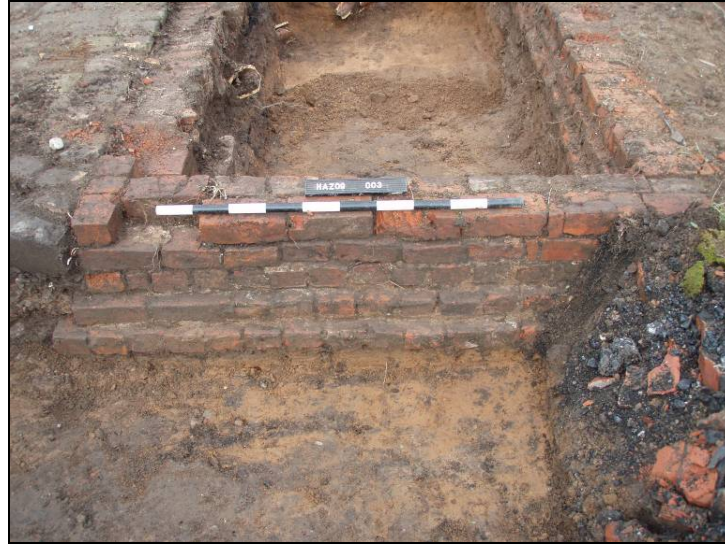
Fig. 5 Building 1: View of brick wall (003), facing north east. (Scale: 1m)

- 2.3.5 A second phase to the building was represented by a short section of wall (003) that abutted (004) the most southerly end of the trench and returned to the north east towards Shady Lane (Fig. 5). A short section of wall (005) which was

a three course, single skinned stepped foundation wall abutted both (003) and (004) to create a small end room measuring 2.75m by 1.42m on the interior. A similar internal wall (014) was found to abut (004) which served to divide the rest of the building into two rooms measuring 5.3m by 1.25m on the interior. All of the walls were bedded on a natural yellow sandy clay layer (009).

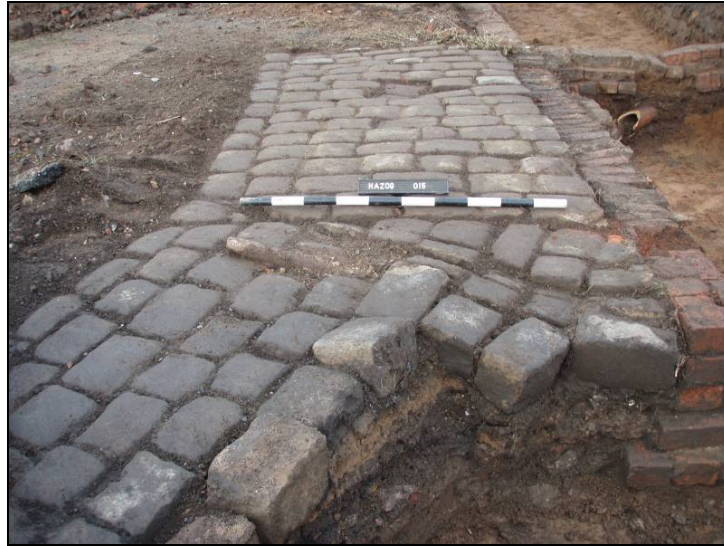
Fig. 6 Building 1: View of cobbled area (015), facing north. (Scale: 1m)

- 2.3.6 Outside the area of the trench there was a cobbled area (015) at the south end of the trench abutting Building 1 (Fig. 6). The cobbled area measured 2.7m x 2.1m. The stones were all roughly uniform in size and shape (0.2m x 0.15m x 0.15m) and were bedded on a sandy levelling layer (009) which was the same foundation layer as below wall (004) from which a number of sherds of Post-Medieval pottery and a Post-Medieval clay pipe stem were recovered from (Appendix III - specialists report).

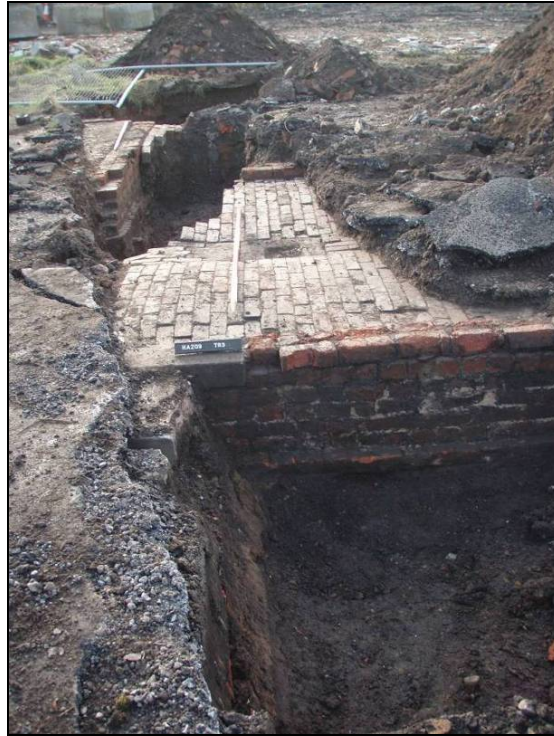
Fig. 7 Trench 3, facing west. (Scale: 2m)

2.4.1 Trench 3 was located along the south east wall close to the MacDonald's car park (Fig. 7). The trench measured 8m x 2m and revealed the presence of a red brick building (Building 2) below the made ground topsoil (001).

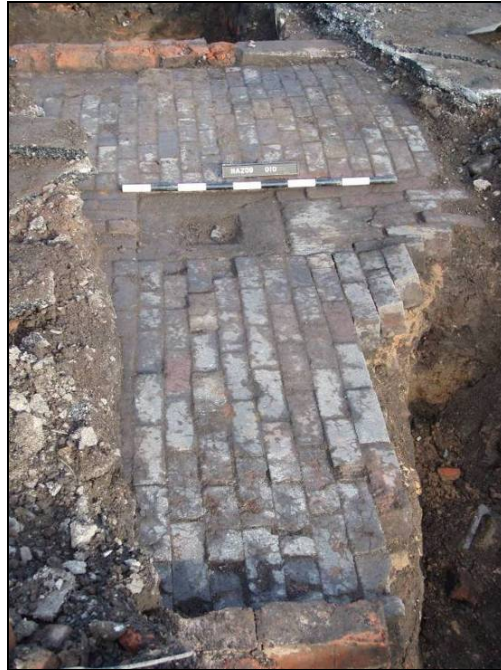
Fig. 8 Building 2: Brick floor (010), facing west. (Scale: 1m)

- 2.4.3 A brick floor (010) was located at ground level running south west from the wall (006) (Fig. 8). The bricks were mostly uniform in size measuring 0.24m x 0.09m and red/grey in colour. They were laid on side, in a stretcher bond. The bricks generally ran on an east west alignment apart from where they were interrupted by a sunken stone drain that was flanked by bricks also running on a north south alignment. A modern service trench had destroyed a large portion of the floor and walls through the centre of the trench. The floor continued on the other side of the gap next to the wall (016). At the south west corner of the trench there appeared to be an internal wall which consisted of double skinned, six course wall seen in section where the floor fell away (Fig. 23 Appendix II).

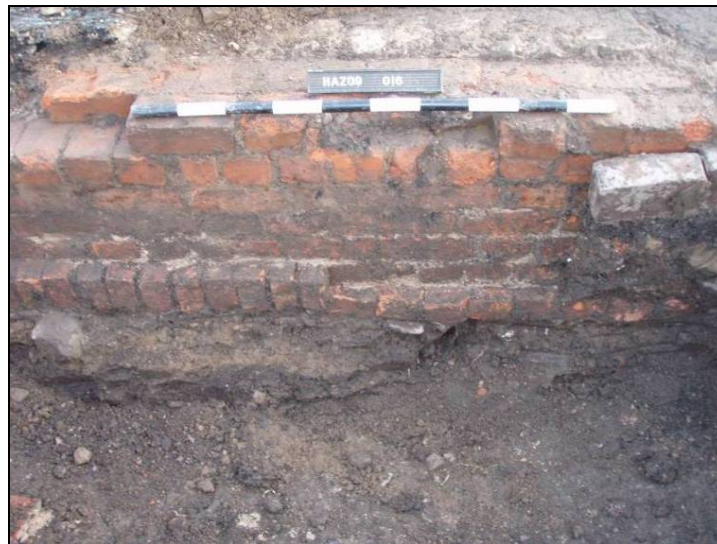
Fig. 9 Building 2: Brick wall (018), facing south. (Scale: 1m)

- 2.4.4 Another external structural wall (016) relating to building 2 was identified in the south west end of the trench. The wall was a double skinned, seven course wall with a stepped foundation level very similar to (006). Remains of the brick floor level (010) could be seen abutting the wall. It was difficult to give any dimensions for this building as its full extent could not be established during the evaluation, but it could have been up to 6m across.

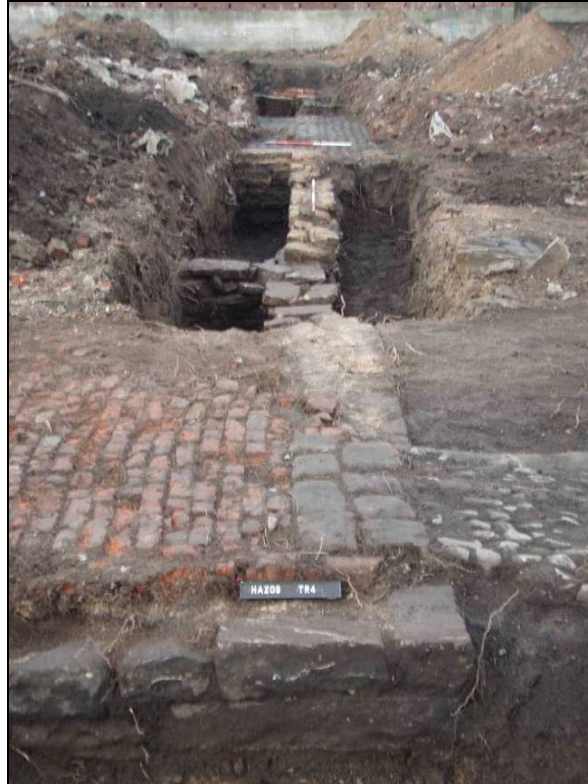
Fig. 10 Trench 4, facing north west. (Scale: 2m)

2.5.1 Trench 4 was located on a north south alignment *c.* 7m south west from Trench 3 in order to target the building shown there on historical maps (Building 3) (Figs. 10 and 27). The trench measured 25.85m x 2.5m and was 'L'-shaped in order to pick up the return wall of the building.

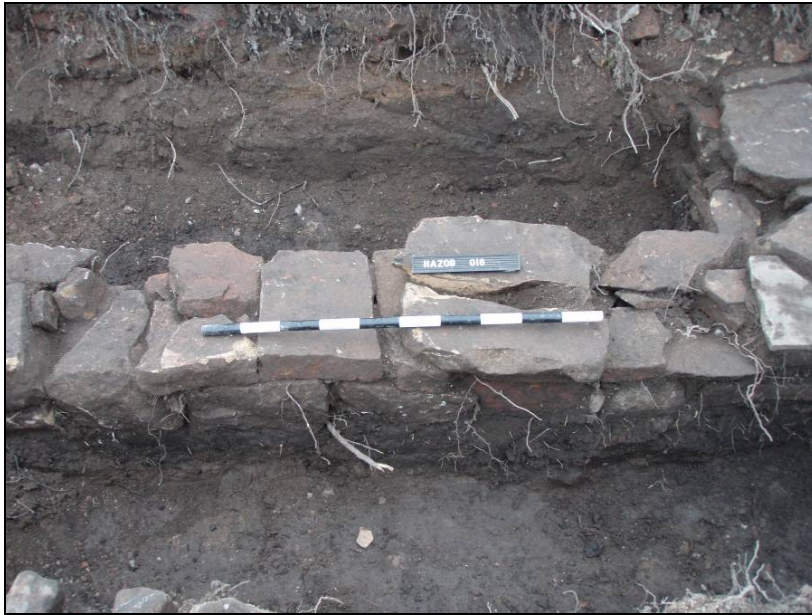
Fig. 11 Building 3: Sandstone foundation wall (018), facing west. (Scale: 1m)

- 2.5.2 The trench was found to contain a substantial sandstone foundation wall that ran for almost the length of the trench with the return wall being picked up in the area of trench running south west (Fig. 11). The wall measured 11.5m by up to 0.6m in places and was constructed from two skins of roughly hewn sandstone blocks up to five courses deep. Flat stones had been used to level the wall and the skins had a core of small stones in places.

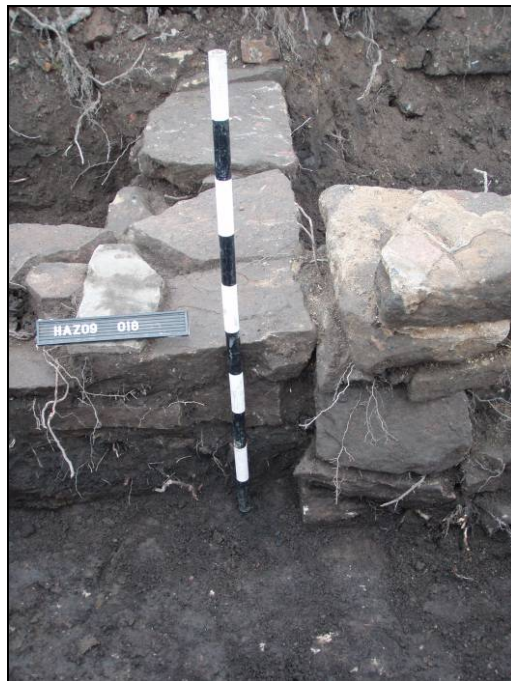
Fig. 12 Building 3: Sandstone wall (018 and (019)abut, facing west. (Scale: 1m)

- 2.5.3 The wall appeared to have had two distinct phases of build creating two adjacent square shaped rooms (Fig. 12). The first phase (018) ran for approximately 7m from the south west end before returning wall into the west baulk of the trench. The second phase (019) abutted this wall and ran for another 4.5m on the same alignment before its return wall turned and also ran into the west baulk of the trench. The wall was obviously the foundation layer of a substantial building. A brick wall would have been built on top of this layer, as seen at the end corner of (019) where a course of bricks (024) directly overlies the sandstone foundation (Fig. 13).

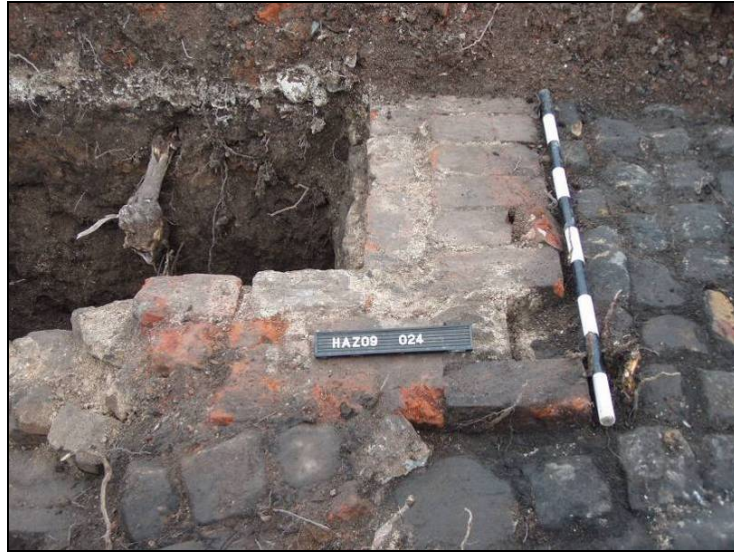
Fig. 13 Building 3: Brick wall (024), facing west. (Scale 1m)

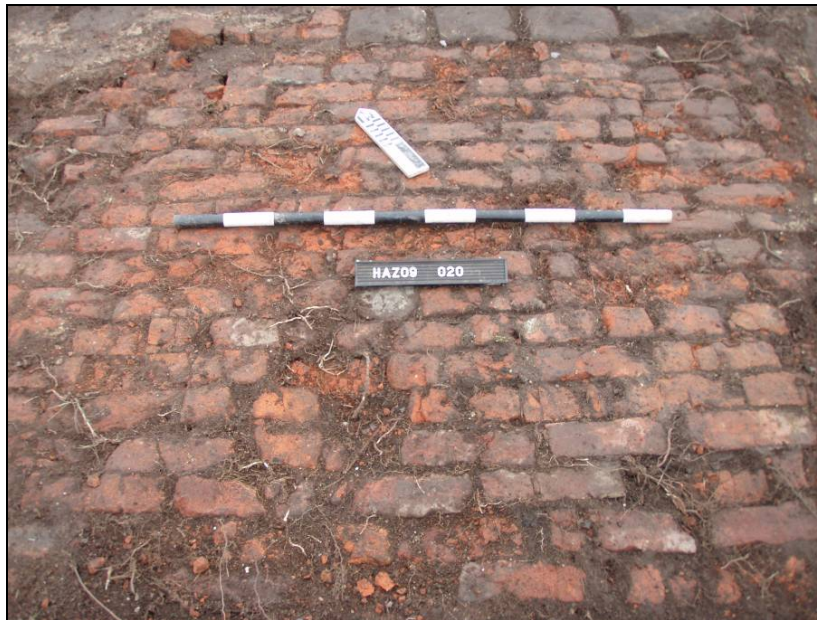
Fig. 14 Building 3: Red brick floor (020), facing north. (Scale: 1m)

- 2.5.4 The end wall corner abutted an area of brick floor (020) measuring 1.8m x 1.4m (Fig. 14). The floor was a single course deep with some of the bricks in a poor state of repair. The bricks measured 0.23m x 0.09m, and were laid on edge in a stretcher bond. On the other side of the wall (018), to the east, there was another area of cobbled floor (021) measuring 1.7m x 1.8m (Fig. 15). Both of these floor levels represent exterior areas, possibly courtyards, relating to building 3.

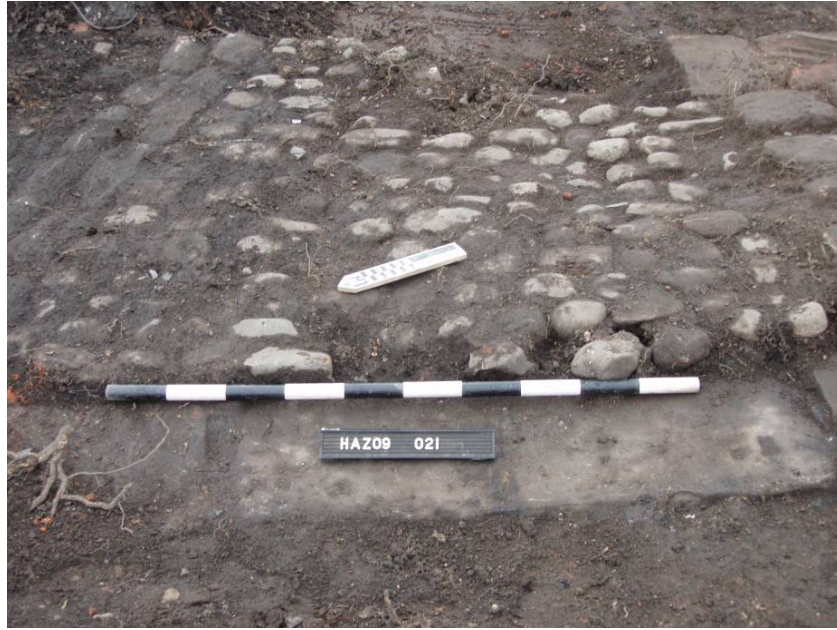
Fig. 15 Building 3: Cobbled area (021), facing south-east. (Scale: 1m)

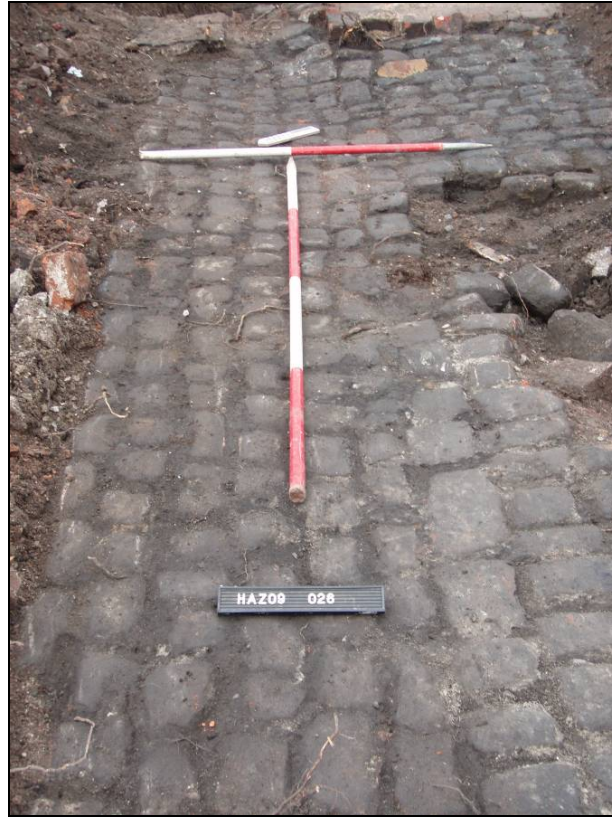
Fig. 16 Building 3: Large cobbled area, facing north. (Scale: 1m)

- 2.5.5 A large area of cobbles (026), directly abutting the north west end of the foundation wall (019), extended for 5m (Fig. 16). The cobbles were mainly uniform in size and were laid on a north-south alignment for approximately half of the floor providing an edging to the cobbles. This area probably represented a yard either at the end of Building 3 or between two contemporary buildings. The remains of two brick walls (025 and 029), probably contemporary with the cobbled floor, lie 4.6m apart from each other at the north-west end of the trench. Modern disturbance between the walls has meant that it is impossible to state accurately if these walls are part of the same building though it seems likely due to their positions. The cobbled floor level appears to be contemporary with both of them.

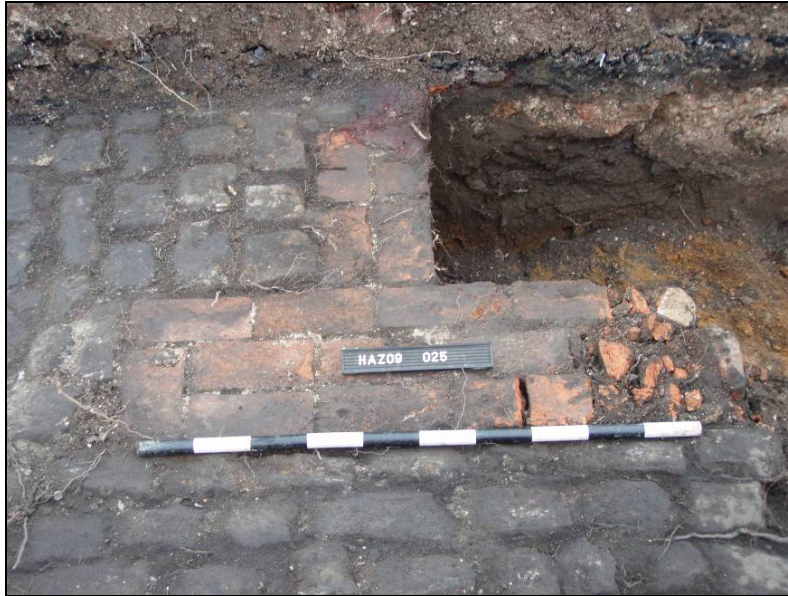
Fig. 17 Building 3: Brick wall (025), facing west. (Scale: 1m)

- 2.5.6 The brick wall (025) survived only as a small 'L'-shaped corner that measured 1.2m x 1m (Fig. 17). The north south wall was three skins wide by four courses deep and was laid in a stretcher bond with the return being the same number of courses but only two skins wide. The wall (029) was three skins wide by six courses deep and appeared to be an English Garden Wall Bond 1 in 5 though there was not enough wall remaining to confirm this (Fig. 18). The return wall was only a single skin wide and six courses deep.

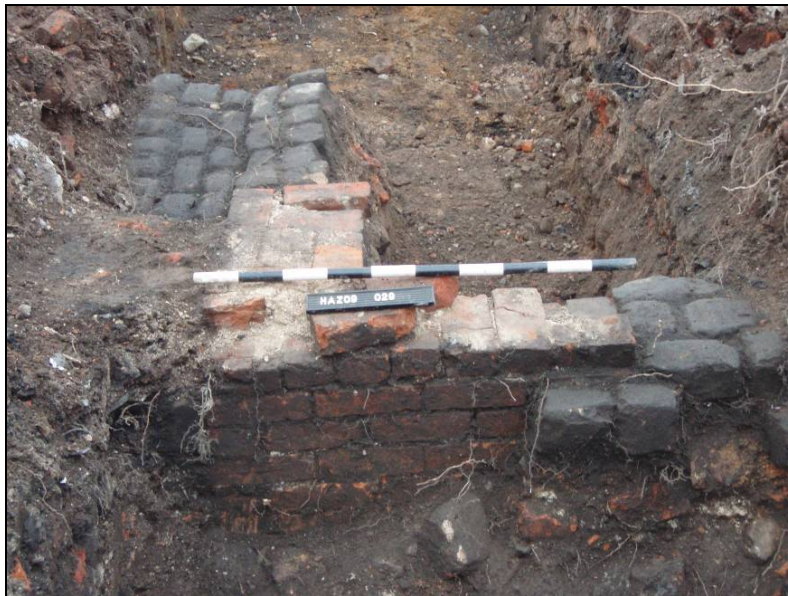
Fig. 18 Building 3: Brick wall (029), facing south. (Scale: 1m)

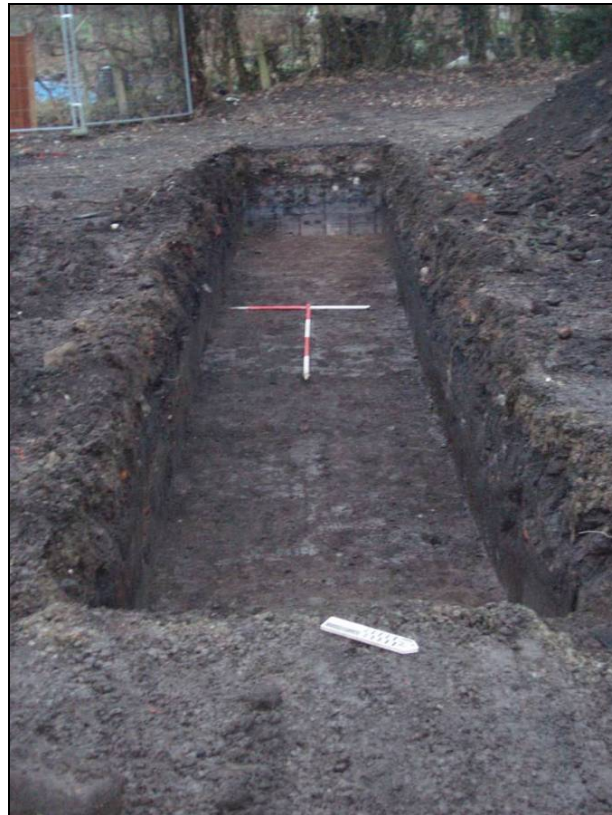
Fig. 19 Trench 5, scale: 2m

2.6.1 Trench 5 was located in the south west area of the site that appeared free of previous development on the historical maps (Fig. 19). The trench measured 10.3m x 2m and consisted of a thin layer, approximately 0.2m thick, of made ground (011) directly below the topsoil (001). The deposit was a coarse, dark brown, clay with small rounded stones and gravel and brick inclusions which measured approximately 0.2m in thickness, the top of which was located approximately 0.3m below the modern ground level.

- 2.6.2 Below (011) at the base of the trench a dark greyish brown sandy clay was encountered (012). The layer was firm and clean from any building rubble. In consultation with the consultation with Assistant County Archaeologist, Trench 5 was not taken any deeper than deposit (012) as the proposed development will not impact tot his depth, and any further excavation would have required shoring or other safety measures.

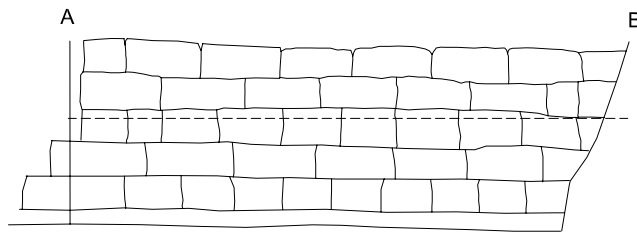
Figure 21
 Sections from Trench 2

N facing section of brick wall (003)

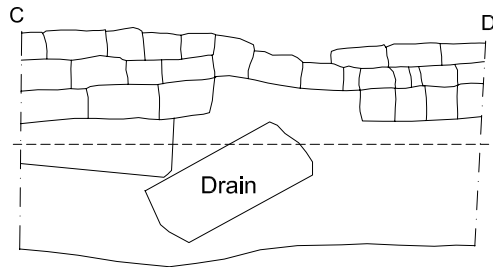
N facing section of brick wall (004)

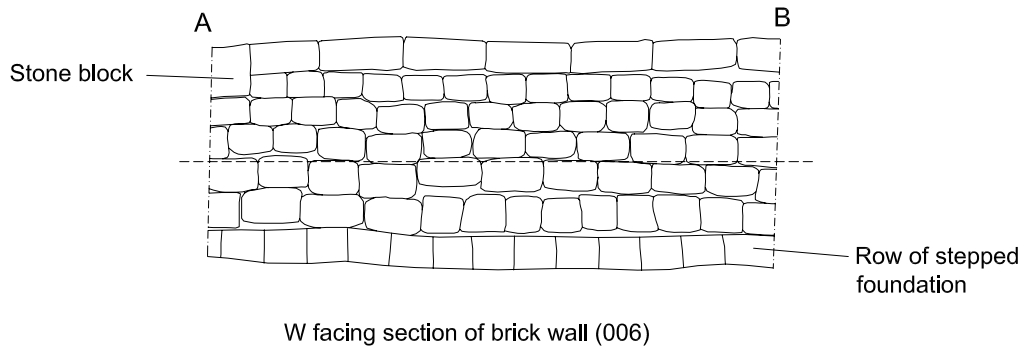
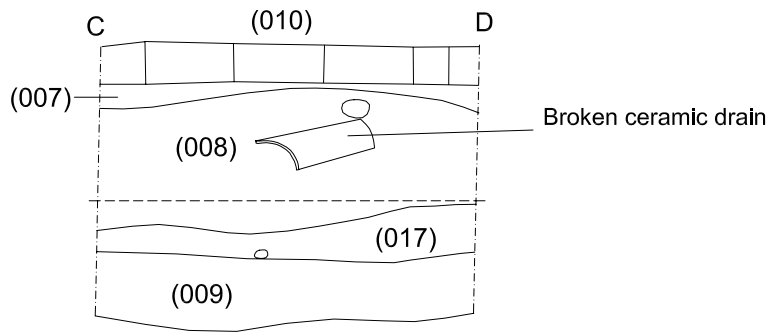
Figure 23
 Sections from Trench 3

N facing section of brick floor (010) and deposits below

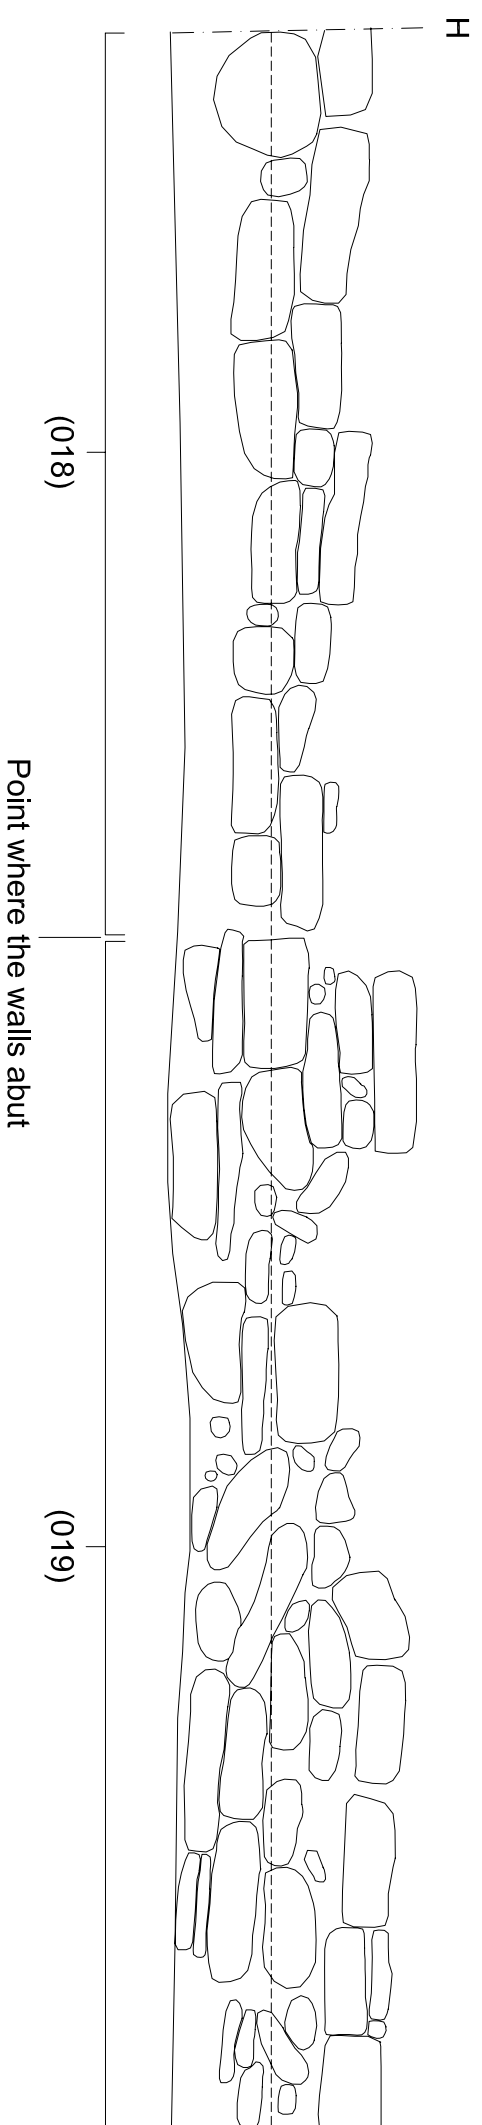
Figure 25
Section of walls (018) and (019)

West facing section of sandstone walls (018) and (019) in Trench 4 (Building 3)

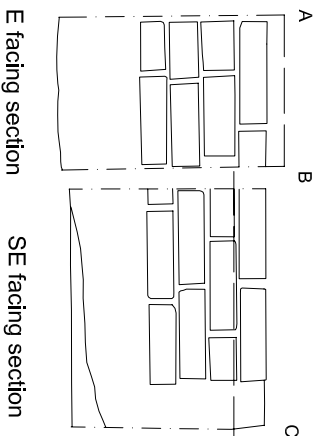
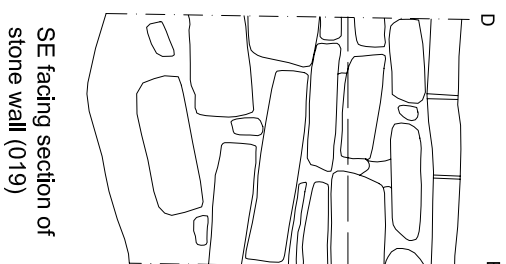
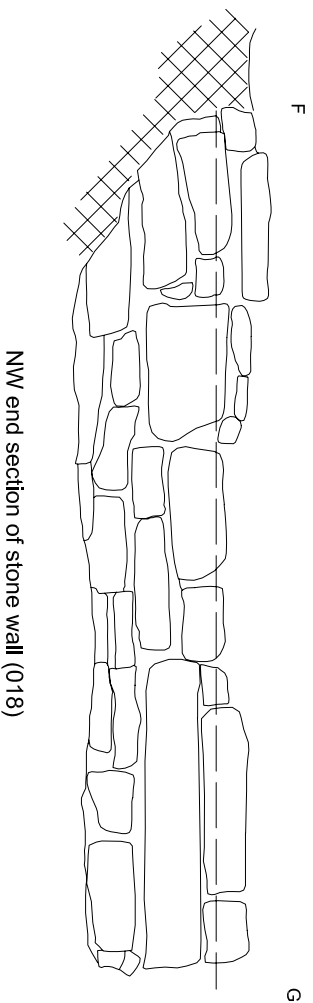
Figure 26
 Sections from Trench 4

Corner of brick wall 025
