# Archaeological Excavation and Survey of Scheduled Coastal Alum Working Sites at Boulby, Kettleless, Sandsend and Saltwick, North Yorkshire

ARS Ltd Report No-2015/42  
OASIS No: archaeo15-208500

Compiled By:  
Samantha Bax, Rupert Lotherington PCIfA and Dr Gillian  
Scott  
Archaeological Research Services Ltd  
The Eco Centre  
Windmill Way  
Hebburn  
Tyne and Wear  
NE31 1SR

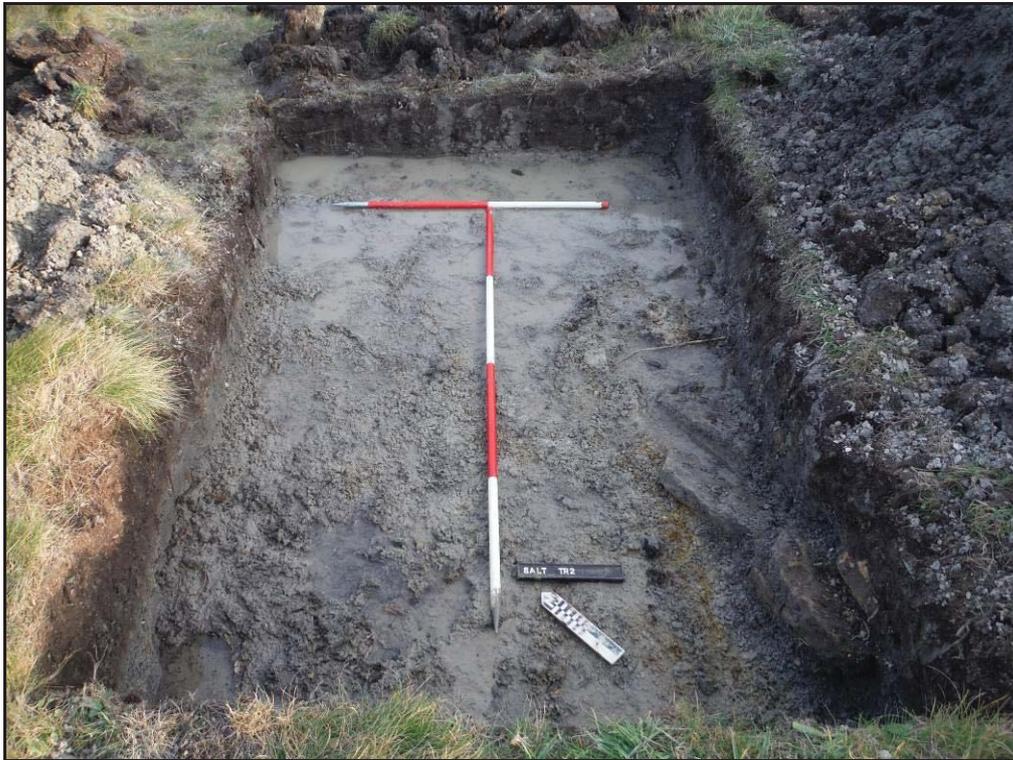
Figure 26- NE facing view of Trench 1 (Scale- 1 x 1m & 1 x 2m)

2.3.8 Trench 2 measured 3m x 2m x 0.45m at its maximum extents and was located 43.98m SE of Trench 1 (Figure 26 & 96). Trench 2 was excavated across eroding quarry edge deposits associated with the Saltwick alum works but was compromised by a high water table which prevented excavation below a depth of 0.45m below ground level. The uppermost deposit within Trench 2 was a brownish-grey, topsoil (101). Topsoil (101) displayed a maximum depth of 0.16m and overlay subsoil (102). Subsoil (102) was visible across the full extent of Trench 2 and had a maximum depth of 0.13m. Subsoil (103) overlay both a bluish-grey, silty-clay (103) and a poorly sorted, deposit of large sub-angular sandstone fragments. Deposit (103) was visible across the base of Trench 2 and continued beyond the limits of excavation (Figure 26). Sandstone (104) was visible principally in section and displayed a maximum depth of 0.16m. Both clay deposit (103) and sandstone layer (104) were tentatively interpreted to be collapse deposits of the superficial geological substrate from the nearby cliff edge. The exposed deposits within Trench 2 were not considered to be of archaeological significance.

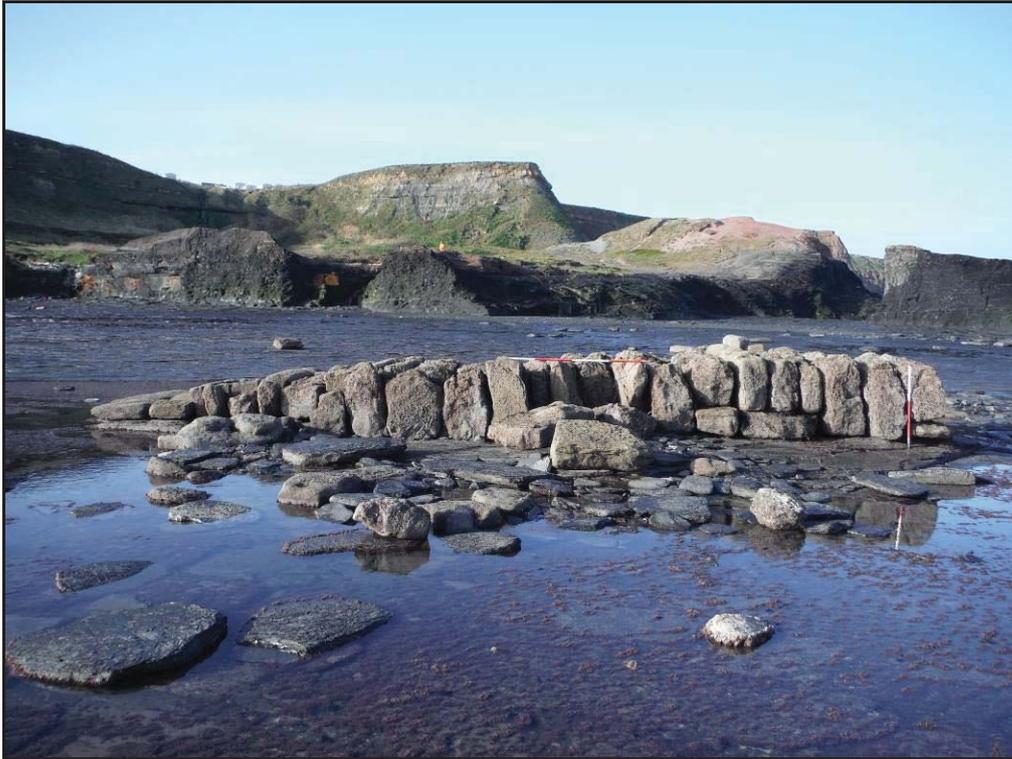
2.3.10 The slipway measured 12.5m x 3.26m x 1.10m at its maximum current extents and was constructed from large, sub-square, shaped sandstone blocks (Figure 27-32 & 125-128). The individual sandstone blocks measured an average 0.98m x 0.67m x 0.68m and displayed no evidence for the use of any bonding materials during construction. Two courses of stonework were identifiable 3.39m south of the northern extent of the quarry. The remaining stonework was constructed to a single, regular course. Additionally, the slipway was aligned on a broadly NNW-SSE orientation and sloped from a maximum height of 1.10m at its northern extent to 0.17m above ground level at its southern extent. Two parallel, near vertically sided grooves had been cut into the superior surface of the slipway and were interpreted as a rutway. The rutway's tracks were similarly aligned on a NNW-SSE orientation and measured an average 11.9m x 0.14m x 0.09m at their maximum extents (Figure 27-32 & 125-128). Associated rutways were also identified cut into the stone geology of the foreshore and ran, on a curving NE-SW alignment, from the southern extent of the slipway.

Figure 27- West facing view of the slipway at Saltwick (Scale- 1 x 1m & 1 x 2m)

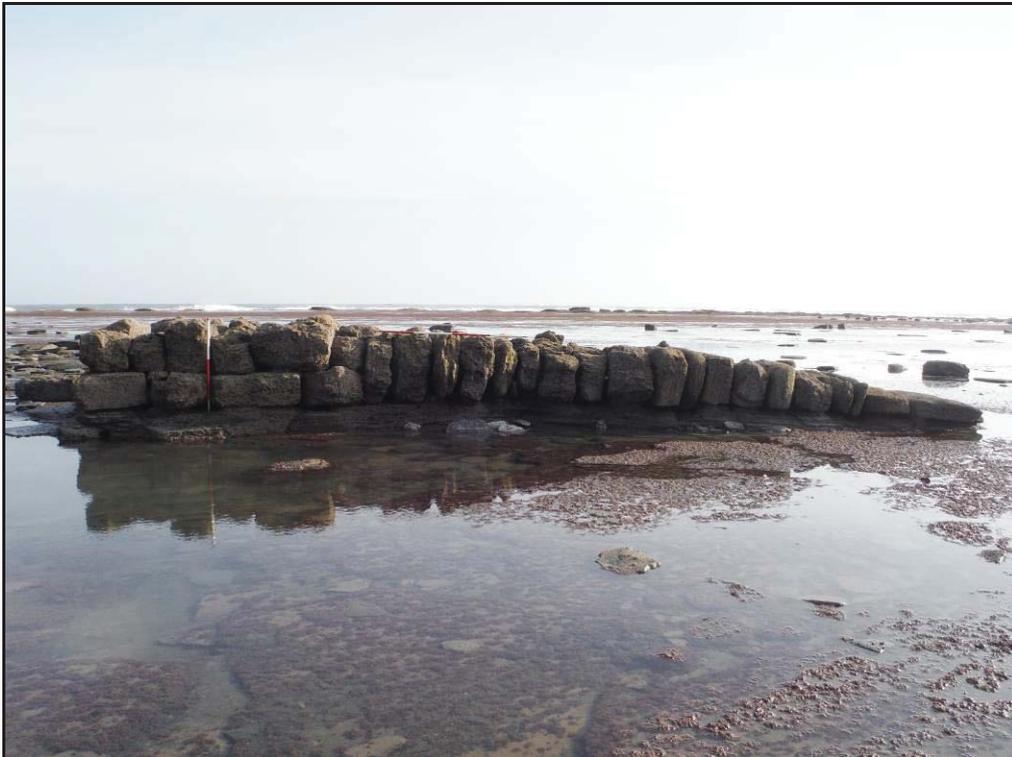
Figure 28- East facing view of the slipway at Saltwick (Scale- 1 x 1m & 1 x 2m)

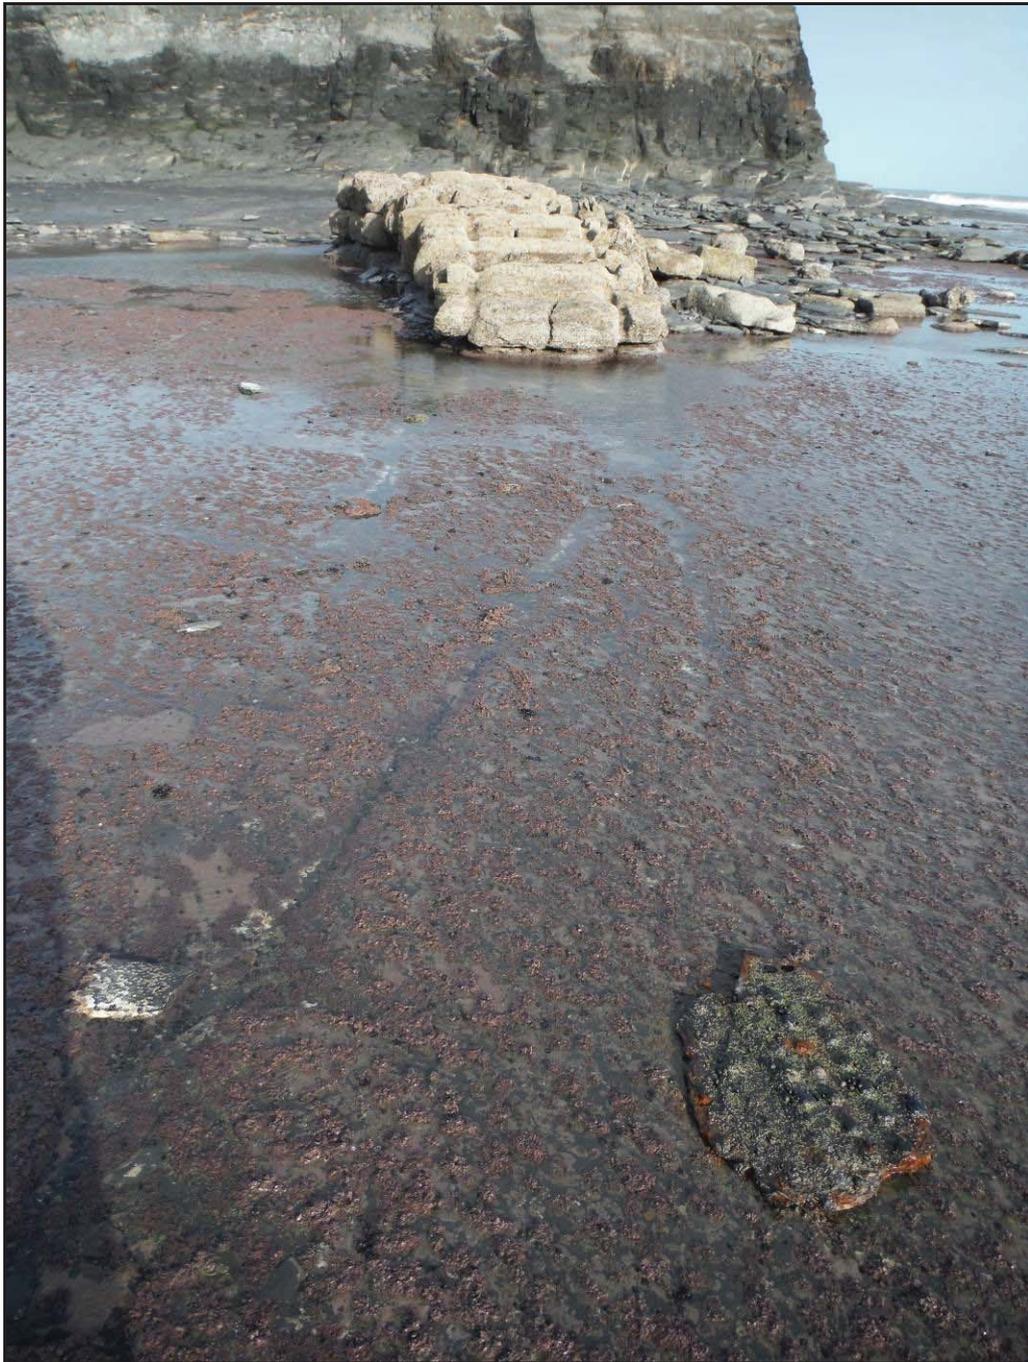
2.3.11 The slipway was interpreted as being used for the transportation of materials, associated with alum production, during the 17th or 18th century. The presence of the rutway on the surface of the slipway and within the stone foreshore may indicate that materials were transported by wheeled carts to and from the alum quarry into shallow bottomed boats which were located at the northern extent of the structure. Similarly, it would not be unreasonable to assume that the slipway originally extended northwards towards Saltwick Nab and that materials were run across the Nab and down the slipway towards the non-scheduled harbour located upon the southern shore of Saltwick Bay. It should be noted, therefore, that the structural form and composition of the slipway was similar to the materials identified within the harbour and may suggest that both structures were broadly contemporaneous. However, both of the afore-mentioned interpretations are speculative and should not be considered definitive explanations for the function of the slipway.

Figure 31- N facing view of the slipway and associated stone-cut trackway within the foreshore.

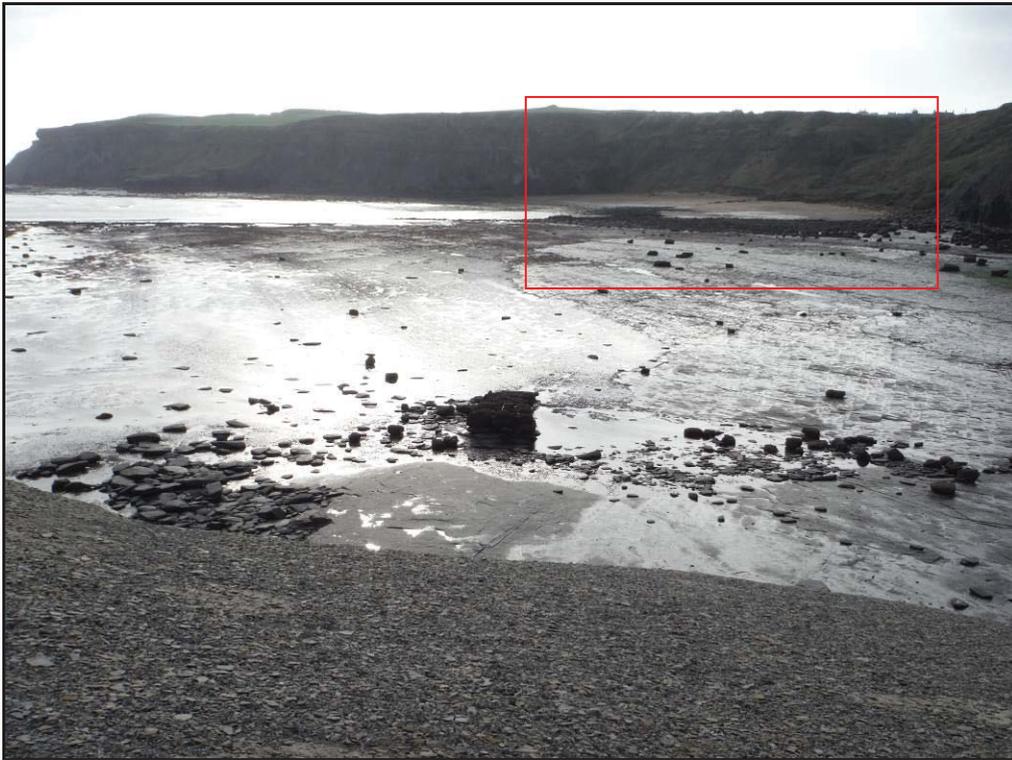
Figure 32- SSW facing view of the slipway. Note the orientation of slipway in relation to the non-scheduled harbour in the background.

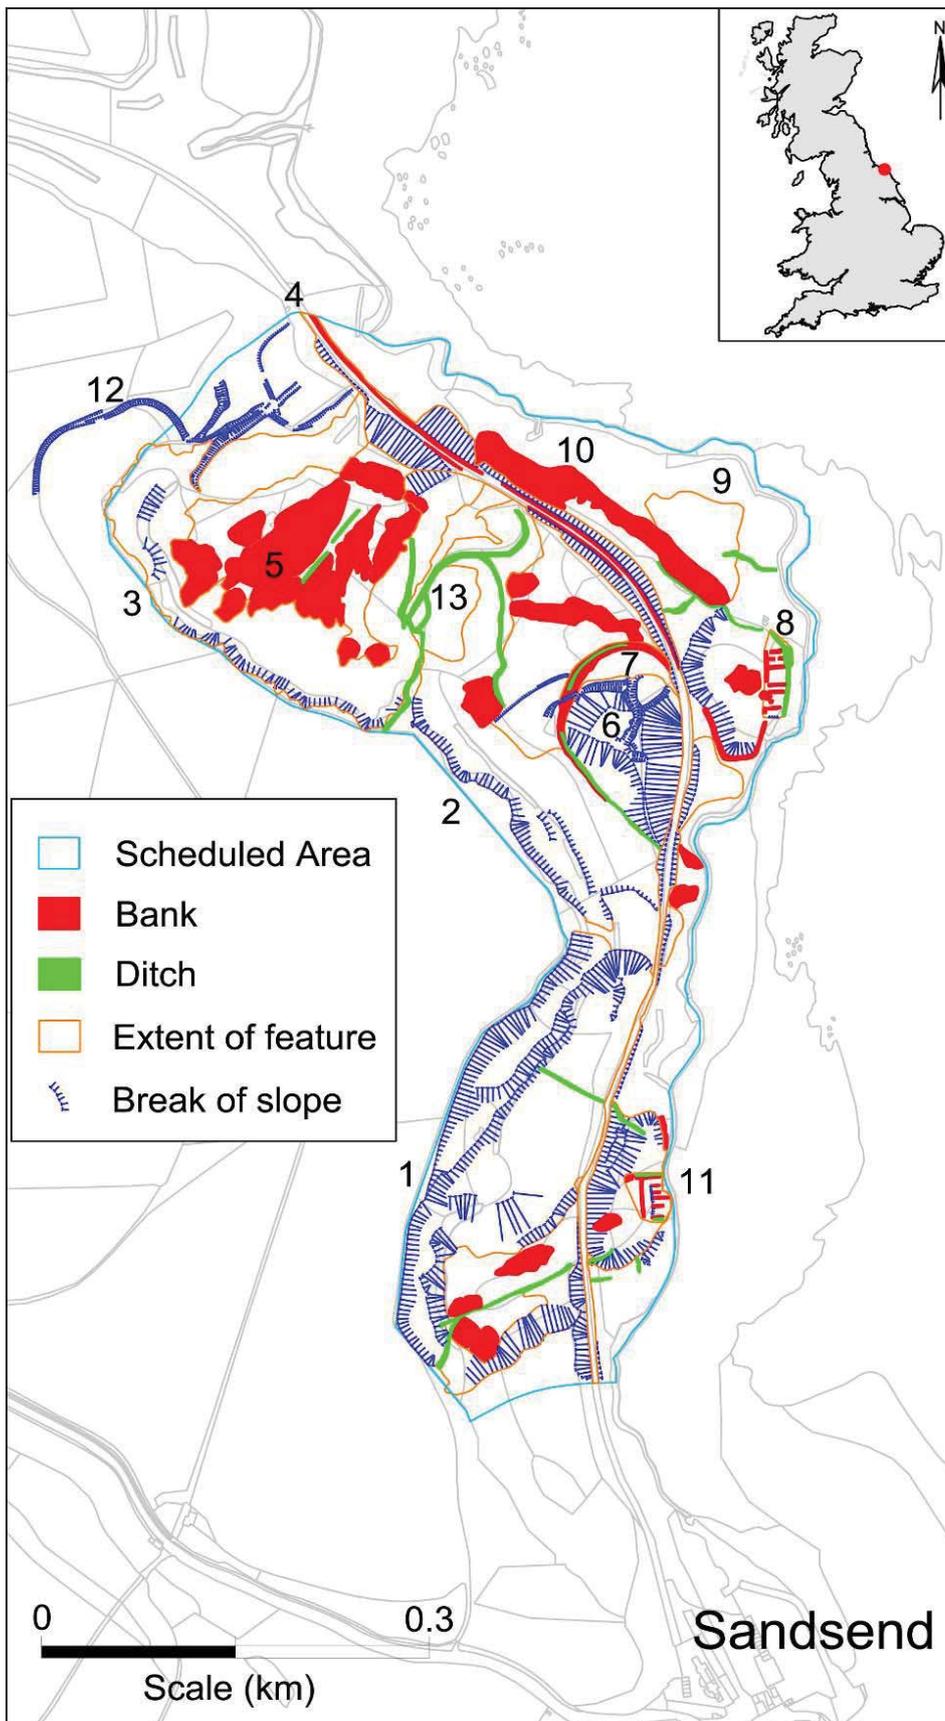
2.4.5 The mapped features were largely either associated with the quarry activities or the Whitby, Redcar and Middlesbrough Union Railway line subsequently constructed through the site. The scheduled area is known to have been made up of three adjacent quarries. The earliest, Gaytress (Figure 33: **Feature 1**), is located at the southern end, closest to the site of the alum house and the village. The quarrying extended north, to Ness End (Figure 33: **Feature 2**) and finally to Deep Grove (Figure 33: **Feature 3**) quarry. The limit of each quarry and the identified area of the quarry floors were recorded as extents of area. T-hachures were used to record prominent breaks of slope in the worked face of the quarry, avoiding undulating surfaces and areas of erosion and slumping.

2.4.6 The construction of the railway has had a significant impact on the site and was mapped to the extent of the scheduled area (Figure 33: **Feature 4**). The earthworks of the railway inclined plane were defined as an extent of area, with additional detail illustrated with T-hachures and banks where present. The T-hachures serve to illustrate where the railways construction truncated existing features, and where ground was built up to maintain a uniform gradient for the track.

2.4.7 Numerous spoil heaps were recorded across the site; these were most distinctive in Deep Grove quarry (Figure 33: **Feature 5**), where subsequent cementstone quarrying is also recorded. From the aerial survey evidence, it was not possible to distinguish the cementstone quarrying from the morphologically similar earthworks associated with the preceding alum quarrying.

2.4.8 The largest single spoil heap (Figure 33: **Feature 6**), named Asylum Hill on the Ordnance Survey Map of 1895 (available here: <http://maps.nls.uk/view/100941788>), is located within Ness End Quarry. A series of trackways lead across the spoil heap and a well-defined bank curves around the northern and western extent of the mound, which may be a tramway (Figure 33: **Feature 7**) leading to an area of quarrying and processing west of the railway. A central ditch extending along the length of the potential tramway could have been caused by the modern footpath, although its presence on 1940s photography may indicate an earlier origin.

Figure 33- Results of the Aerial Photography and Lidar Transcription.

2.4.9 The alum processing features are located on the coastal edge and comprise of a linear water channel widened at the northern end and extending north-south, from which a number of linear banks extend west (Figure 33: **Feature 8**). These are likely to be remains of steeping tanks, and are depicted on the 1856 six-inch 1:10,560 scale map as a row of 10 narrow rectangular enclosures. The depicted features are morphologically alike to the illustrated and labelled Steeping Pits in Deep Grove quarry on the same map, now destroyed or masked by the large earthwork bank of the railway inclined plane. The gully is clearly extant on the 2009 Bluesky photography. The other elements are difficult to identify due to vegetation cover but are likely to be extant also. A lack of control points on the source photography resulted in some of the rectification being less accurate. In these instances an extent of area was mapped around the features to indicate this.

2.4.10 Water may have been supplied to the steeping tanks by a closely located pond or reservoir to the north (Figure 33: **Feature 9**). Historic mapping indicates a trackway existed between the pond and steeping tanks, which may support this association. The pond is defined on the south-west side by a linear bank (Figure 33: **Feature 10**). The bank encasing the pond has clearly been modified in places, but may have natural origins indicated by a rise in height of the north-west extent, where it may have connected to the dividing ledge between Deep Grove and Ness End quarries prior to the construction of the railway.

2.4.12 Trackways or hollow ways to the north of Deep Grove quarry (Figure 33: **Feature 12**), and on the dividing ledge between Deep Grove and Ness End quarries (Figure 33: **Feature 13**), appear to have originated with the quarrying activity and continue in use today as footpaths. Other footpaths with clear modern origins were numerous across the site and were not mapped.

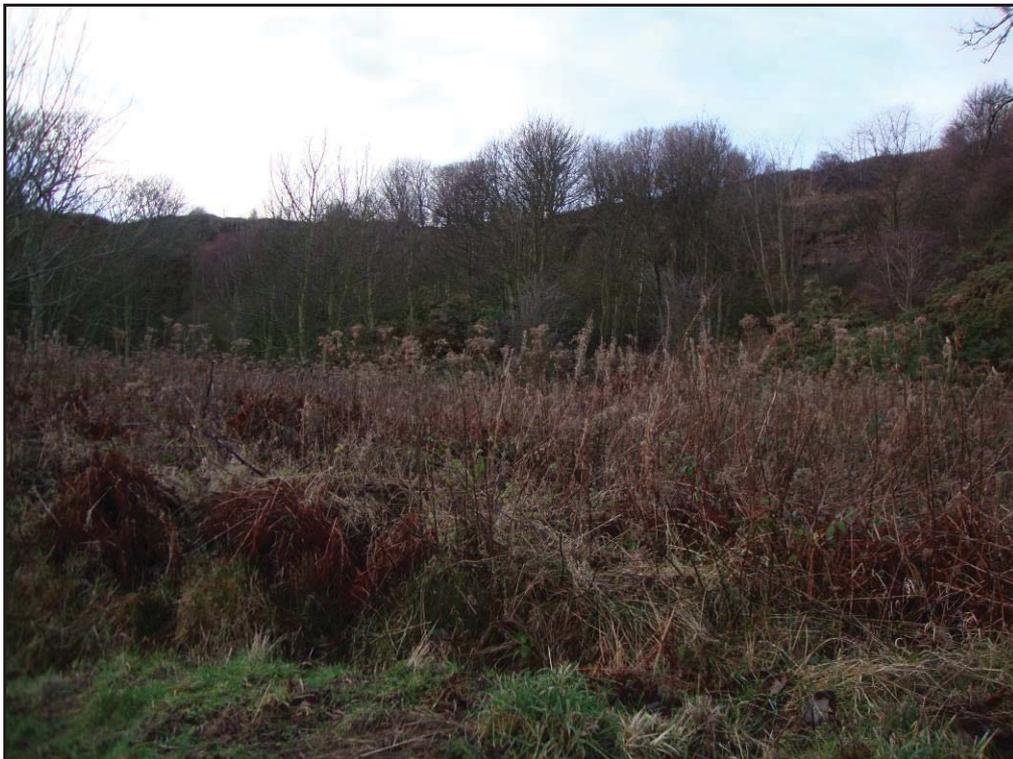
2.4.16.2 **Feature 1** records the extent of Gaytress Quarry (Figure 34) which is mapped as an elongated C-Shape facing east. The quarry extends for c.270m north/south and c.160m east/west (the eastern extent being under coastal erosion). The quarrying activities at Gaytress involved the removal of sandstone overburden and the subsequent quarrying of the alum shale beneath. Across the length of the quarry the sandstone overburden has been removed, however, a hillock of unquarried shale is present roughly in the centre of the quarry area, extending eastwards from the former working face (**Feature 21**). This hillock may represent a former extent of Gaytress quarry, in its first phase, with the present extent of the quarry representing a northwards expansion of the quarry, though under the same name.

Figure 34- View into Gaytress Quarry, looking south-west.

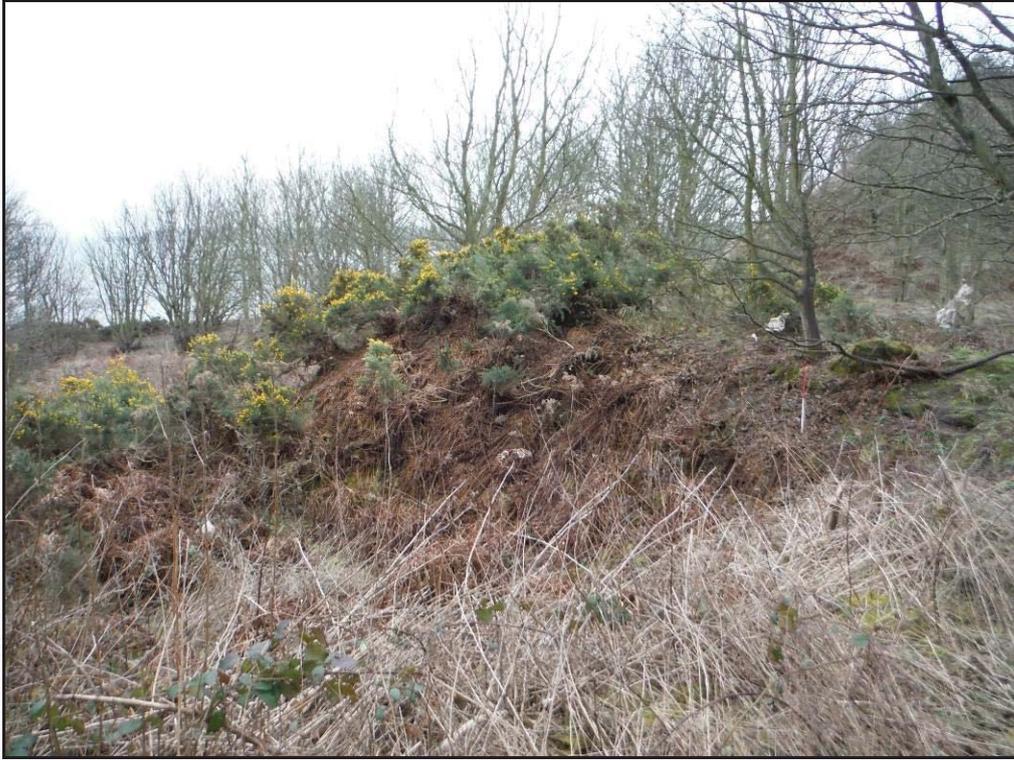
2.4.16.3 At the western extent of the quarry floor, areas of spoil dumps and land slippage (**Feature 14**) were noted on the aerial photography and Lidar transcription and confirmed by the site walkover (Figure 35). Probable cementstone mining activity (**Feature 20**) was also noted in the form of at least two openings in the back of the quarry beneath the sandstone overburden (Figure 36). These features were not investigated further at the time of the walkover survey, but are already mentioned within the Scheduling description of the site. Further investigation would only be possible with the application of specialist health and safety provision.

Figure 35- Spoil heap within Gaytress Quarry looking south-east (Scale- 1 x 1m).

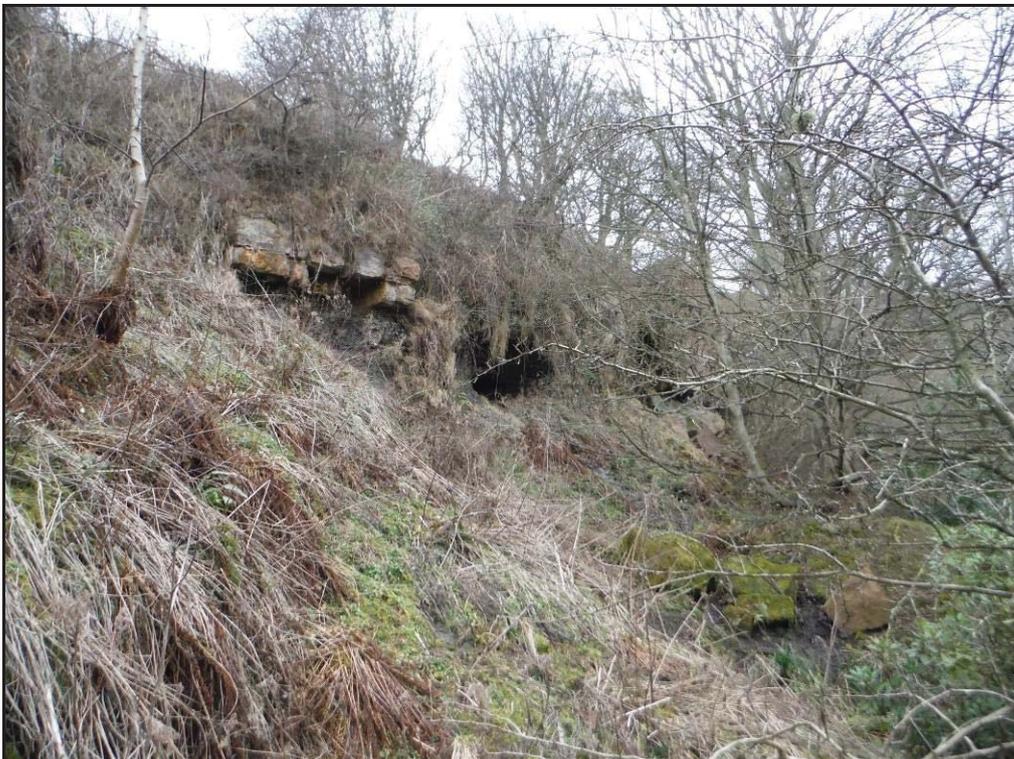
Figure 36- Western extent of Gaytress Quarry showing the entrance to a possible cementstone mine, looking west.

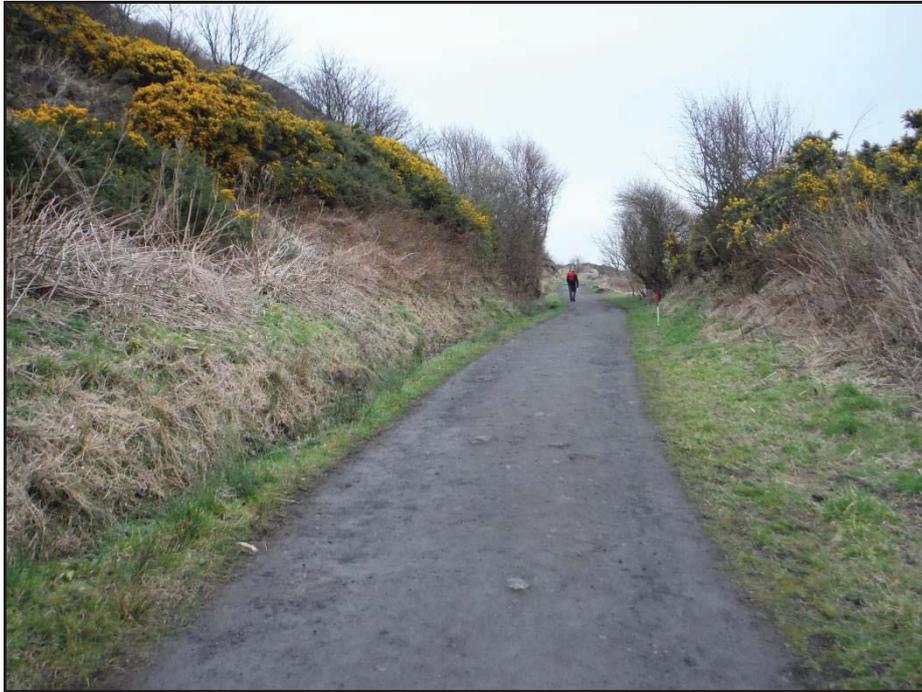
2.4.16.5 **Feature 4** records the Whitby, Redcar and Middlesbrough Union Railway which was constructed across the quarry site by 1883, following the closure of the alum works. Within Gaytress Quarry the railway has been largely cut into the existing quarry floor on its west side and runs along the top edge of a lower quarry area on its east side. At the northern and possibly the southern extents of the quarry the railway cuts through arms of unquarried shale that project eastwards from the working face of the quarry demarcating its extents (Figure 38). The former track is now a public footpath. An area

Figure 38- Northern extent of Gaytrass Quarry looking northwards through the cut made for the Whitby, Redcar and Middlesbrough Railway (scale = 1m).

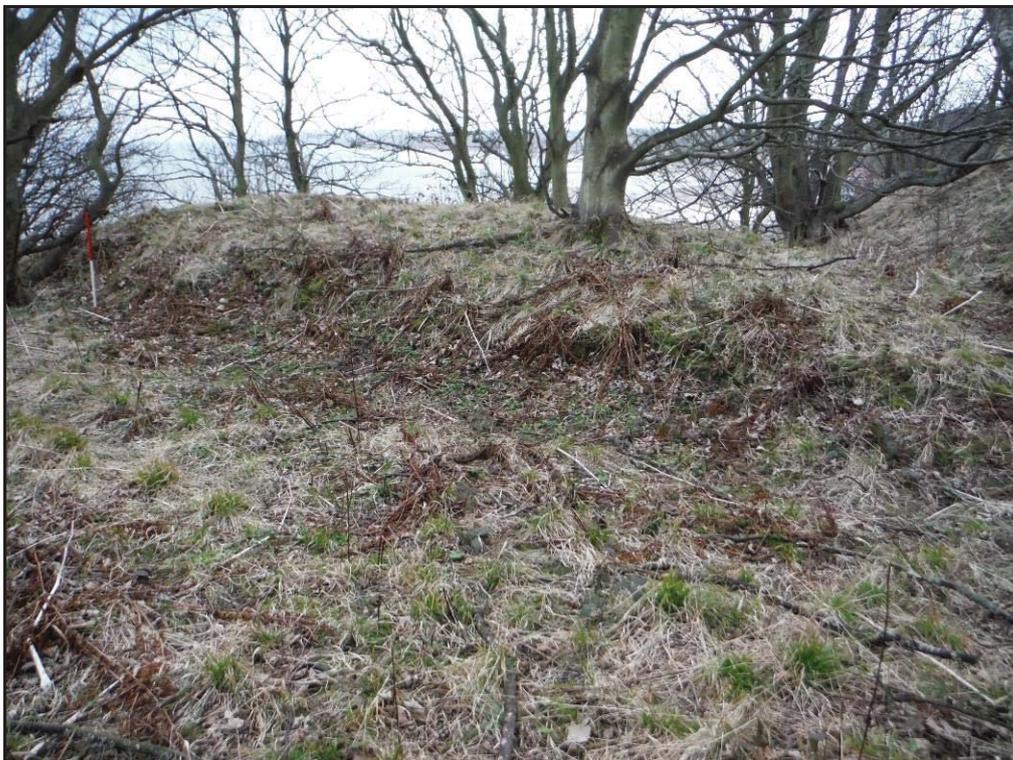
2.4.16.6 Within the quarry floor to the west side of the railway line, three features probably associated with the former alum workings were identified. The first is a possible barrowway (**Feature 15**) aligned north-east/south-west and running adjacent to the north side of the 'arm' of unquarried shale forming the southern extent of Gaytress Quarry. The possible barrowway consists of a flat raised bank of earth and sandstone (Figure 40). The sandstone contained within the earthwork is occasionally squared blocks, however, no evidence was found during the walkover to suggest that the earthwork was constructed of or retained by stone. In plan the feature is wedge-shaped with a V-shaped terminal on its south-western extent. On its north-east side the possible earthwork is cut by the railway line and an associated drainage gully running parallel (Figure 43). On the eastern side of the railway line the line of the feature could not be traced. In profile, the bank on the southern side of the earthwork is more pronounced, with a height of c.1.4m as opposed to the bank on the north side which stands to c.0.6m (Figures 40 and 41). The feature is c.6m wide (Figure 42). The orientation of the feature suggests that it may have been used to transport material from the working face of the quarry either to the steeping pits identified to the east (**Feature 11**), or to the cliff edge for dumping or transportation. The elevation of the feature would require that a winch or inclined plane was in operation for goods to be lowered over the cliff edge, however no evidence of either remains.

Figure 40- Possible barrowway looking south-east (Scale- 1 x 1m).

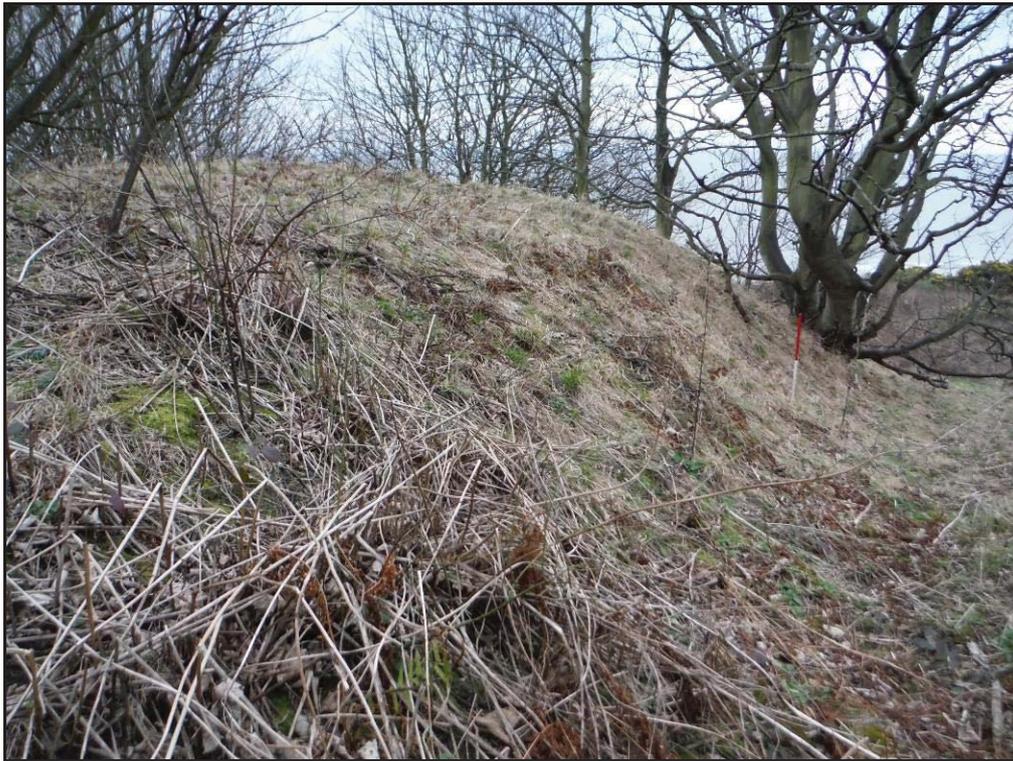
Figure 41- South bank of the possible barrowway, looking east (Scale- 1 x 1m).

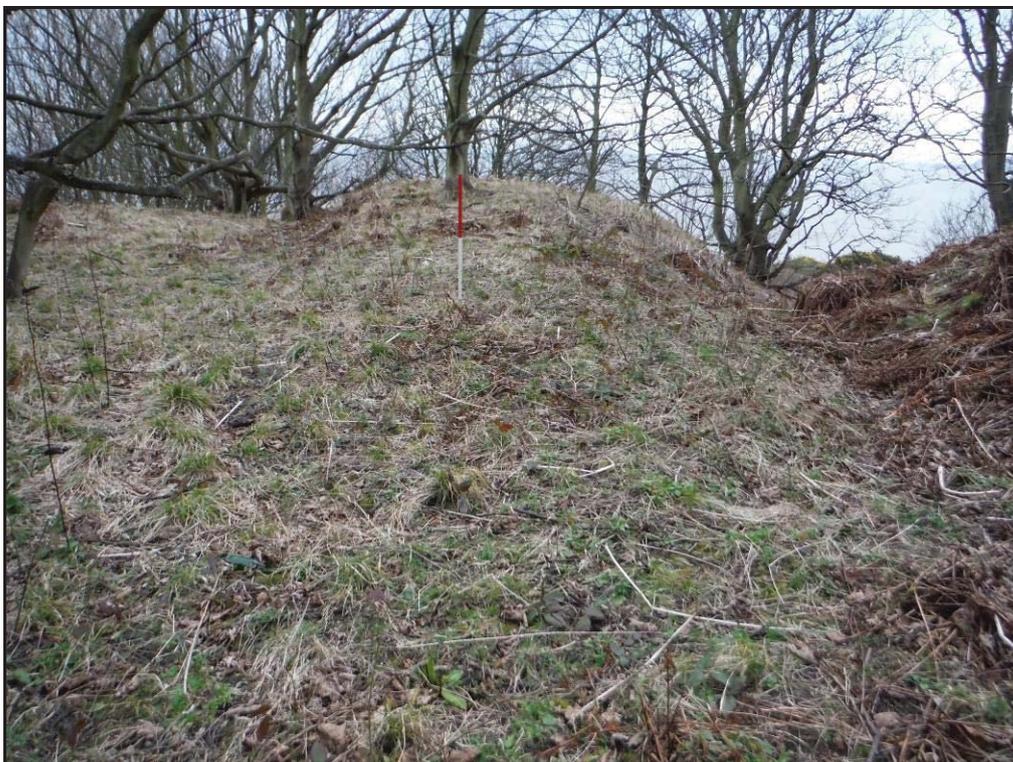
Figure 42- Top of the possible barrowway, looking north-east (Scale- 1 x 1m).

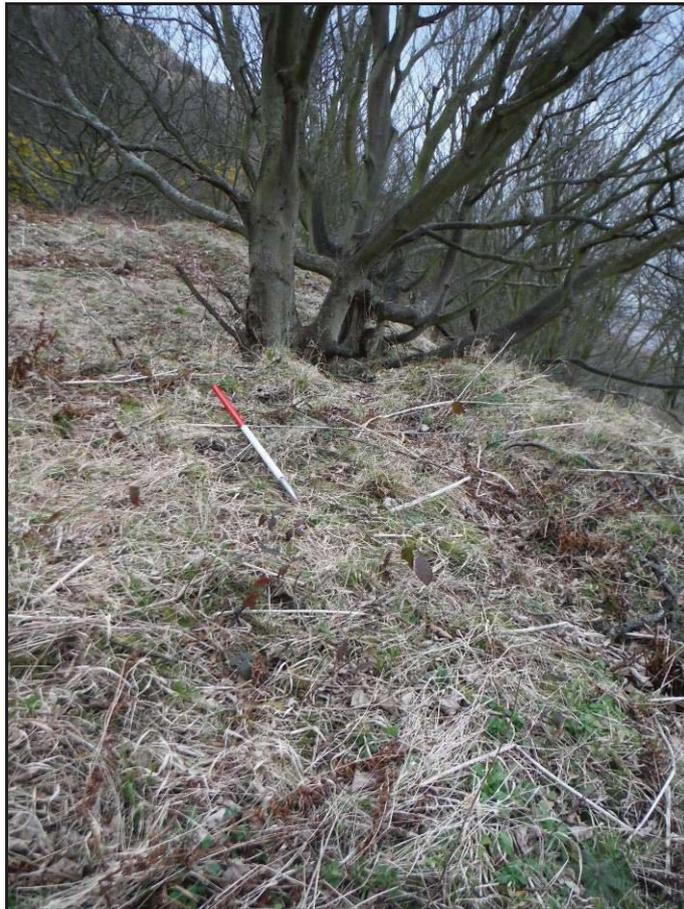
Figure 43- Drainage gully and railway cut on the north-eastern extent of the possible barrowway, looking north (Scale- 1 x 1m).

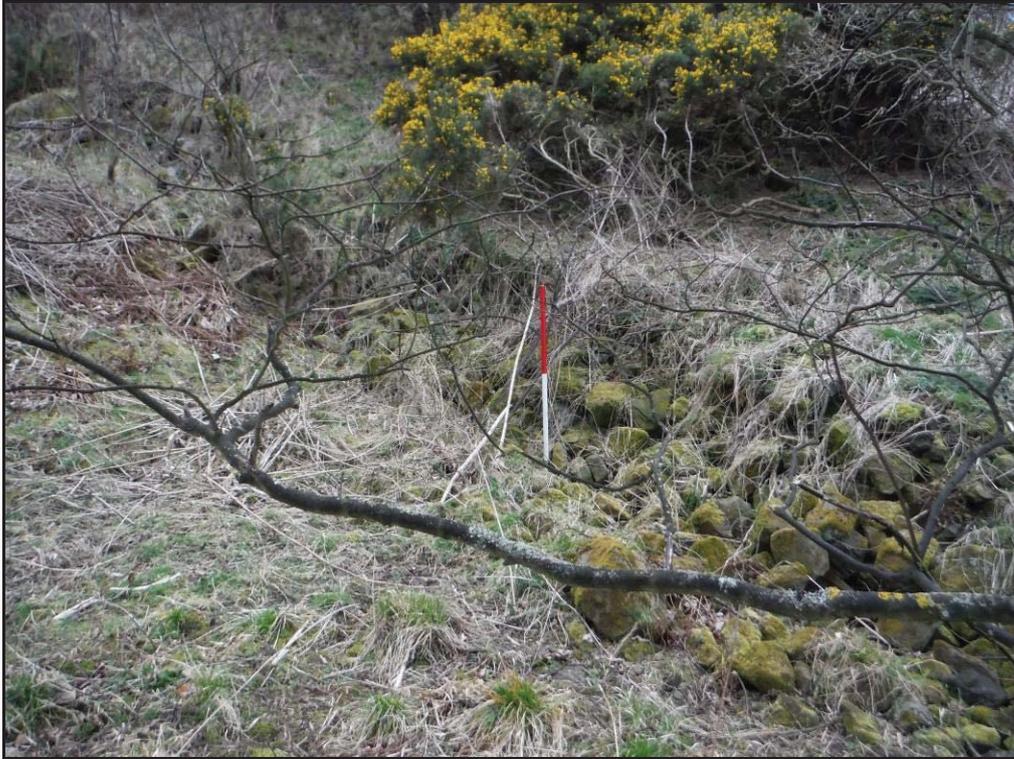
2.4.16.7 **Feature 19** records a stone-built retaining wall within the quarry floor which is situated to the immediate north of a recorded French drain (**Feature 18**) (Figure 44). The wall is constructed of unbonded, non-coursed, roughly-squared sandstone blocks. The line of the wall was traced for a length of at least 15m and it stands to a height of c.0.7m. The purpose of this wall is unknown, although its close proximity to the French drain may indicate an associative function between the two.

Figure 44- Retaining wall adjacent to a rubble-filled French drain within the quarry floor at Gaytress Quarry, looking north-west (Scale- 1 x 1m).

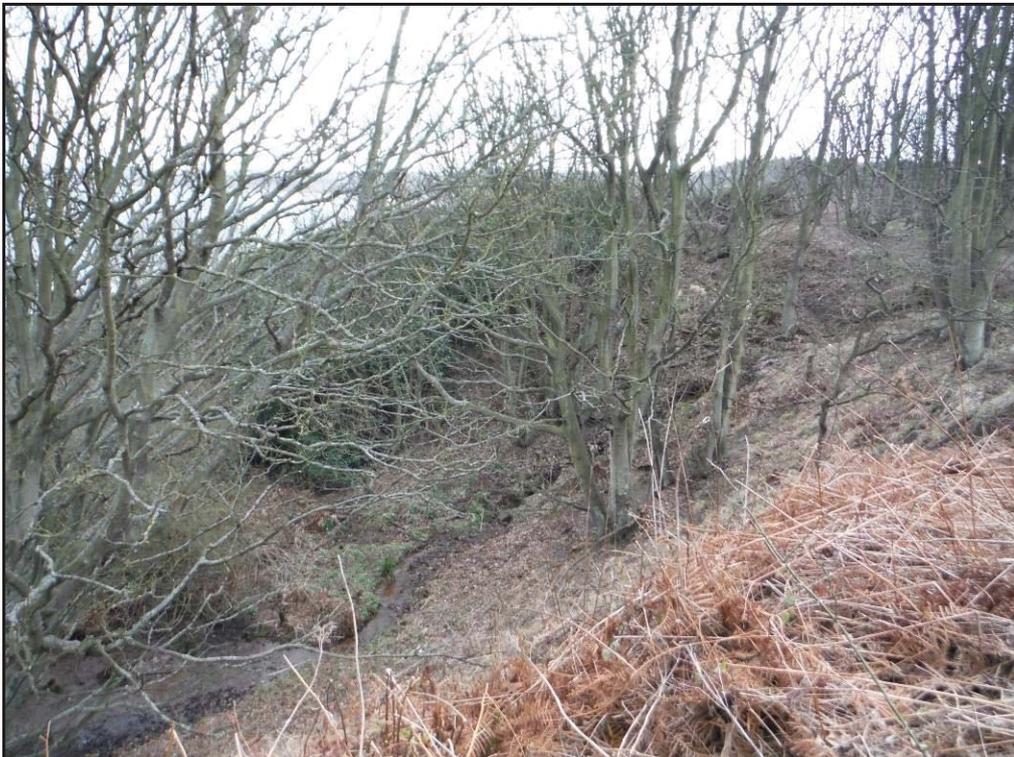
Figure 45- The lower quarry area on the eastern side of the railway line looking south-east. Note water channel entering the quarry floor from a culvert beneath the railway in the background.

2.4.16.9 On the east side of the railway line a further area of quarrying has created a further, lower, C-shaped quarry floor (**Feature 24**) within which a number of alum working-related features have been identified (Figure 45). This further quarry area is aligned in the same way as the main Gaytress Quarry and it extends for c.100m from north to south and c.50m from east to west. The extent of the lower quarry is demarcated by ridges of unquarried shale. The walkover survey recorded the presence of sandstone retaining walls on the terminals of the 'arms' forming the northern and southern extents of the quarry area (Figure 46 and 47). That on the southern side survives as only a small number of aligned dressed-stone blocks, however on the north side the level of preservation was higher and the retaining wall could be traced for a length of c.10m. The retaining walls and the sloping nature of these 'arms' (Figure 47) may indicate that they were used as barrowways to transport material to the steeping pits (**Feature 11**) within, however there was not enough evidence present to confirm this identification. Though neither was an alternative means of transporting material to these steeping pits identified.

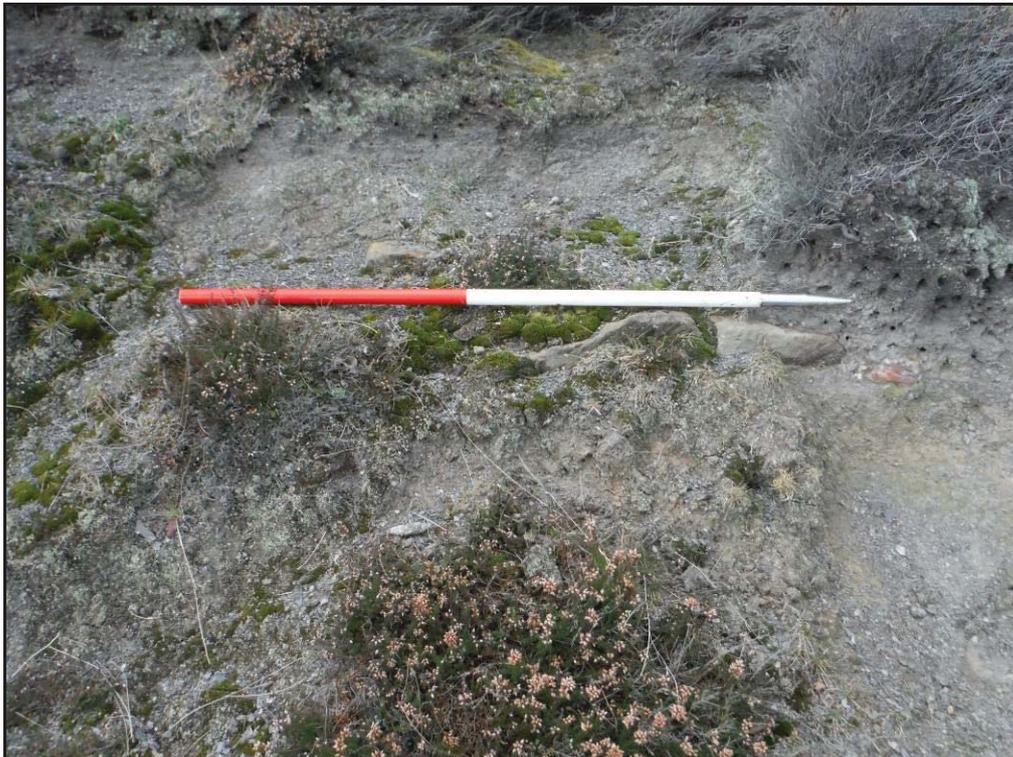
Figure 46- Remains of a stone retaining wall on the eastern face of the southern 'arm' of the lower quarry area, looking west (Scale- 1 x 1m).

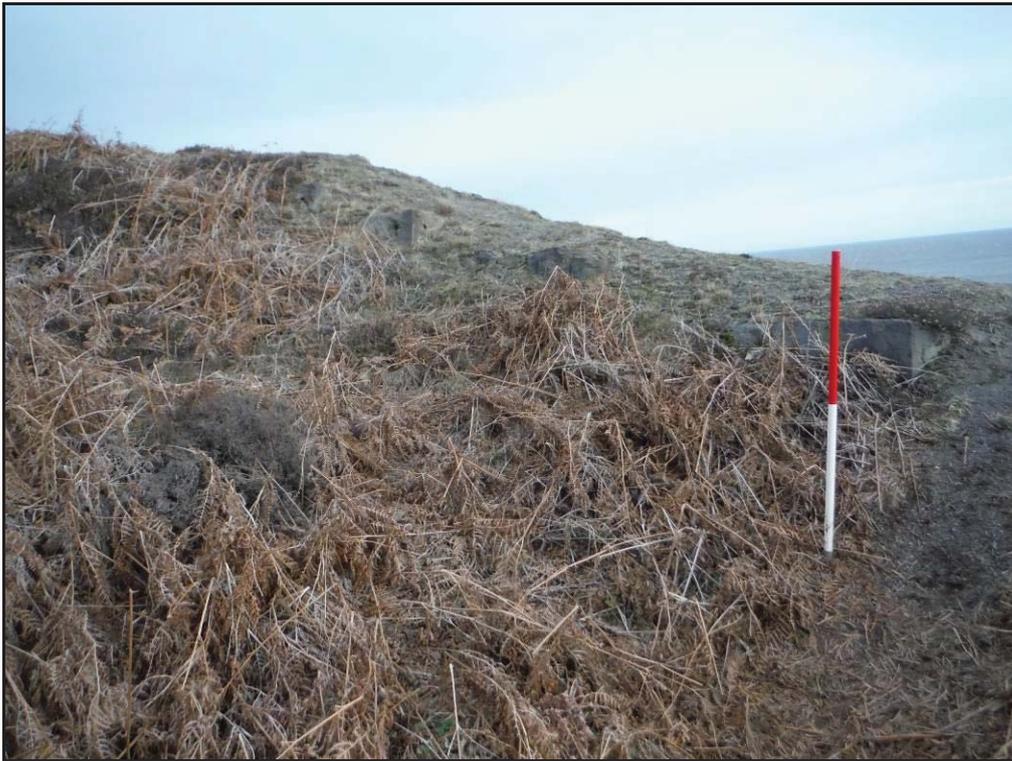
Figure 47- Remains of a stone retaining wall on the western face of the northern 'arm' of the lower quarry area, looking north-east (Scale- 1 x 1m).

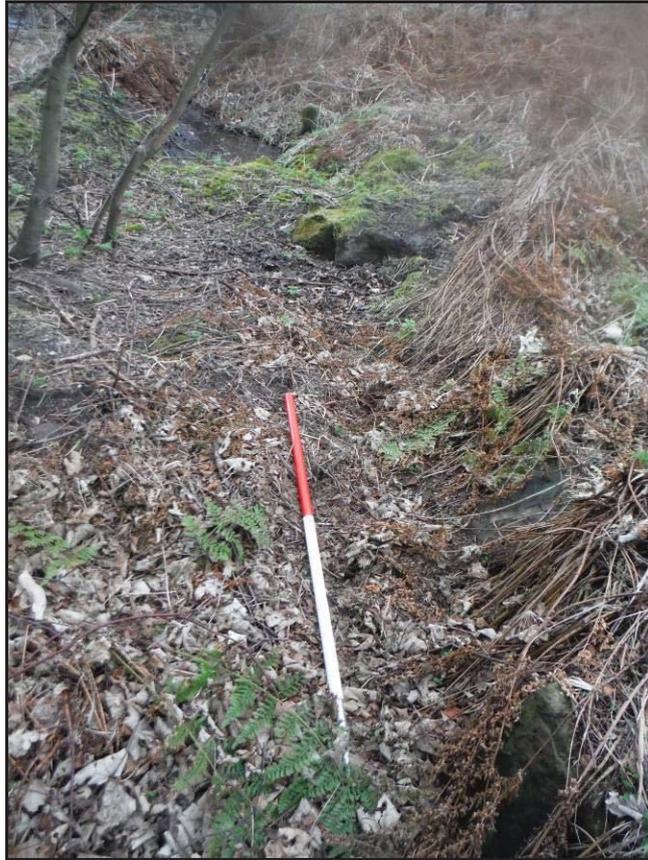
Figure 48- Stone-lined water channel to the north of the area of steeping pits mapped as part of the transcription exercise, but most likely associated with those features, looking south (Scale- 1 x 1m).

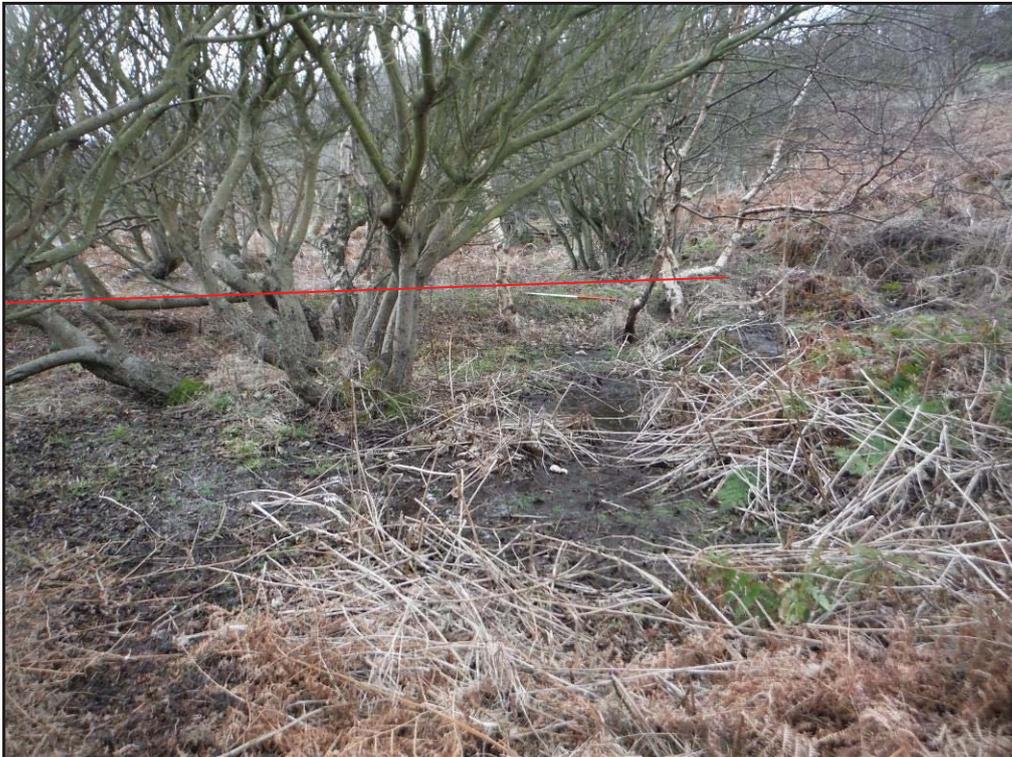
Figure 49- East-west aligned bank to the north of the area of steeping pits mapped as part of the transcription exercise, but most likely associated with those features, looking south (Scale- 1 x 1m).

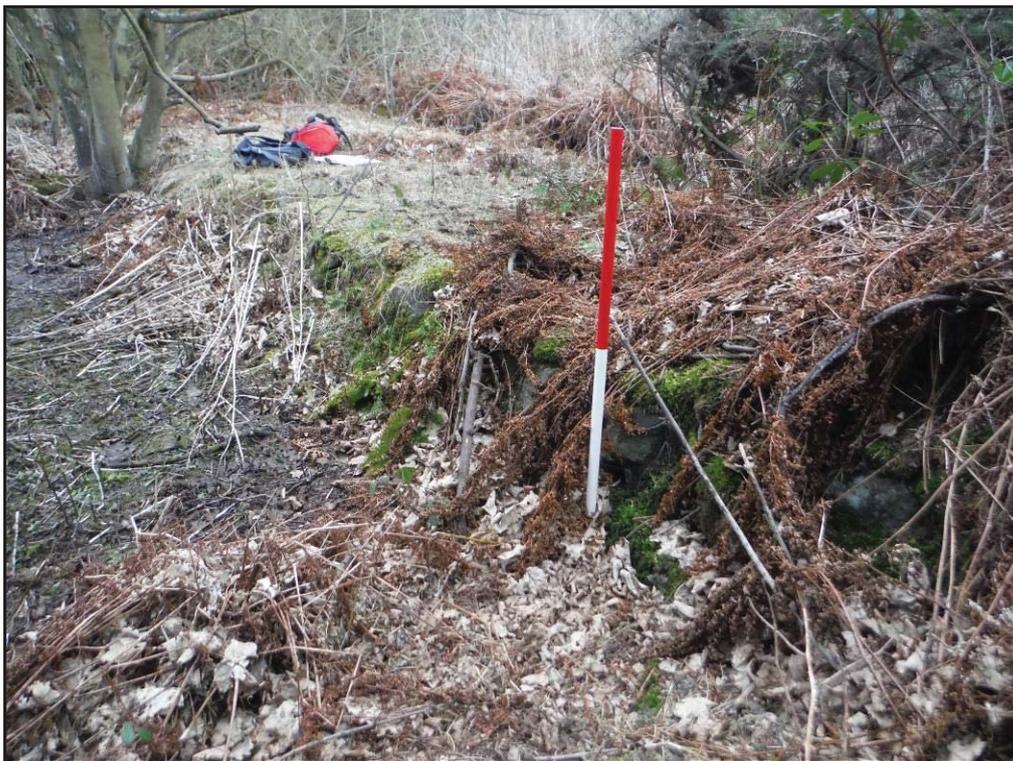
2.4.16.11 **Feature 16** has been interpreted as a possible reservoir which would sit to the immediate west of the mapped steeping pits and could represent management of the water supply to these features. The feature comprises a stone-lined north/south aligned earthen bank with a width of c.3m, which was mapped during the aerial photography and Lidar transcription (Figure 50). This forms a sharp 90° angle with a stone-lined section of the southern 'arm' of the lower quarry area (Figure 51). This arrangement, together with features already mapped, forms the south-eastern corner of a rectangular feature. The ground within the possible reservoir is very boggy and over 0.5m of a ranging pole could be inserted into these deposits with ease. The water channel from the main quarry floor (**Feature 25**) also feeds into this area and this appears to be the original arrangement (see Section 2.4.16.8). No evidence of an outlet into the steeping pits was observed during the walkover survey, however, this may exist within the overgrown and inaccessible area of the steeping pits. A pump is shown near to this location on the Ordnance Survey 6 inch map 1856 which may therefore have been associated with this reservoir. Jecock has suggested that this pump was possibly associated with the liquor trough transporting liquor from the later steeping pits at Ness End (Jecock pers. comm.), so there may be an element of phasing within these remains that further investigation could elucidate.

Figure 50- Stone-lined banked feature interpreted as a possible reservoir, looking north-east (Scale- 1 x 1m).

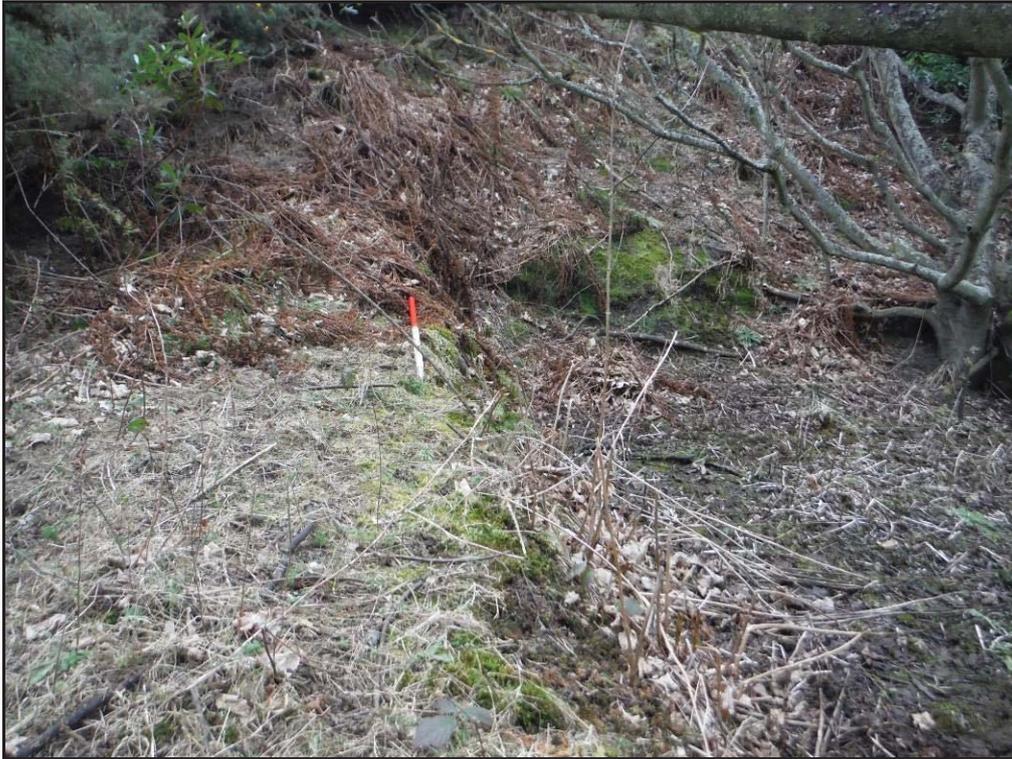
Figure 51- A 90° angle forming the south-east corner of a rectangular feature interpreted as a possible reservoir, looking south (Scale- 1x 1m).
