# Archaeological Excavation and Survey of Scheduled Coastal Alum Working Sites at Boulby, Kettleless, Sandsend and Saltwick, North Yorkshire

ARS Ltd Report No-2015/42  
OASIS No: archaeo15-208500

Compiled By:  
Samantha Bax, Rupert Lotherington PCIfA and Dr Gillian  
Scott  
Archaeological Research Services Ltd  
The Eco Centre  
Windmill Way  
Hebburn  
Tyne and Wear  
NE31 1SR

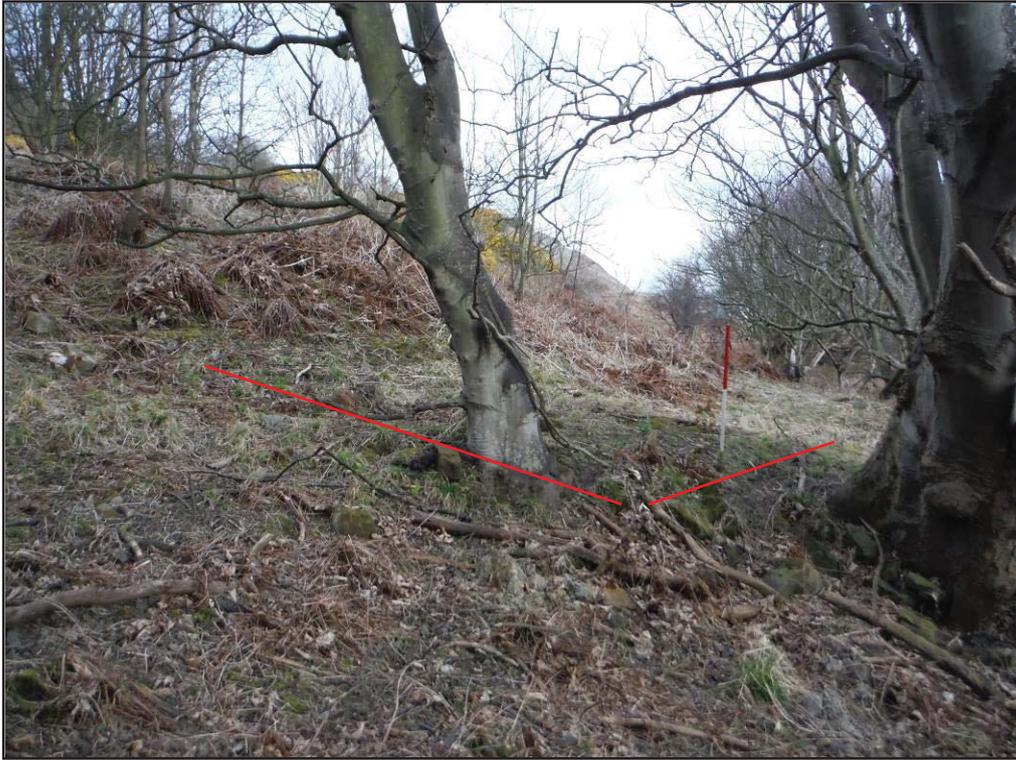
2.4.16.12 **Feature 17** records the possible remains of a building platform within the lower quarry floor. Only a very small portion of this feature was visible beneath a dump of slag material (**Feature 23**) that is likely to be much later in date and associated with the destruction of part of the railway. The remains consist of a raised flat area containing a high quantity of sandstone rubble (Figure 52). The sandstone may represent build-up material to create a platform for building. The area of the platform that is visible beneath the slag dump extends for c.2m from north to south and c.8m from east to west. The possible platform is located on the immediate north-west corner of the possible reservoir (**Feature 16**). A building in this location is likely to have had a function associated either with the control of water flow, or with the management of the steeping pits.

Figure 52- Possible building platform in the lower quarry area, looking north-west (Scale- 1 x 1m).

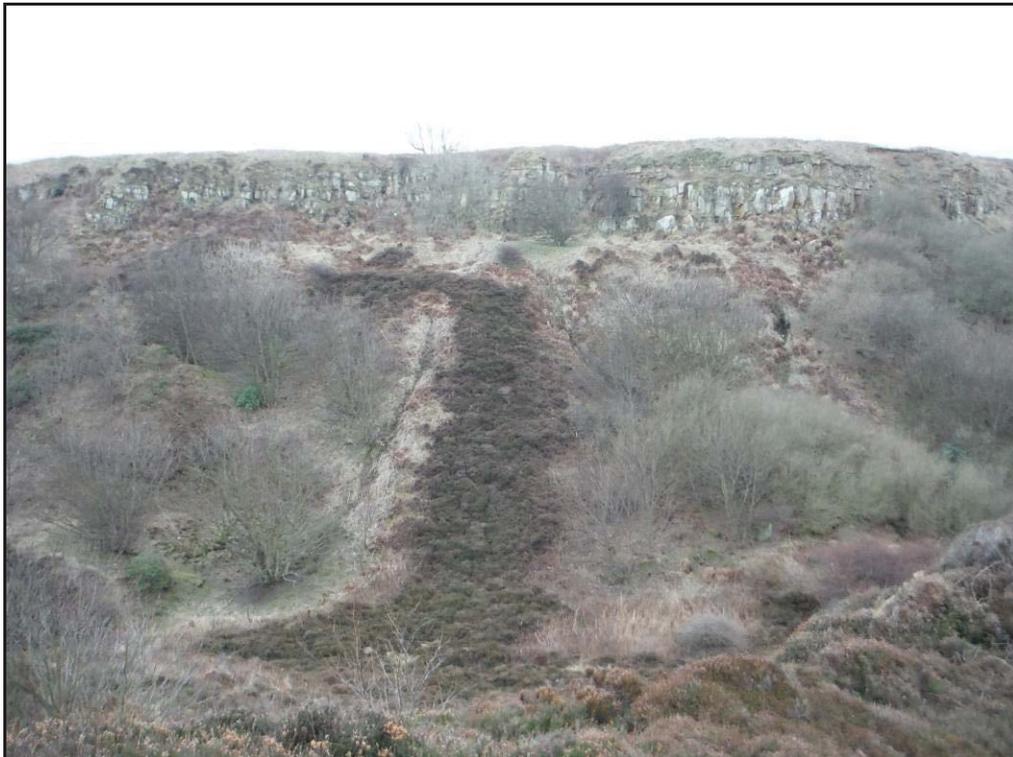
2.4.17.2 **Feature 2** records the extent of Ness End Quarry (Figure 53 and 54) which is mapped as a wide C-shape facing north-east. The quarry extends for c.230m north-west/south-east and c.320m north-east/south-west (the eastern and north-eastern extent being under coastal erosion). The quarrying activities at Ness End involved the removal of sandstone overburden and the subsequent quarrying of the alum shale beneath. In this respect Ness End is the same as Gaytress Quarry in its operation. Unlike Gaytress, however, there appears to have been a lip of unquarried shale (**Feature 32**) retained around the eastern and north-eastern extent of the quarry (Figure 55). This lip of shale effectively serves as a seawall and creates a bowl-like quarry floor behind. It likely protected the quarry and alum workings from offshore winds and erosion. Such a feature has been noted at Saltwick Nab Alum Quarry (Eadie 2014, 25) and may have been common practice, but lost to erosion at a number of sites. The lip of shale is partially eroded and survives as a series of characteristic lumps at the north-east end of the quarry site.

Figure 53- View into Ness End Quarry from the top of Asylum Hill, looking west.

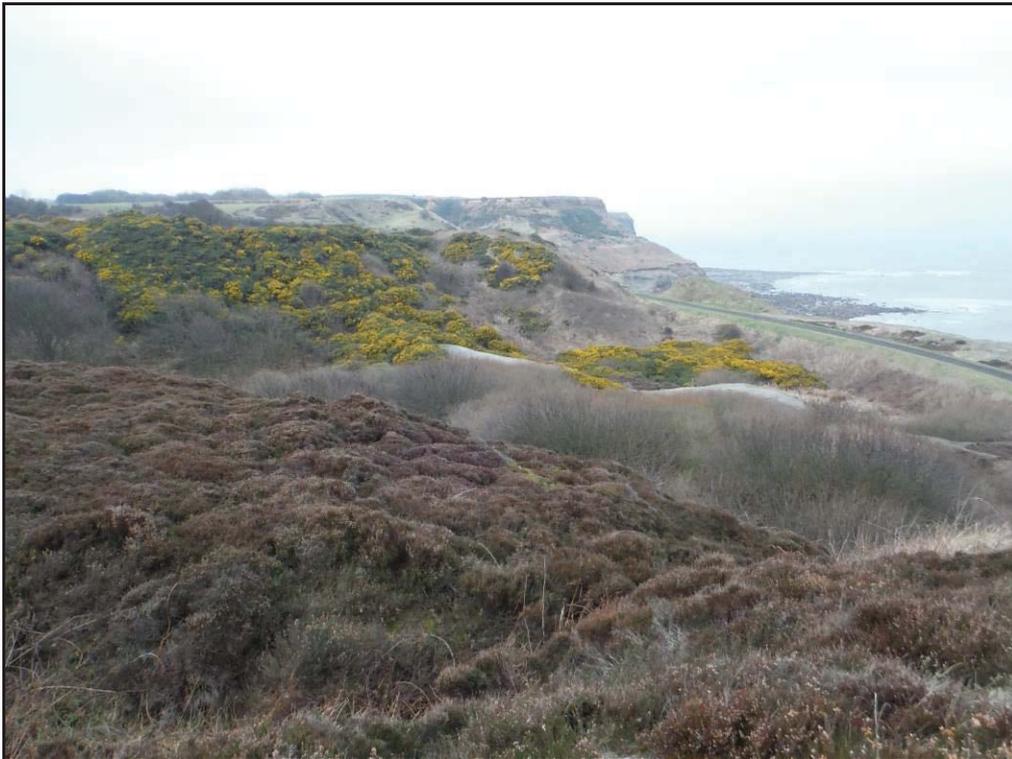
Figure 54- View into Ness End Quarry from the top of Asylum Hill, looking north-west.

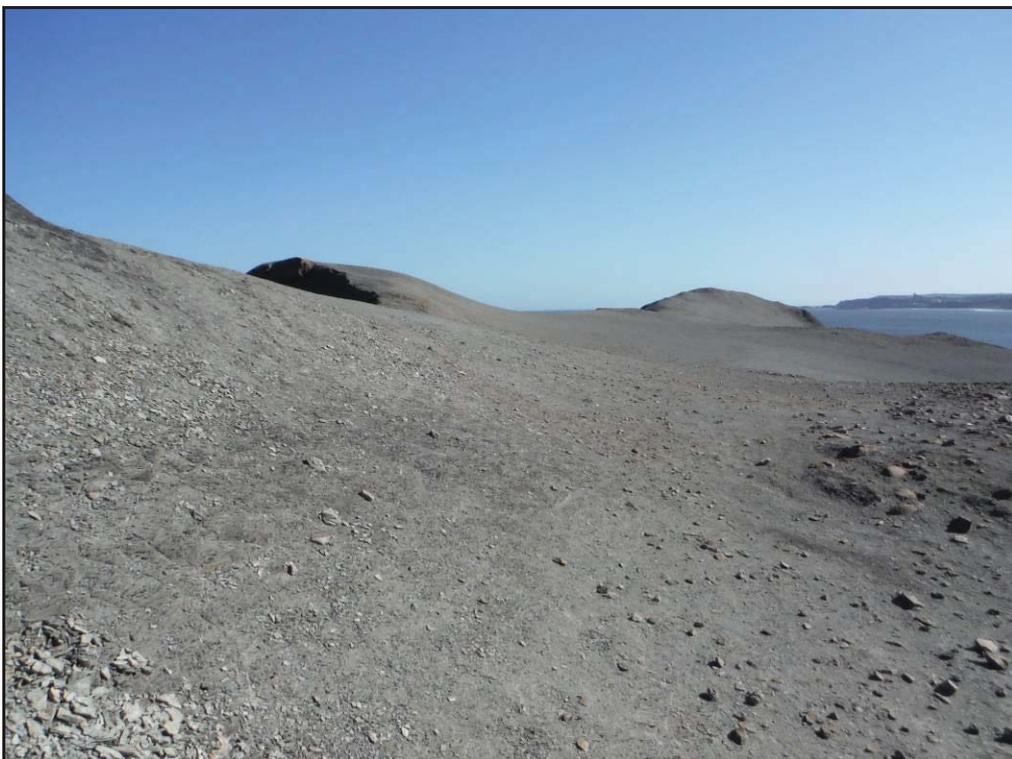
Figure 55- Partially eroded lip of unquarried shale around the east and north-east sides of Ness End Quarry.

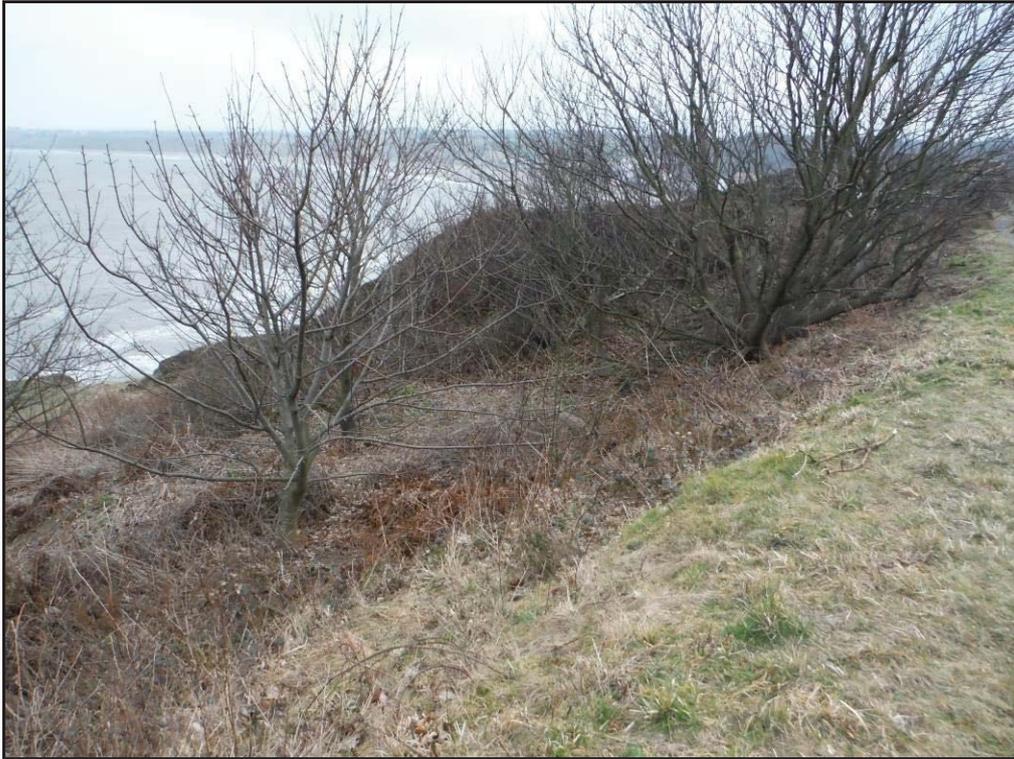
2.4.17.3 Within the quarry floor a small number of discrete spoil heaps (**Feature 30**) were identified during the aerial photography and Lidar transcription and confirmed through site walkover (Figure 56). For the most part these spoil heaps are relatively small, however one very large spoil heap exists on the central south side of the quarry floor which is named as Asylum Hill on the Ordnance Survey map of 1895 (**Feature 6**). Asylum Hill is a prominent feature of the quarry, easily identifiable from the village of Sandsend to the south (Figure 57 and 58). Erosion to the south-east end of the heap indicates that it is formed of sandstone (Figure 59), which suggests that the sandstone overburden at Ness End was not all tipped over the cliff edge, as is thought to have been the case at Gaytress. The mound has steeply sloping sides and a flat top. Its purpose is unknown, however, its relationship with other features within the quarry (e.g. **Feature 7**) suggests that it was in place during much of the quarry's operational phase. Such a large mound of material within the confines of the quarry floor would have made the movement of material around the quarry awkward, so it must be assumed that the purpose of Asylum Hill was one of some importance. The Ordnance Survey map of 1856 shows a small building on the top of the hill labelled as a shed. A large roughly square-shaped depression (**Feature 29**) on the top of the hill was recorded as part of the site walkover (Figure 60 and 61), although this appears to be much larger than the 'shed' shown on the historic map. A building in this location would have had good views of the entire quarry operation and may therefore have had an administrative or management function. Several trackways crossing the mound were noted during the transcription exercise. A similar flat-topped mound with steeply sloping sides is present within Boulby Alum Mines which is thought to have been created out of a former working platform (Blood 1993, 9). The Boulby mound is still engaged with the quarry face, whereas Asylum Hill is a discrete feature, perhaps having been mined around. The mound is cut by the Whitby, Redcar and Middlesbrough Railway (**Feature 4**).

Figure 56- Spoil heap on the south-eastern extent of Ness End Quarry, indicative of other small heaps within the quarry floor.

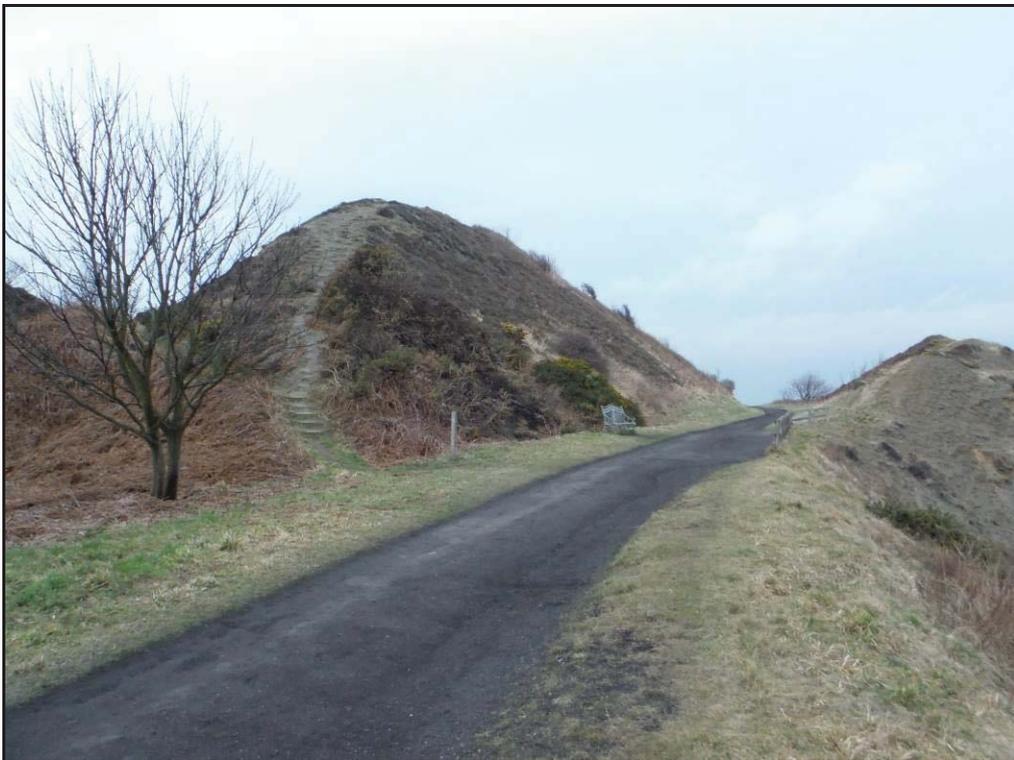
Figure 57- Asylum Hill looking north. Note that the mound is cut by the Whitby, Redcar and Middlesbrough Railway.

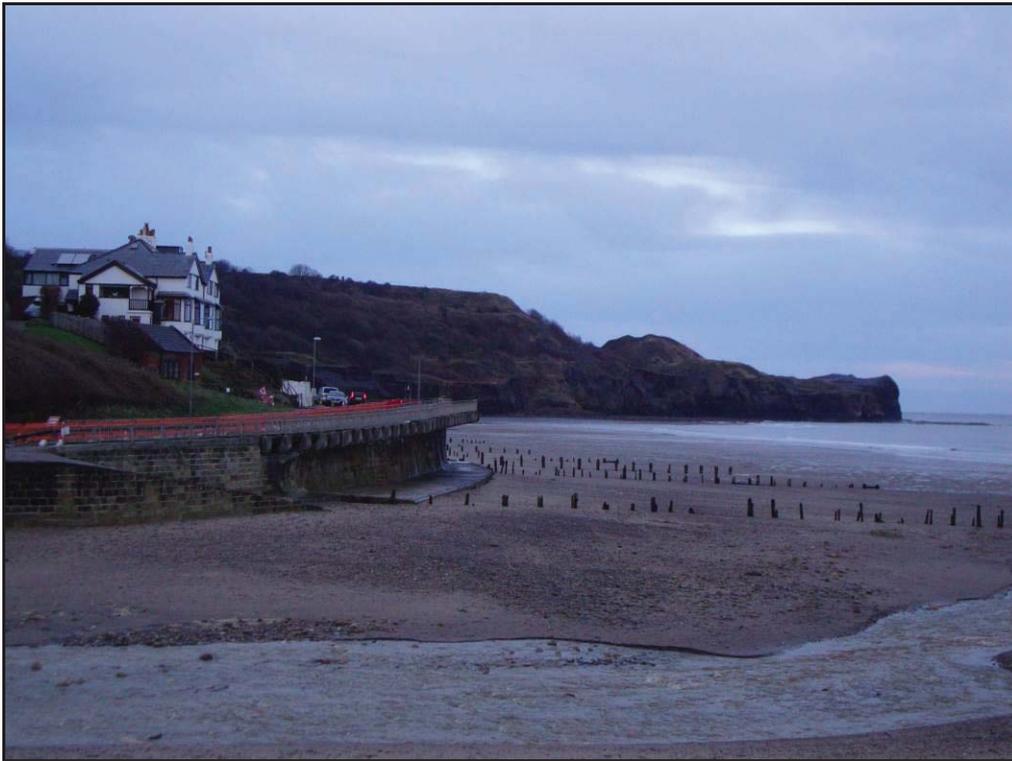
Figure 58- Sandsend Quarries from Sandsend Village to the south. Asylum Hill is the mound of material around the centre of the cliff edge.

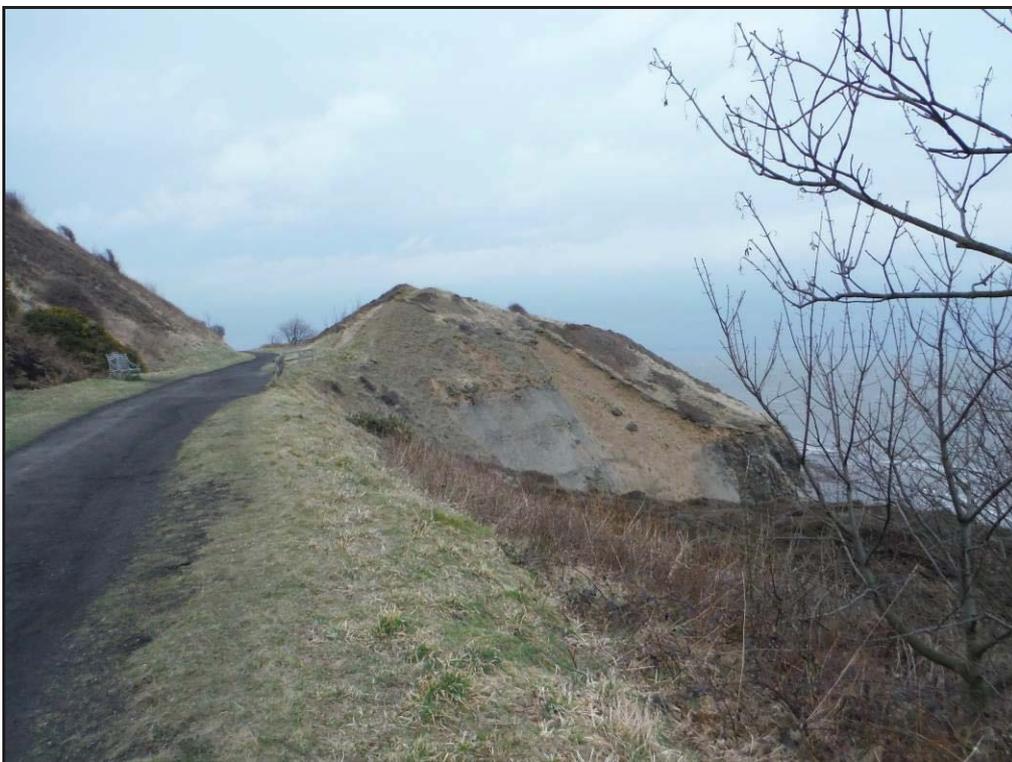
Figure 59- Erosion to the south-east end of Asylum hill shows that it is made up predominantly of sandstone.

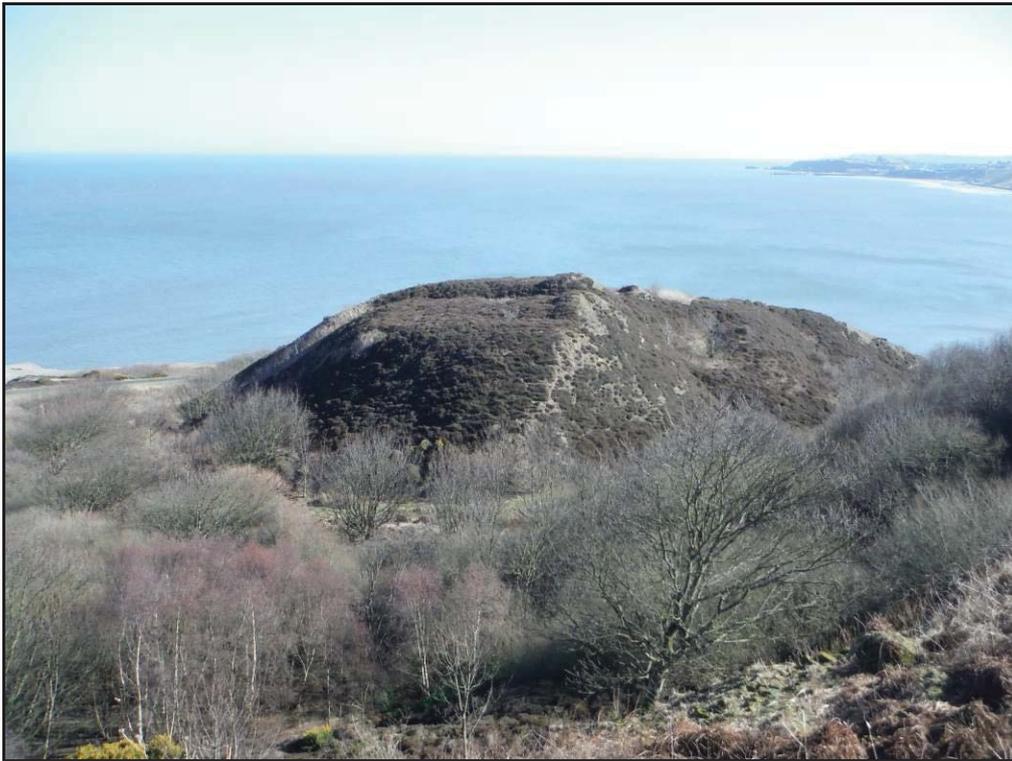
Figure 60- Square-shaped depression on the top of Asylum Hill, viewed from the northern extent of the quarry, looking south-east. Also visible in this photograph is the possible barrowway around the base of the mound.

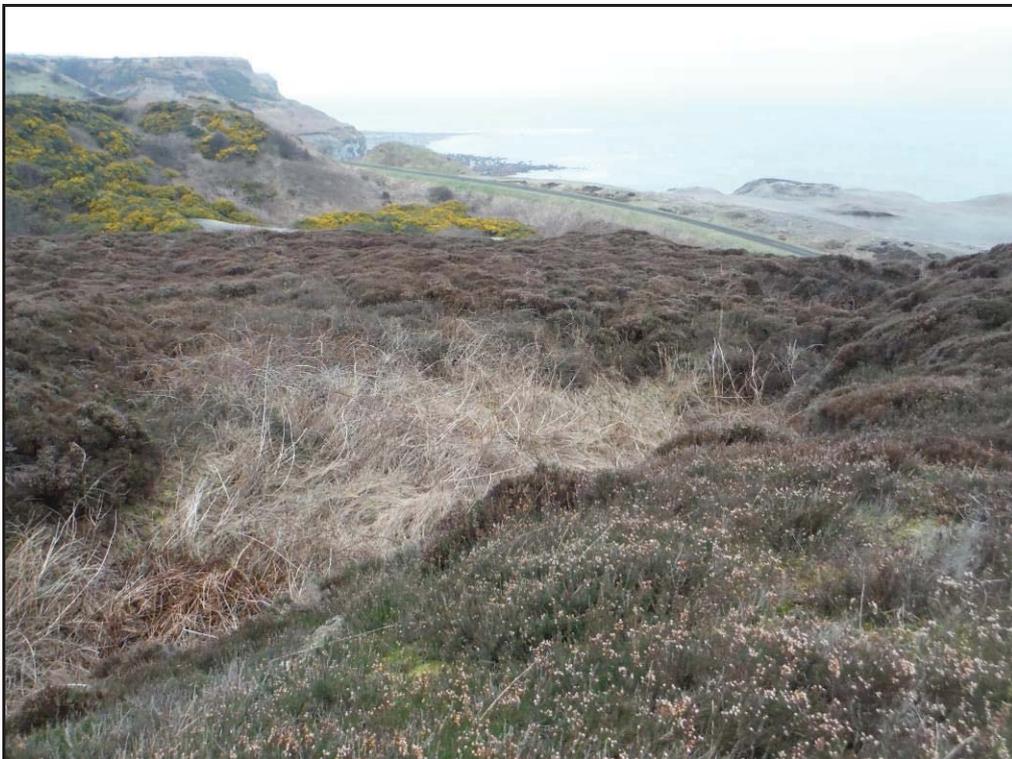
Figure 61- Square-shaped depression on the top of Asylum Hill, looking north.

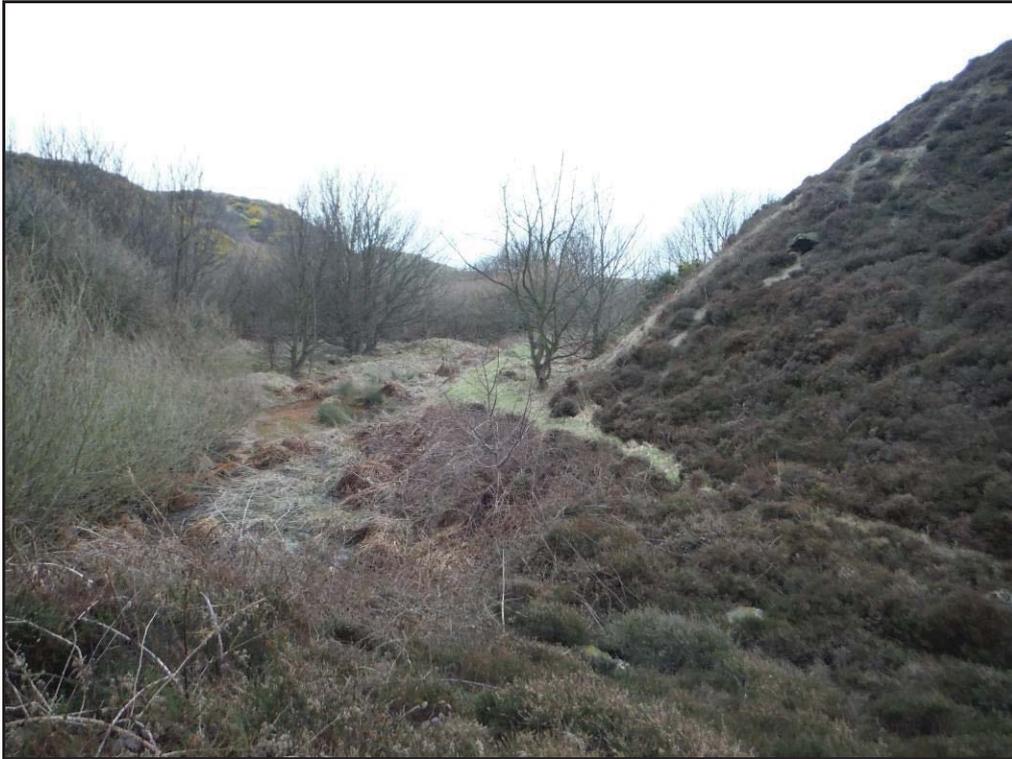
2.4.17.5 Within the quarry floor to the west side of the railway line, two probable barrowways and a series of routeways were identified (**Feature 7, 13 and 26**). **Feature 7** is interpreted as a probable barrowway and appears to be built-up against the base of Asylum Hill (**Feature 6**), skirting around its west and north sides (Figure 63). It possibly connects with a bank running along the top edge of a lower quarry area (**Feature 33**) on the east side of the railway line, however this relationship is masked by the railway embankment. It may also have served a purpose connected to the spoil heaps on the east side of the railway line at its southern extent (**Feature 30**), although again this relationship is obscured by the railway embankment and vegetation. The possible barrowway is c.6m wide in total and runs for a length of c.190m as a built-up feature, before it becomes a ditched feature along the south-west end of Asylum Hill for a length of c.55m. This ditched feature may or may not be part of the barrowway. The purpose of this barrowway is likely to have been the movement of material around the quarry floor, and in particular the movement of material past the obstacle that Asylum Hill must have presented. As the ditched feature does not appear to have a gradual or constant fall it seems unlikely to be any type of water management feature and would seem most likely to represent part of the barrowway (**Feature 7**).

Figure 63- Possible barrowway (Feature 7) running around the base of Asylum Hill, looking north-east.

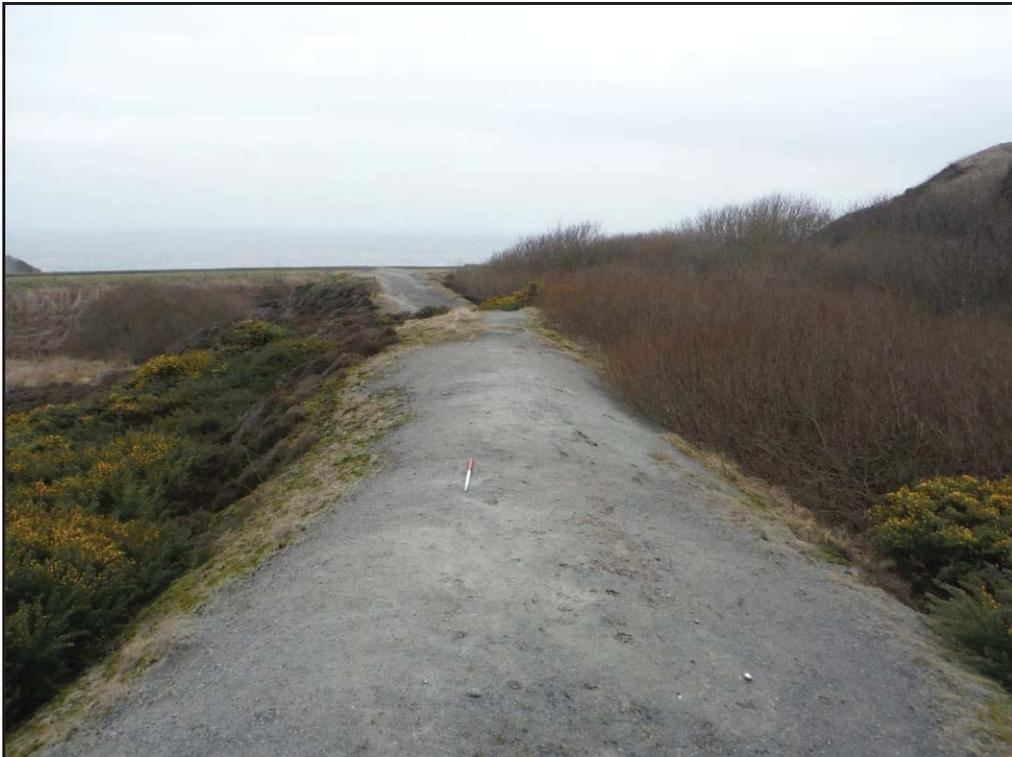
2.4.17.6 **Feature 26** is interpreted as a possible barrowway. It is a fairly regular, flat-topped ridge of unquarried shale with a total width of c.8m. It runs for a length of c.100m roughly east-west from the working face towards the railway line (Figure 64). Beyond the railway line the possible barrowway can be traced until it meets another possible barrowway (**Feature 10**) which appears to be later than **Feature 26** and truncates, or overlies it (Figure 65). As mapped, it appears as though **Feature 26** turns

Figure 64- Possible barrowway (Feature 26) running eastwards from the quarry face at Ness End towards the steeping pits, looking east-south-east (Scale- 1 x 1m). Note the feature is truncated by the railway embankment and an area of erosion and/or remodelling is present just in front of it.

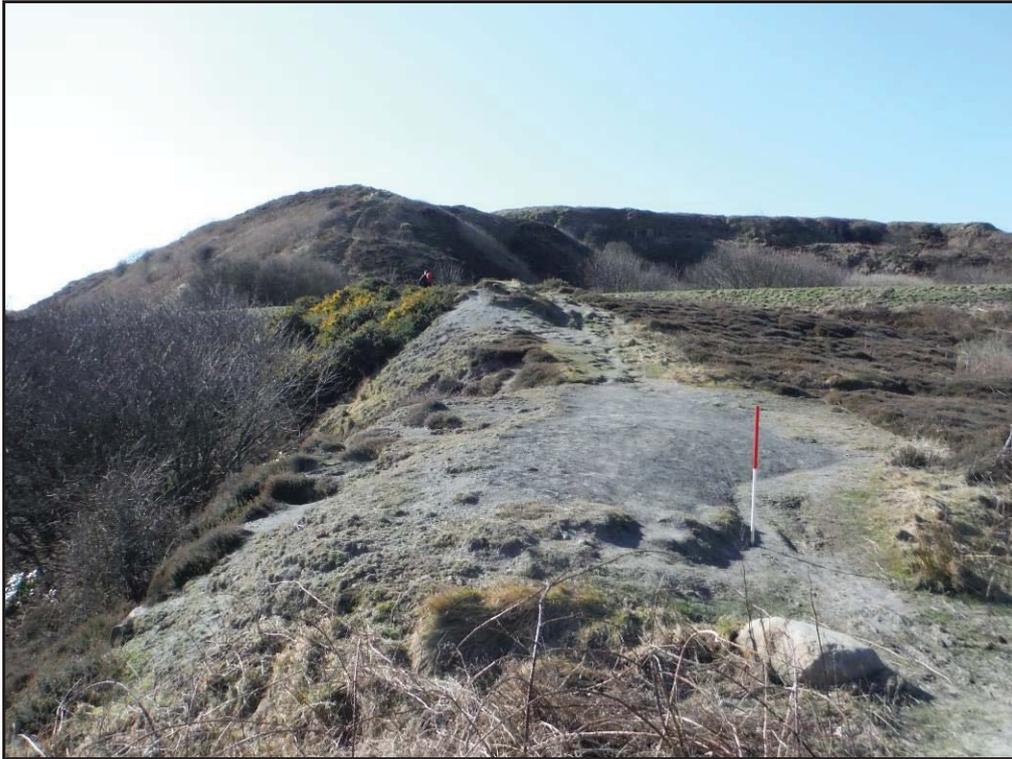
Figure 65- The likely continuation of the possible barrowway (Feature 26) on the east side of the railway line, looking west (Scale- 1 x 1m).

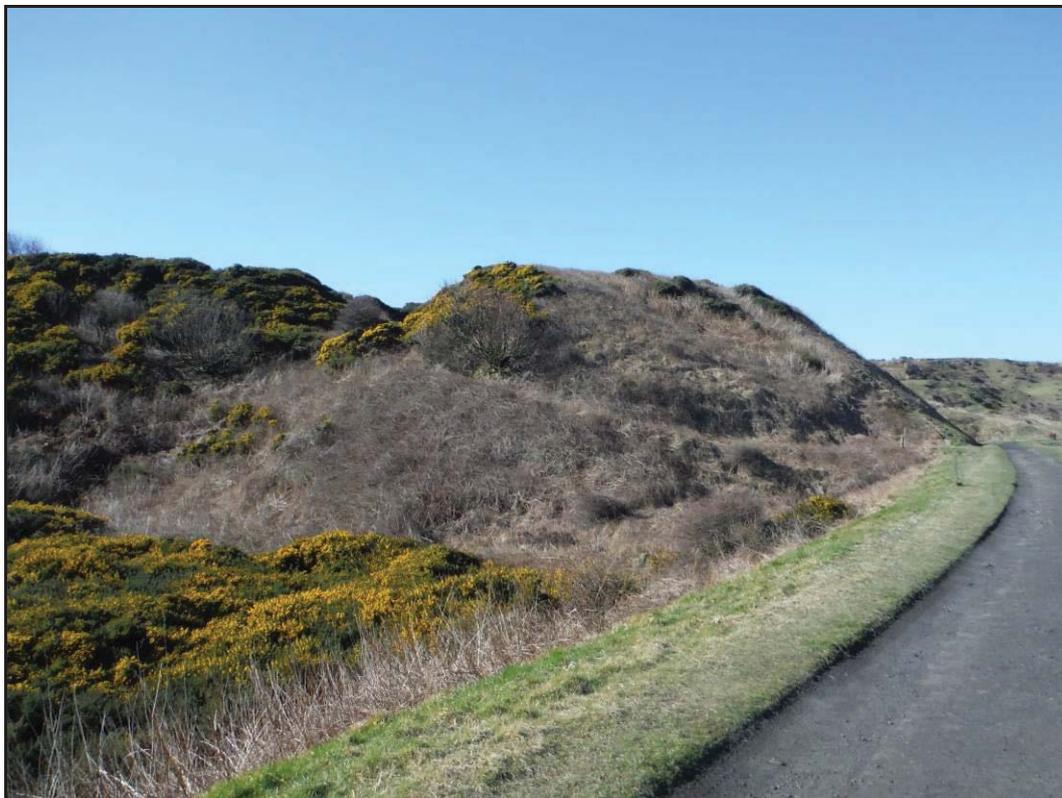
2.4.17.7 **Feature 13** is recorded in the aerial photography and Lidar transcription as a series of trackways or hollowways. The route is an incline cut into the south side of the 'arm' of unquarried shale that defines the northern extent of Ness End Quarry (Figure 66). It then runs around the top of the 'arm' before joining with another incline cut into the north side of the 'arm' which is effectively the southern extent of Deep Grove Quarry (Figure 67). At the top of the 'arm' of unquarried shale the routeway encircles a notable depression which is shown on the First Edition Ordnance Survey map occupied by an unlabelled building. There is no indication of whether the southern and northern inclines of **Feature 13** are of different phases, or are both of the same phase, but it is possible that the southern incline originally served a purpose within Ness End, before being extended when Deep Grove Quarry came into operation. Taken as a whole, the feature provides access between the two quarries and out of the quarries towards the fields to the west. The routeway may have communicated with **Feature 10**, which is a probable barrowway located on the east side of the railway line (**Feature 4**), although the railway line obscures this relationship. The incline on the south side of the 'arm' is at an angle that would be consistent with barrowing material, however, that on the north side appears too steep for this purpose, unless some form of winding gear was in operation. This might give credence to the notion that the southern and northern inclines may be of different phases.

Figure 66- Inclined routeway (Feature 13) cut into the south side of the projecting 'arm' of unquarried shale forming the northern extent of Ness End Quarry.

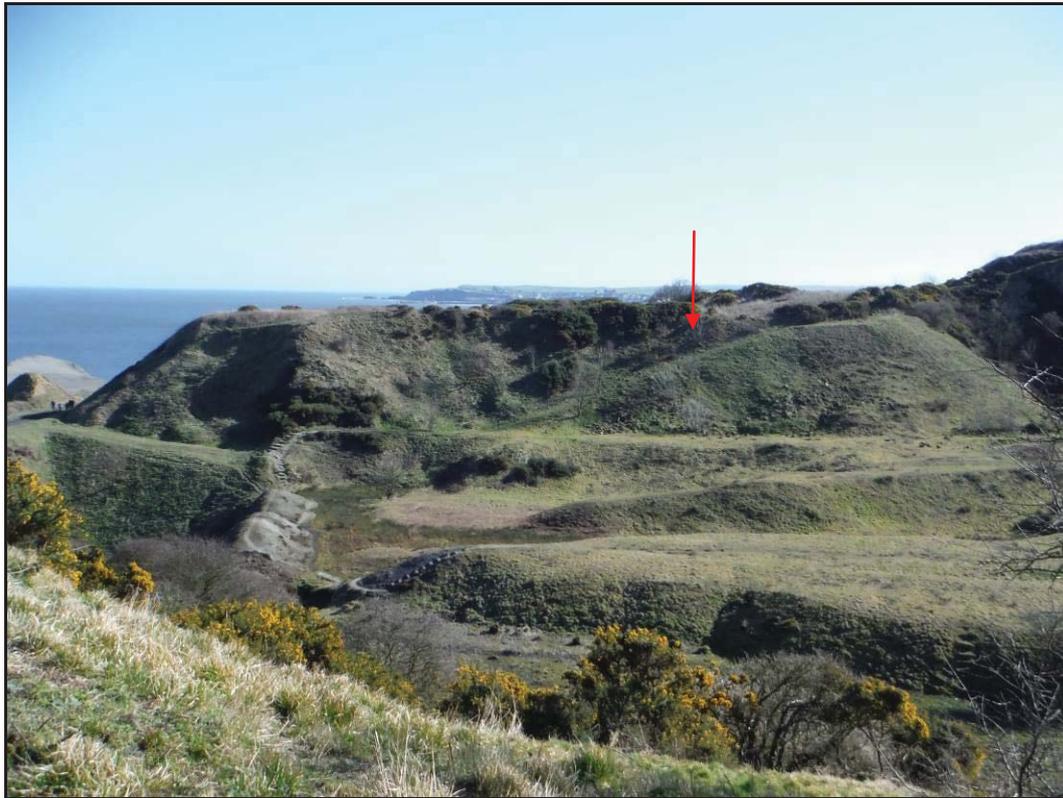
Figure 67- Inclined routeway (Feature 13) cut into the north side of the projecting 'arm' of unquarried shale forming the southern extent of Deep Grove Quarry.

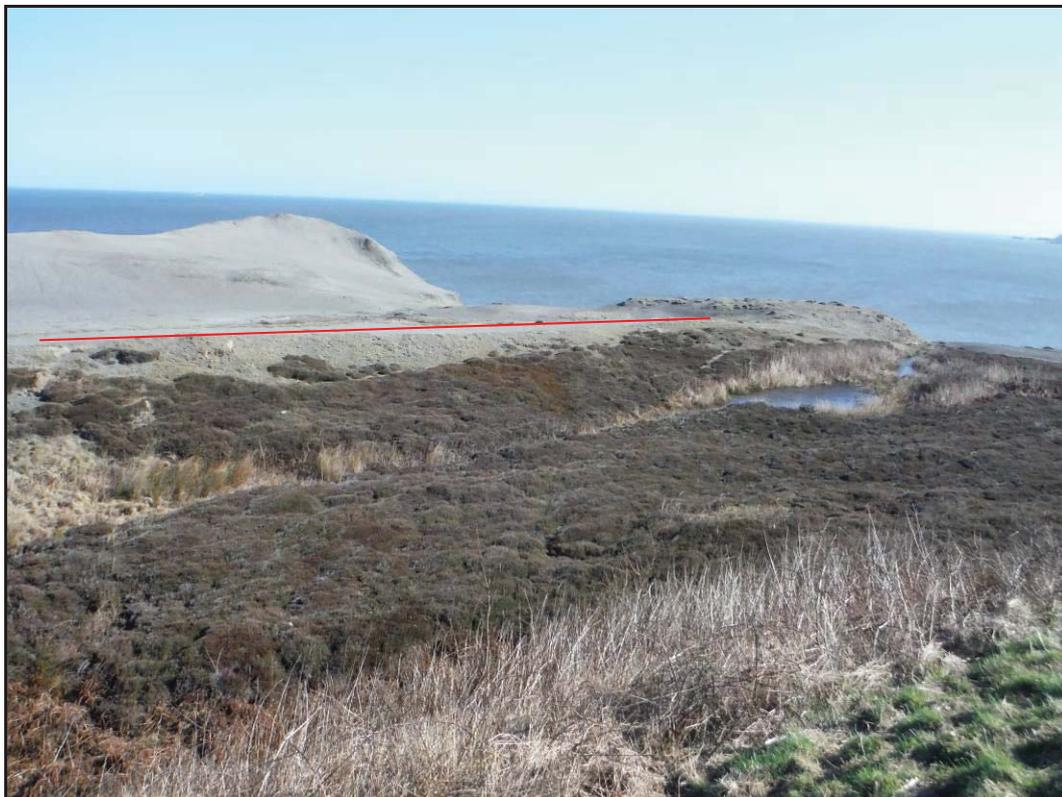
Figure 68- View of Feature 10 from the railway embankment, looking south-east.

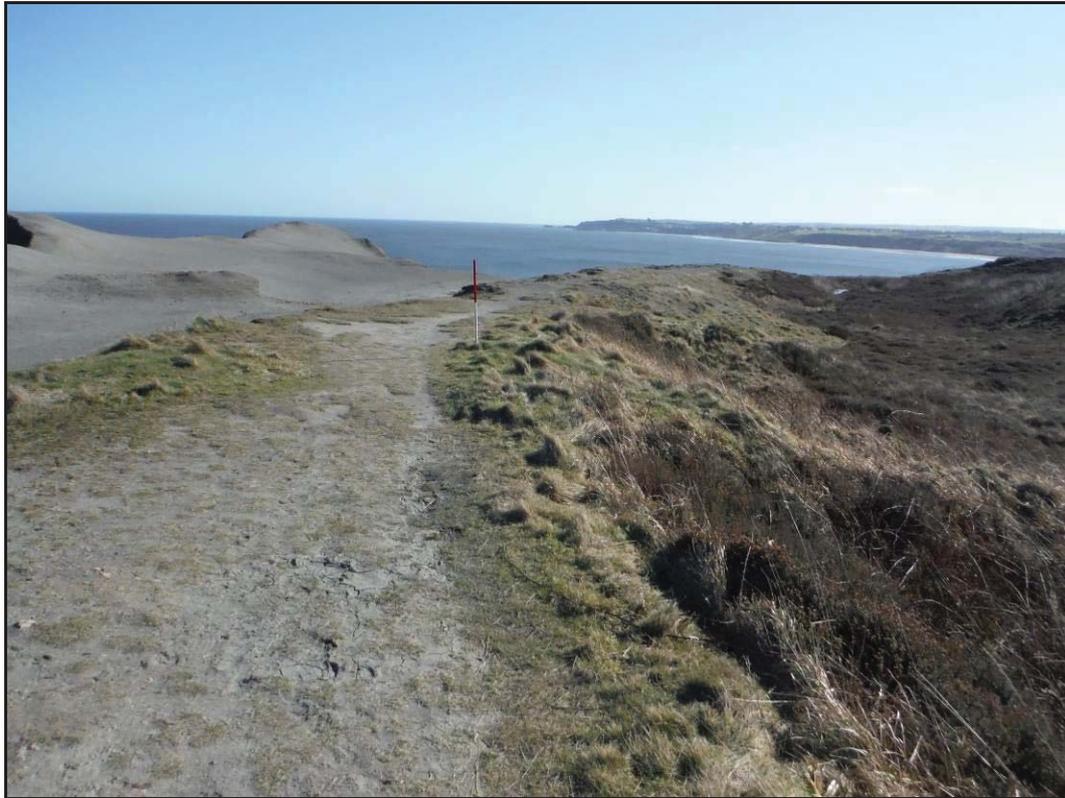
Figure 69- Possible barrowway (Feature 10), looking south-east (Scale 1 x 1m).

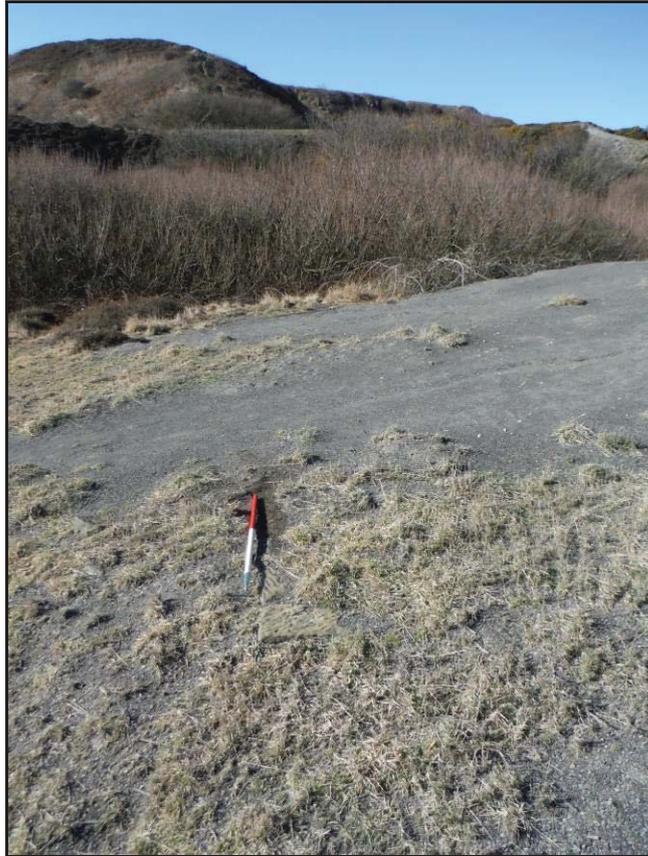
2.4.17.10 Towards the south-eastern extent of **Feature 10**, there are structural remains (**Feature 28**) protruding from loose shale deposits. These take the form of short, single leaf, alignments of dressed sandstone blocks (Figures 70 and 71). The remains appear to be contained within a cut into natural unquarried shale deposits. The structural remains may represent three walls of a building, however, too little was exposed to confirm this. A building in this location may have been related to processes taking place in the adjacent steeping pits (**Feature 8**). The remains appear to pre-date **Feature 10**, however excavation would be needed to confirm this relationship.

Figure 71- Structural remains at the south-eastern end of Feature 10, looking west (Scale- 1 x 1m).

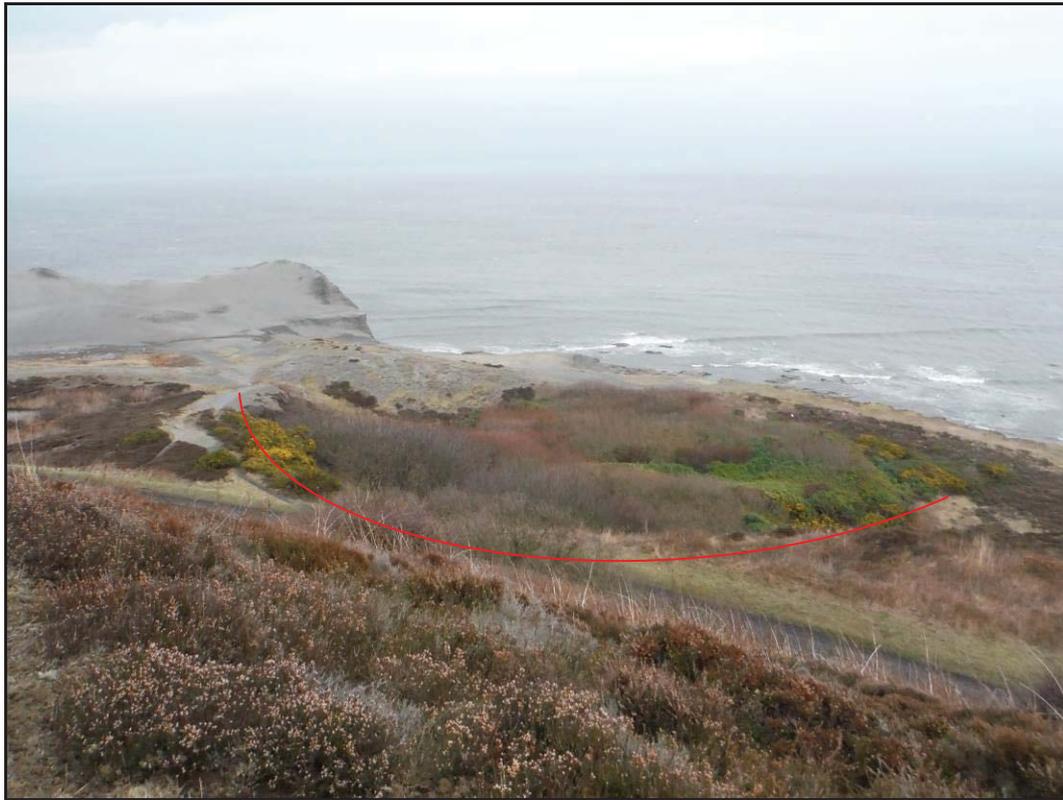
2.4.17.13 In the south-eastern corner of the quarry floor a lower quarry area (**Feature 31**) has been excavated similar to that seen within Gaytress Quarry (**Feature 24**) (Figure 73). This lower quarry floor contains an area of steeping pits (**Feature 8**) identified through the aerial photography and Lidar transcription. The lower quarry is C-shaped in plan, and aligned roughly north/south. It extends for c.100m from north to south and c.90m from east to west. The eastern extent is subject to erosion. The extent of the lower quarry is demarcated by ridges of unquarried shale. The walkover survey recorded the presence of a sandstone retaining wall on south side of the northern 'arm' of the quarry (Figure 74). This arrangement is similar to that noted within Gaytress Quarry. A similar section of sandstone walling was noted eroding from the south side of the southern 'arm' of the quarry and may also be a retaining wall (Figure 75), although its alignment suggests that it may also be a separate feature entirely. Along the top of the northern and southern 'arms' of the quarry the walkover survey also identified possible barrowways. That on the north has been discussed as the continuation of **Feature 26**, and that on the south was identified through aerial photography and Lidar transcription (**Feature 33**). The southern bank runs along the top of the 'arm' which slopes down to the level of the quarry floor (Figure 76). It is possible that this was used as a routeway or barrow run and it may have been related to **Feature 7** on the west side of the railway. The possible barrowways could have been used to transport material to the steeping pits (**Feature 8**).

Figure 73- Lower quarry area (Feature 31) seen from the top of Asylum Hill, looking east.

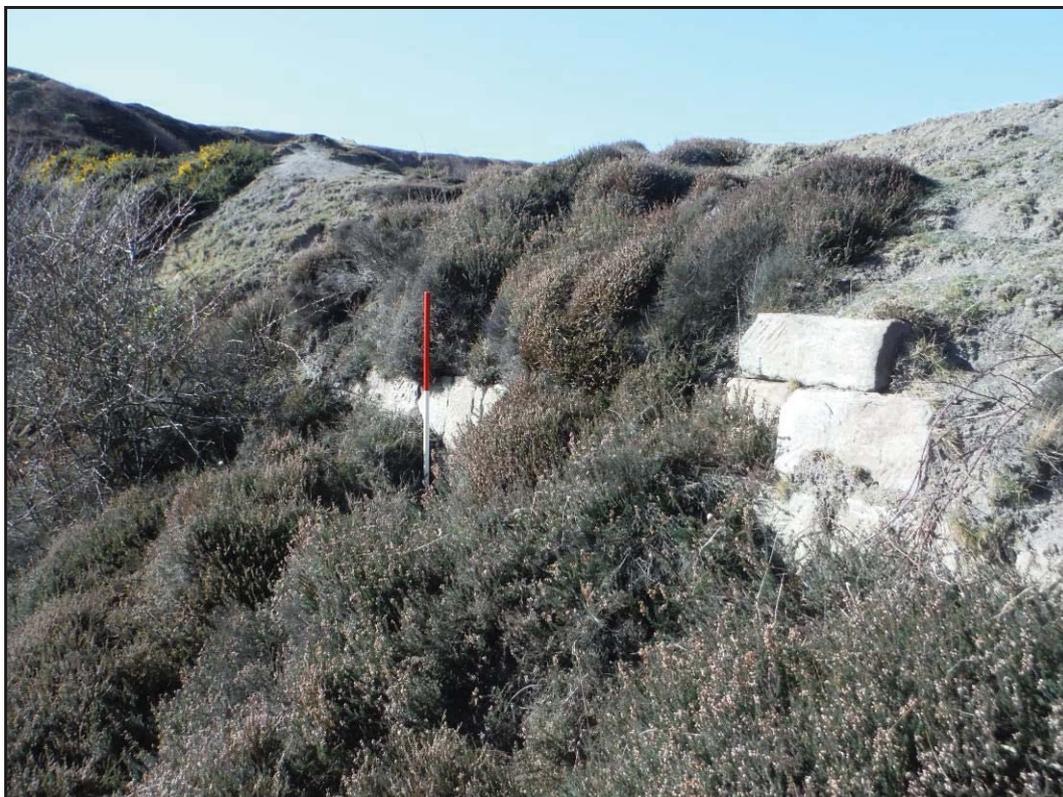
Figure 74- Sandstone retaining wall on the south side of the northern 'arm' of the lower quarry, looking north-west (Scale- 1 x 1m).

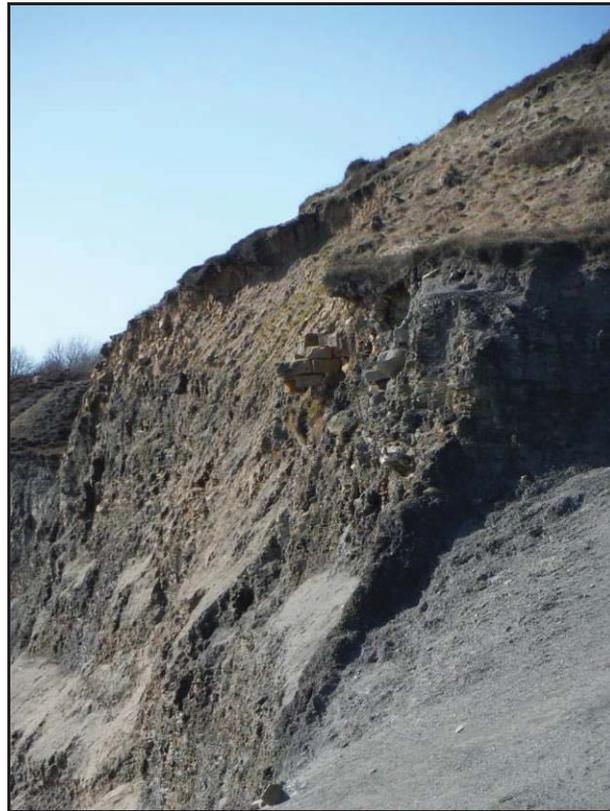
Figure 75- Sandstone wall eroding from the south side of the southern 'arm' of the lower quarry, looking south.

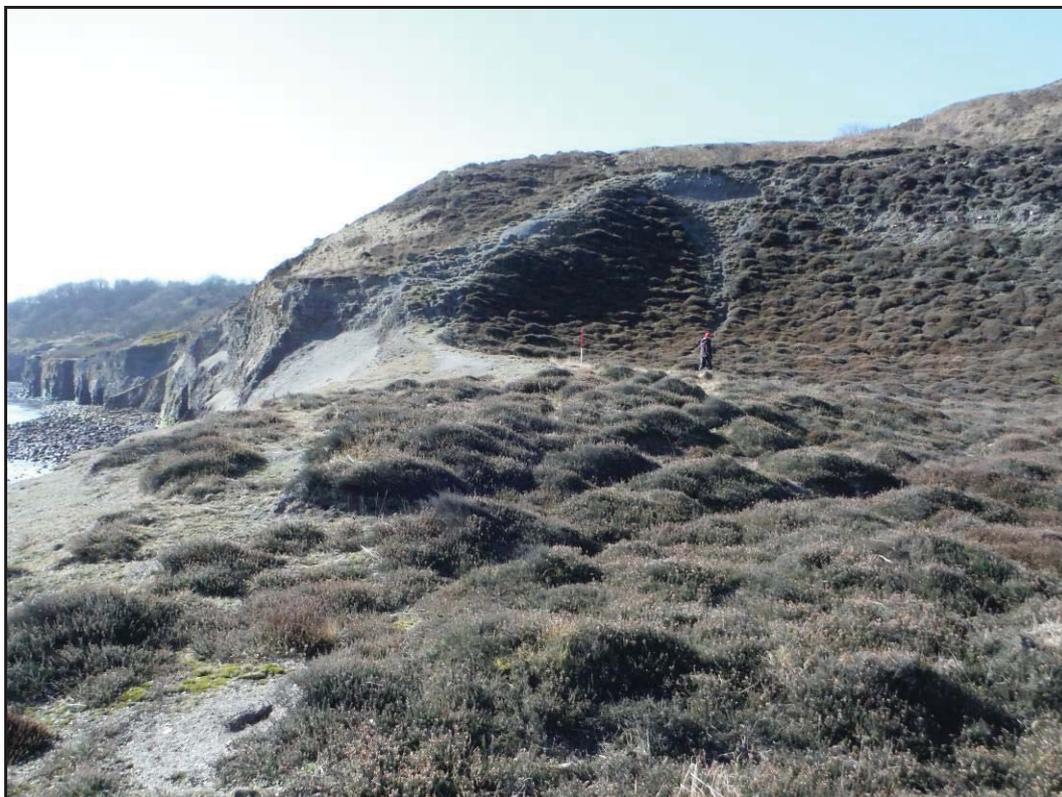
Figure 76- Bank along the top of the southern 'arm' of the lower quarry, looking south-west (Scale- 1 x 1m).

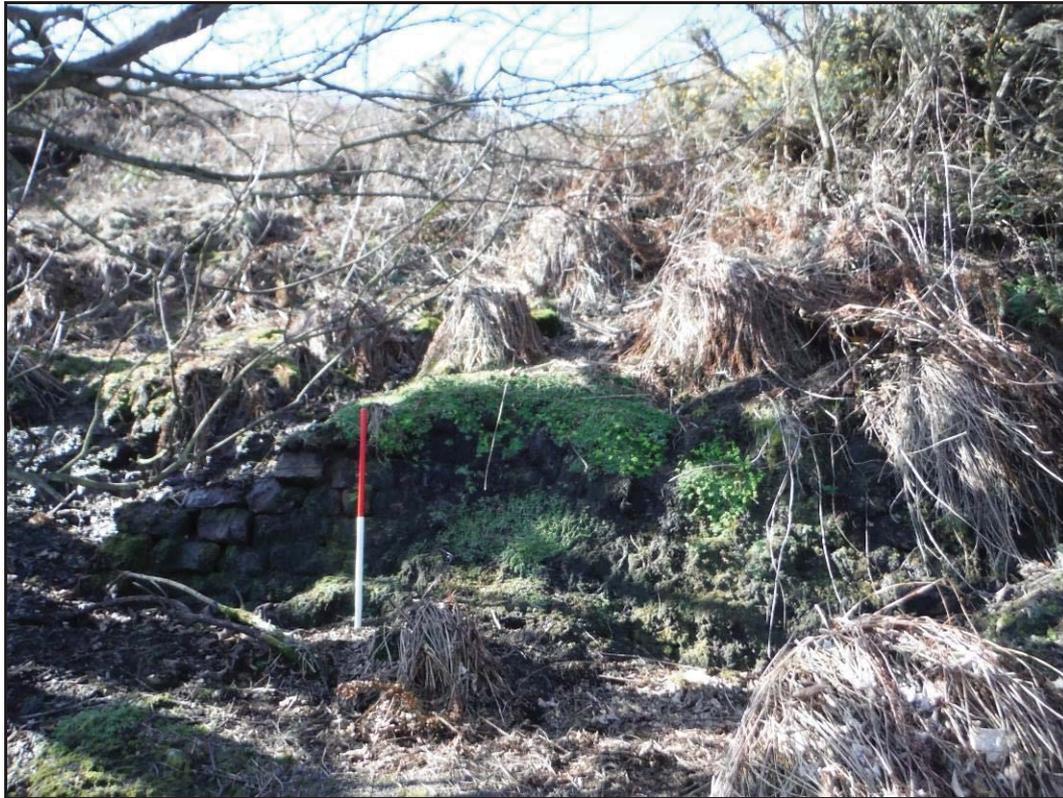
2.4.17.14 The walkover survey also recorded a short section of retaining wall at the base of the working face at around the centre of the C-shaped quarry (**Feature 27**). This was different in character to the retaining walls noted on the northern and southern 'arms' (Figure 77) and was located in area which was very damp, possibly representing a seasonal water course. This retaining wall is likely to be related to the erection of the railway (**Feature 4**) which runs very close to the top edge of the quarry face at this location.

Figure 77- Retaining wall at the base of the working face in the lower quarry floor, looking west (Scale- 1 x 1m).

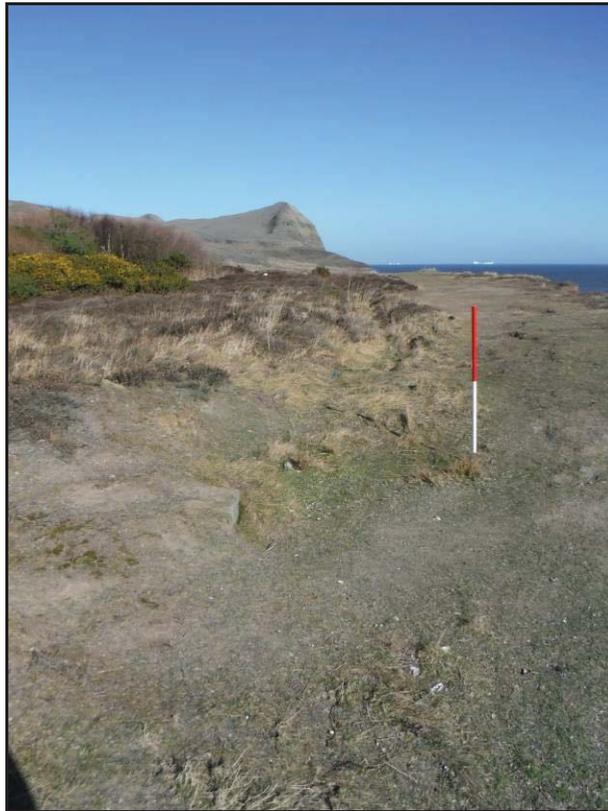
Figure 78- Stone-lined channel on the east side of the steeping pits, looking north (Scale- 1 x 1m).

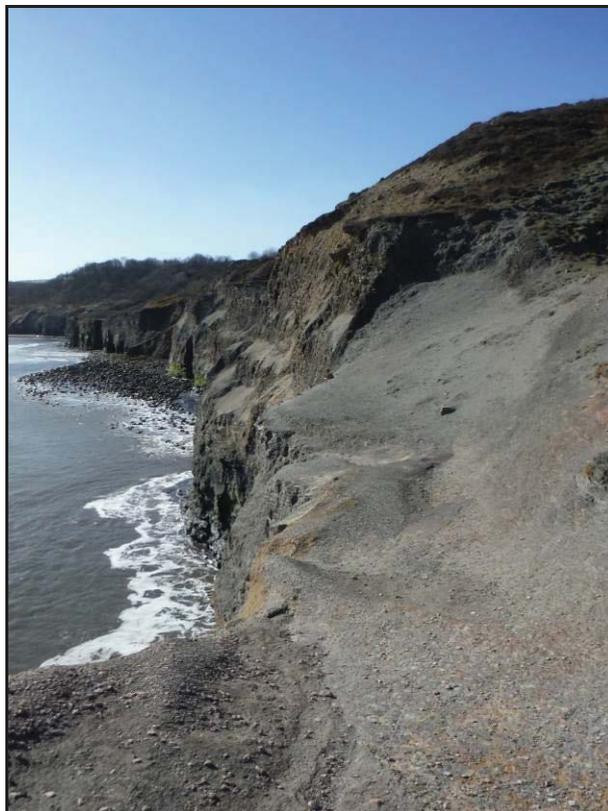
Figure 79- Continuation of the liquor channel eroded to the south of the steeping pits, looking south.
