# Archaeological Excavation and Survey of Scheduled Coastal Alum Working Sites at Boulby, Kettleless, Sandsend and Saltwick, North Yorkshire

ARS Ltd Report No-2015/42  
OASIS No: archaeo15-208500

Compiled By:  
Samantha Bax, Rupert Lotherington PCIfA and Dr Gillian  
Scott  
Archaeological Research Services Ltd  
The Eco Centre  
Windmill Way  
Hebburn  
Tyne and Wear  
NE31 1SR

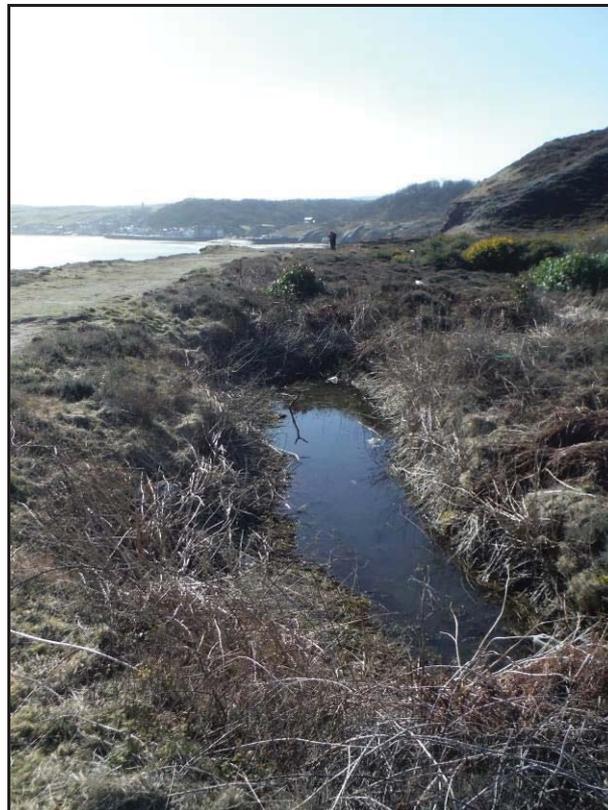
2.4.17.16 At the north end of the possible liquor channel (**Feature 34**) there was a small rectangular stone-lined tank feature (Figure 80 and 81). This was holding water at the time of the walkover survey. The purpose of this feature is not known and its relationship with the liquor channel could not be established during the walkover, however, it appears to relate to the system of steeping pits (**Feature 8**). The aerial photography and Lidar transcription shows the stone-lined tank as being fed from a channel running along the south-west end of **Feature 10** and down the side of the quarry edge (**Feature 31**). This channel cuts the possible barrowway **Feature 26** at its junction with **Feature 10** at which point the channel appears to have been crudely culverted under the possible barrowway (Figure 82). Further upstream the channel runs alongside **Feature 10** and also contains a pool. This area, however, is sandwiched between the inserted railway embankment (**Feature 4**) and the inserted barrowway (**Feature 10**) so it is difficult to say with any certainty that the water courses within it are representative of the original quarry workings. The identified channel may or may not be the intended feed for the steeping pits, or they may represent a feed during one phase of its history. It is likely that if **Feature 9** was indeed a reservoir that this would have somehow fed the steeping pits, however no channel is now present between the two. Aside from the water channel and tank, the steeping pits (**Feature 8**) themselves were recorded as a series of indistinct linear banks, some of which contained short sections of exposed sandstone walling (Figure 83). The area of the steeping pits was overgrown with heather at its eastern end and denser vegetation towards its western end. It is likely that there is good preservation of features beneath the vegetation however.

Figure 80- Stone-lined tank feature at the north end of the liquor channel, looking south.

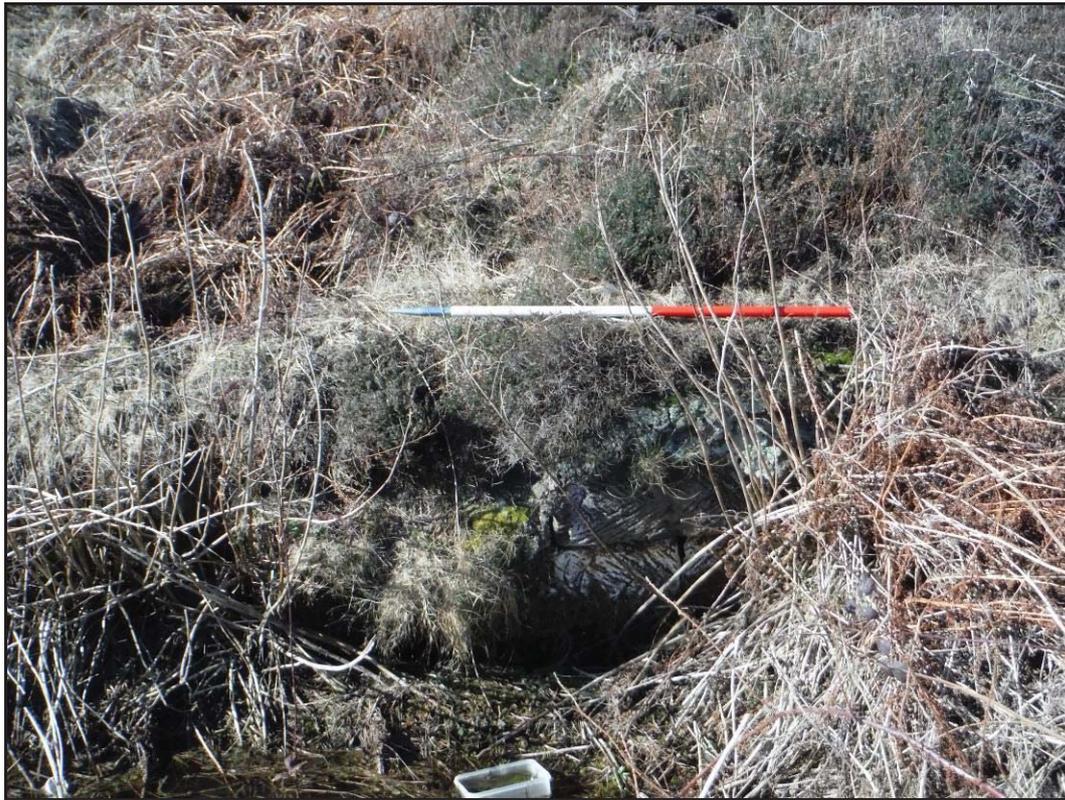
Figure 81- Stone lined tank feature at the north end of the liquor channel (Scale- 1 x 1m).

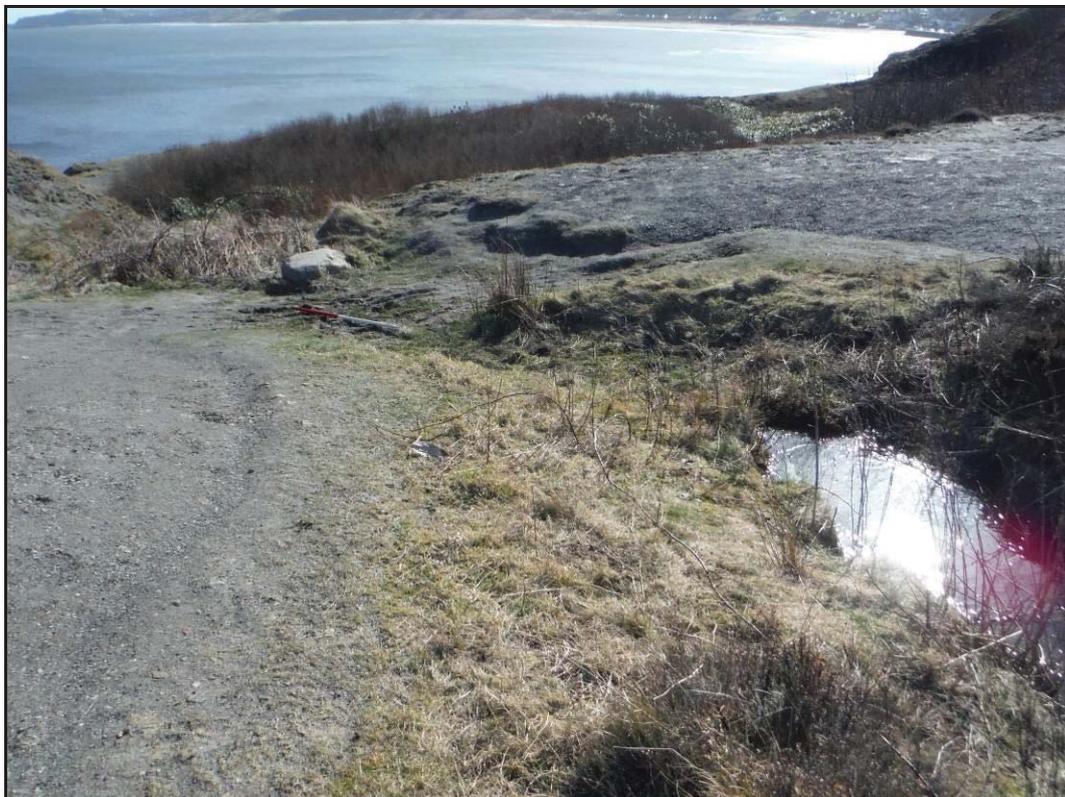
Figure 82- Channel cutting Feature 26 and running towards the steeping pits, looking south (Scale- 1 x 1m). Note that the channel appears to have been crudely culverted under the barrowway.

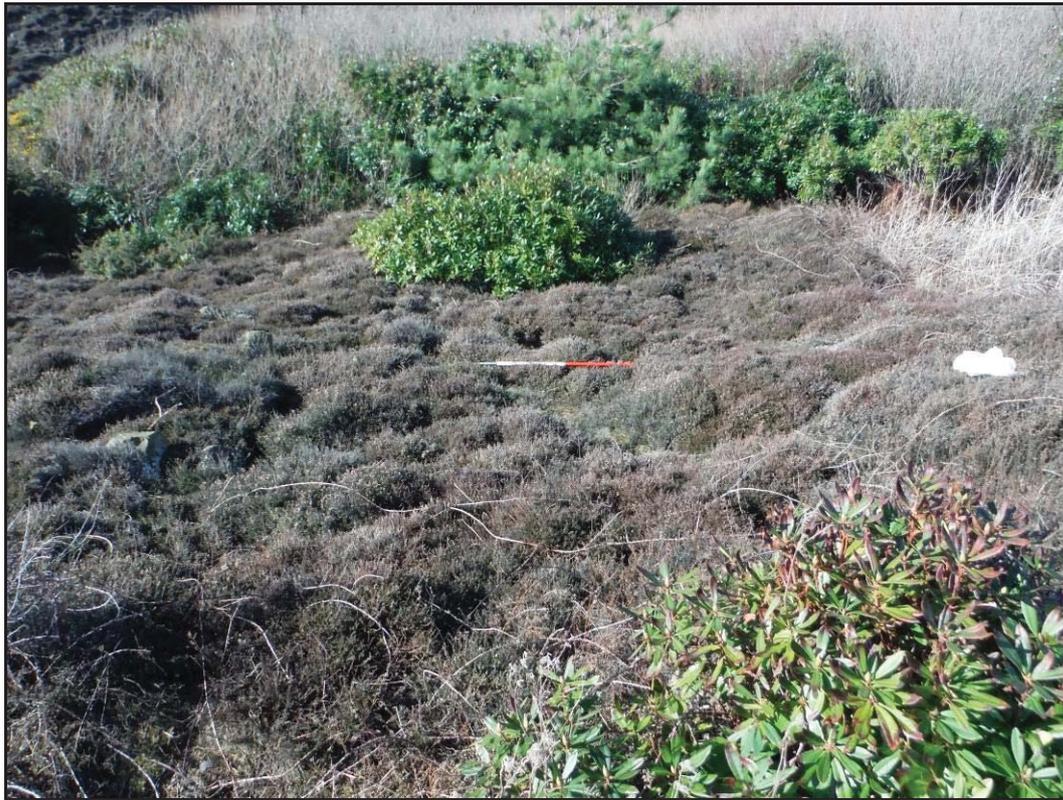
Figure 83- Representative view of a steeping pit, looking west (Scale- 1 x 1m). Stonework on left and right sides of the photograph demarcate the extent of the pit.

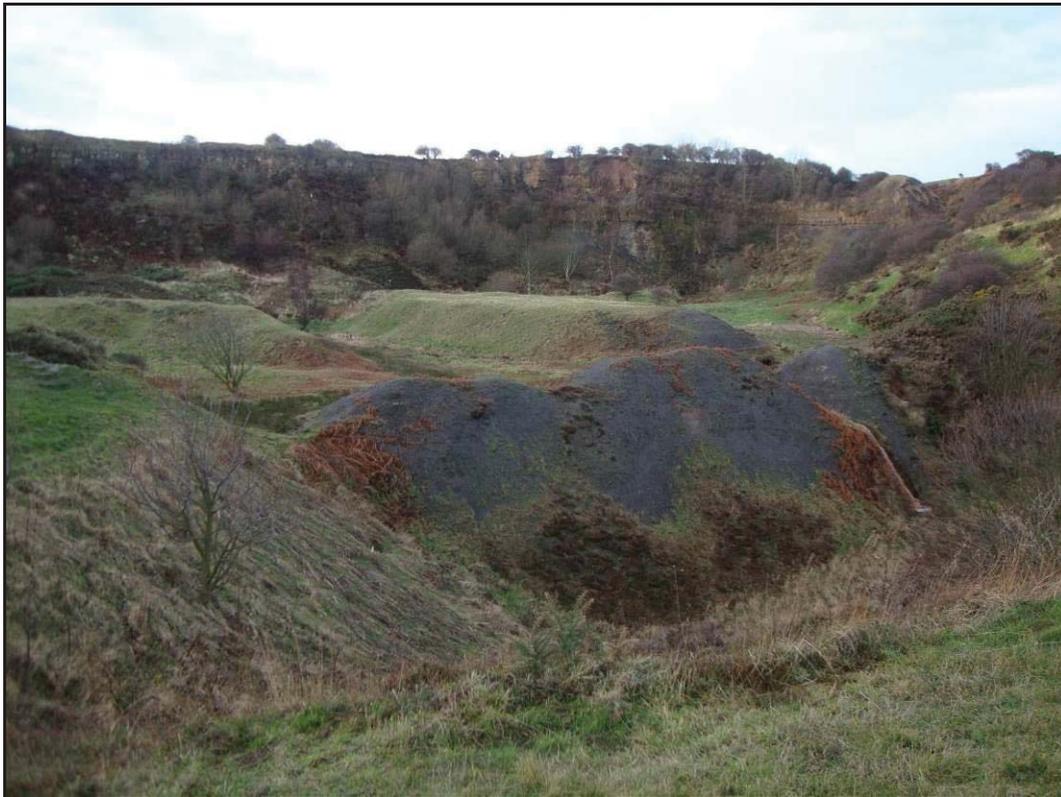
2.4.18.2 **Feature 3** records the extent of Deep Grove Quarry (Figure 84) which is mapped as an elongated C-shape facing north-east. The quarry extends for c.200m north-west/south-east and c.225m north-east/south-west (the north-eastern extent being under coastal erosion). The quarrying activities at Deep Grove involved the removal of sandstone overburden and the subsequent quarrying of the alum shale beneath. In this respect Deep Grove is the same as Gaytress and Ness End Quarries in its operation. Unlike Ness End, however, there does not appear to have been a lip of unquarried shale

Figure 84- The interior of Deep Grove Quarry, looking west.

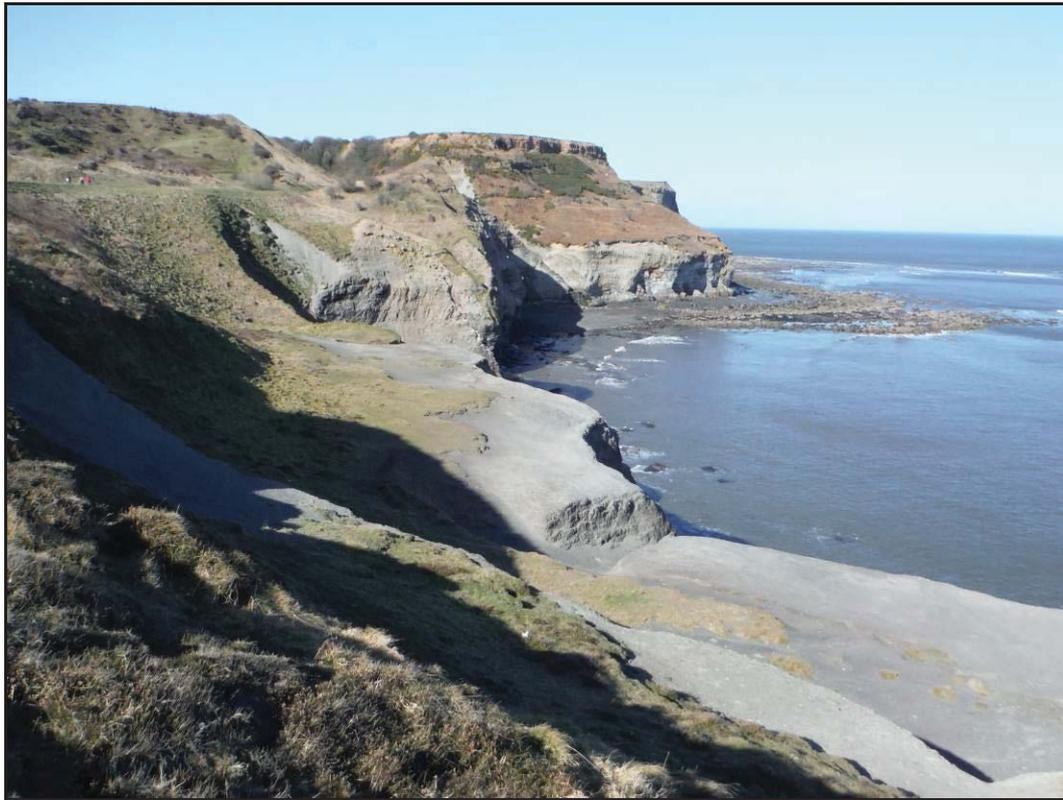
retained around the seaward edge of the quarry, or at least this feature no longer survives (Figure 85). The north-eastern third of the quarry floor has been quarried to a lower level than the western two-thirds.

Figure 85- The north-eastern extent of Deep Grove Quarry showing no lip of unquarried shale around its seaward edge.

2.4.18.6 The lower north-eastern quarry area (**Feature 35**) has been largely built-over by the railway and the walkover survey did not identify any alum working related features in the visible portions of this quarry floor (Figure 85).

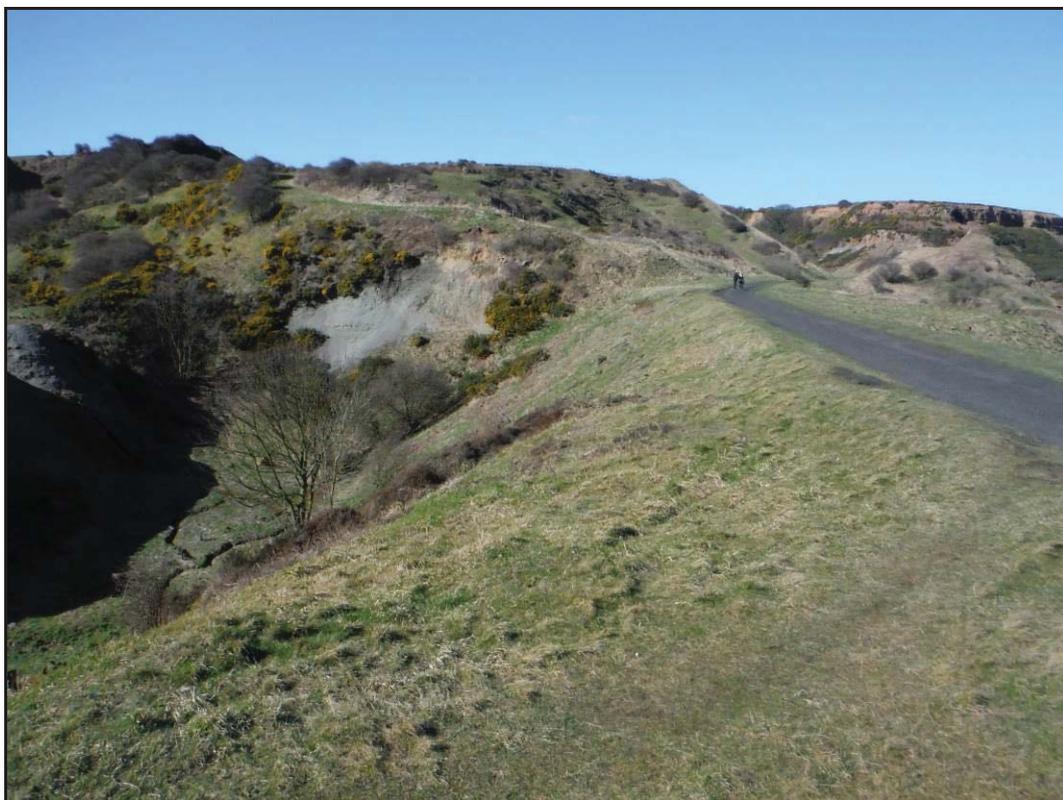
Figure 86- The large-scale railway embankment within Deep Grove Quarry, looking north-west.

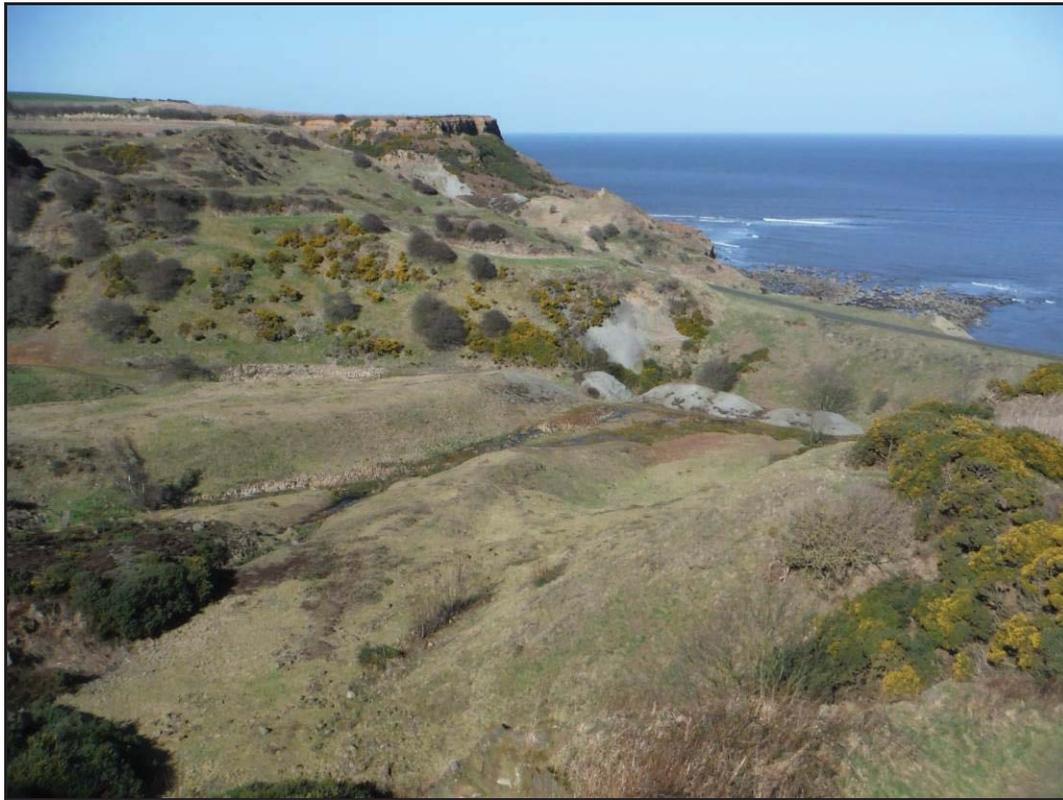
2.4.18.5 Between the spoil heaps (**Feature 5**) the aerial photography and Lidar transcription also recorded a water channel (**Feature 36**) running north-east/south-west for c.70m (Figure 87). The spoil heaps respect this water channel, suggesting that it may have been an important water supply to the alum workings. The channel feeds into a pool of water before spilling over the top edge of the lower north-eastern quarry area (**Feature 35**) and running into a culvert beneath the railway embankment. The triangular pool is essentially formed on all three sides by the spoil heaps, although that along its north-eastern edge appears to be a deliberate bank of material created for this purpose (**Feature 37**). The pool may have been used as a reservoir and a means to control the flow of water into the now built-over steeping pits. The culvert emerging from the far side of the railway embankment was wrongly identified as a liquor trough in the initial assessment report (Eadie 2014, 40).

Figure 87- The south-western two-thirds of the quarry floor at Deep Grove, occupied by large spoil heaps, looking north. Note also the central water channel feeding in to a roughly triangular reservoir defined by the prominent bank of material along its north-eastern edge.

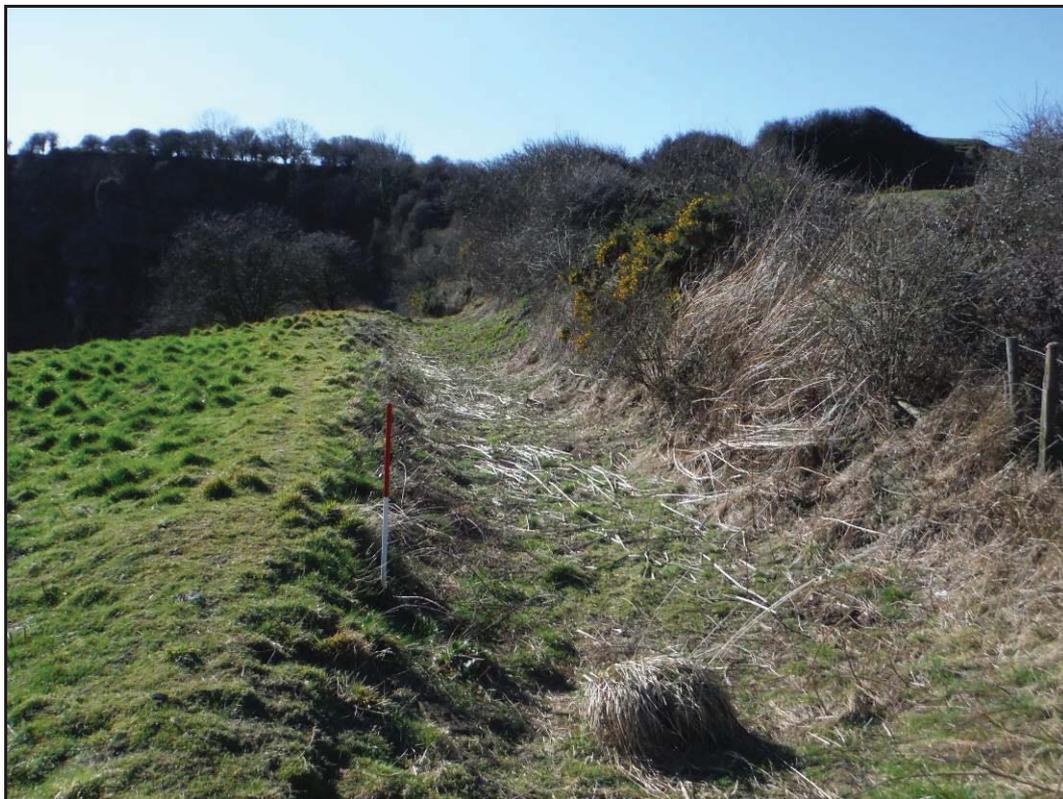
Figure 88- Hollowway running south-west into Deep Grove Quarry (Scale- 1 x 1m).

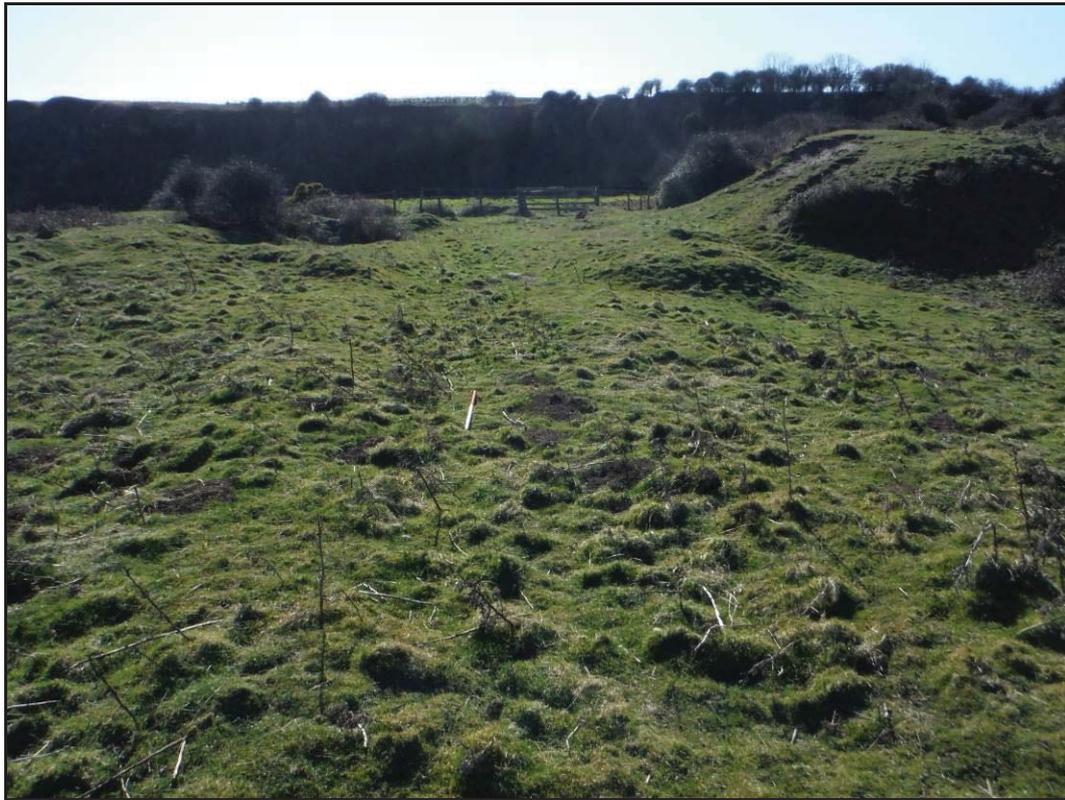
Figure 89- 'Crossroads' area to the north-east of Deep Grove Quarry, looking south (Scale- 1 x 1m).

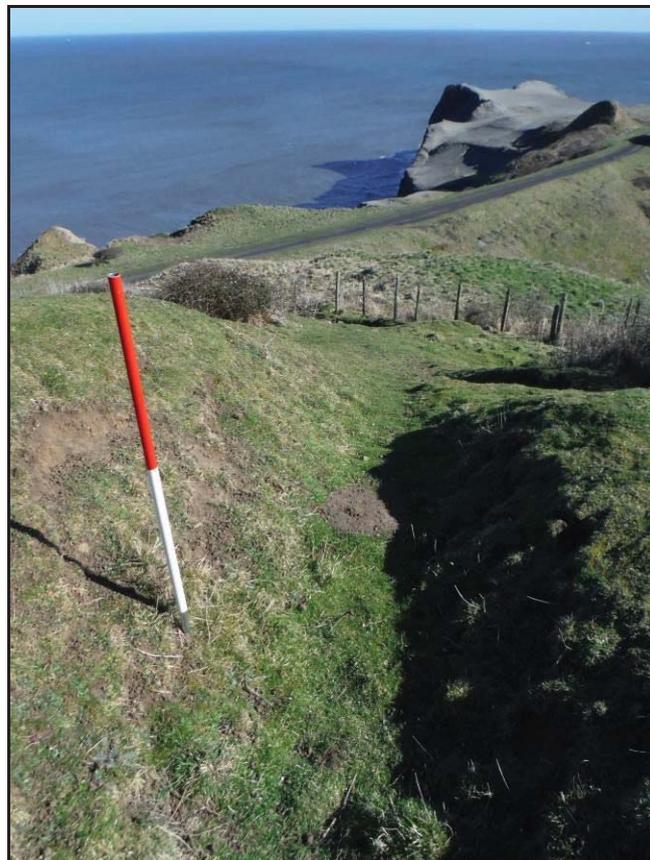
2.4.19.3 The site walkover also identified a substantial gully running east-north-east from the 'crossroads' (**Feature 38**). This ran as a U-shaped ditched feature for a length of c.50m, the final c.20m of which contained carved stone blocks to direct the flow (Figure 90 and 91). Similar carved stone drain blocks are present at the Pithill building at Boulby Alum Quarries and within Peak Alum House. A similar gulley, or 'stone gutter' was also identified at Kettlewell where it was interpreted as part of the water supply to steeping tanks. At Kettlewell there was also evidence that the gutter had capping stones presumably to preserve the cleanliness of the water. Whilst the route of the gully cannot be traced beyond its mapped extent on Figure 129, it may have served the purpose of bring water into the works.

Figure 90- Drainage gully, looking east-north-east (Scale- 1 x 1m).

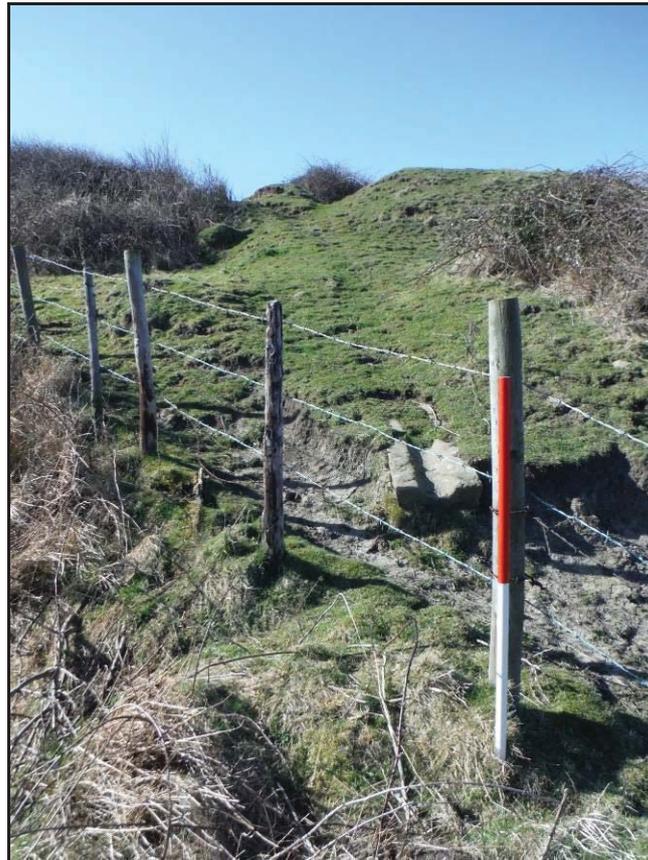
Figure 91- Drainage gully, looking west-south-west, showing carved stone drainage channel (Scale- 1 x 1m).
