An Archaeological Building Recording at Whirlow Hall Farm, Sheffield

ARS Ltd Report 2011/59
May 2011

ARS Ltd Report 2011/59

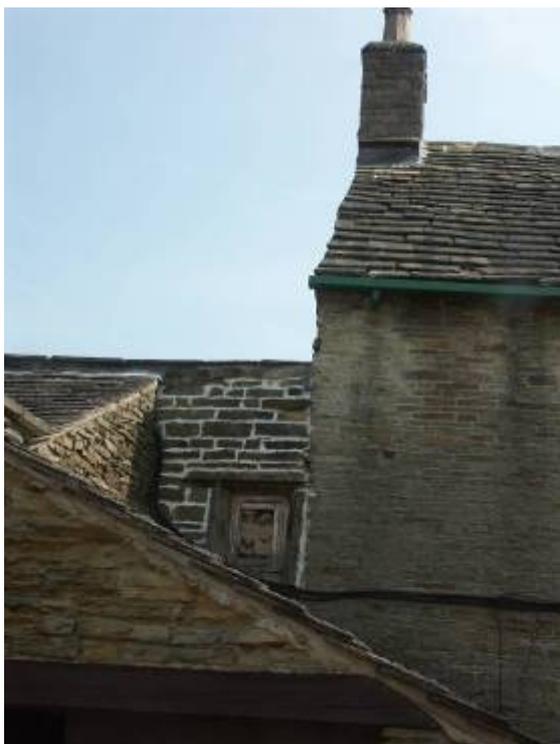
- 4.39 The north wall of this building and the north elevation contain evidence of significant remodelling of this structure which has essentially reduced the size of the building by half. This is most notable on the northwest corner (Plate 15), which has a distinctly ragged appearance, with no quoin stones, marking where part of the building has been taken down. The north end of the current building is also missing the coping and kneeler seen on the south end (Plate 14). The north elevation of what is now Building G, along Broad Elms Lane, incorporate the remains of part of the original north wall of Building F, showing the original extent of the structure (Plate 17). The remains include some in-situ quoin stones and the lower part of a fine, dressed-gritstone doorway, similar to that on the south wall of Building F (Plate 18). One interesting feature is that the northeast corner of the building, which should be as ragged as the northwest, has been remodelled with inserted quoin stones to create some symmetry in the building's frontage (Plate 16). The quoins are clearly inserted as they are not as well done as those on the southeast corner and the uppermost quoin actually projects outwards from the north wall.

Plate 15. Junction of Building F and Building G, showing the ragged north end of Building F where part of the structure has been demolished.

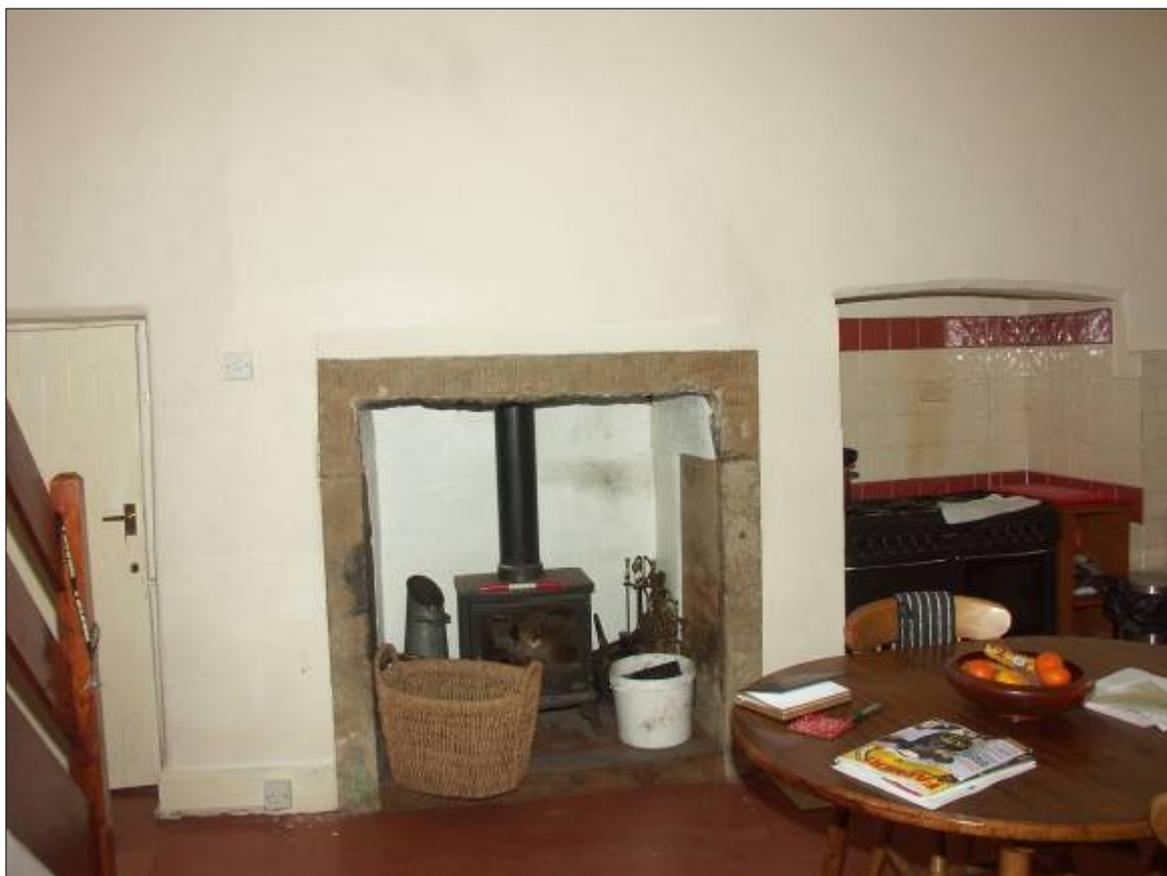
Plate 21. Ground floor of Building F. Interior of north wall showing modified central fireplace with original doorway on the left and possible built-in cupboard opening on the right.

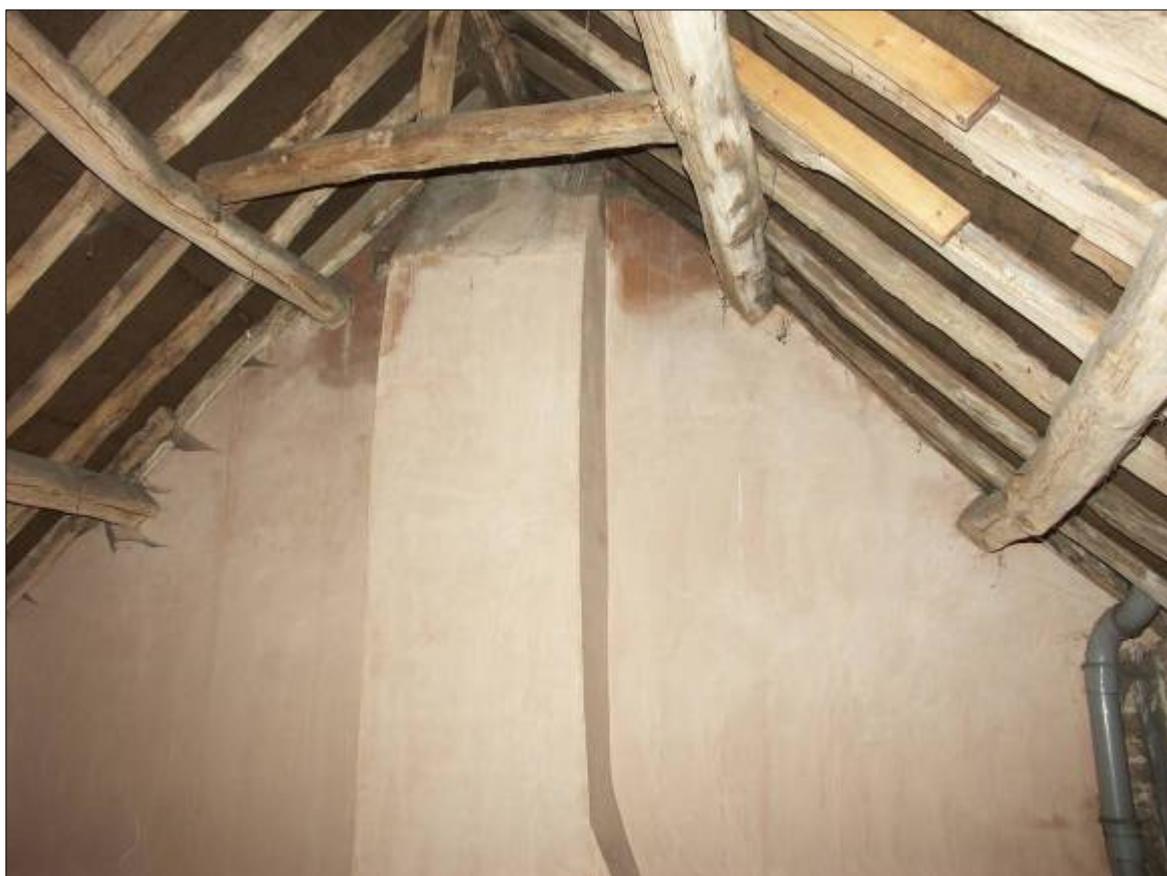
Plate 22. Attic level of Building F. Interior showing the inserted chimney flue in the south wall.

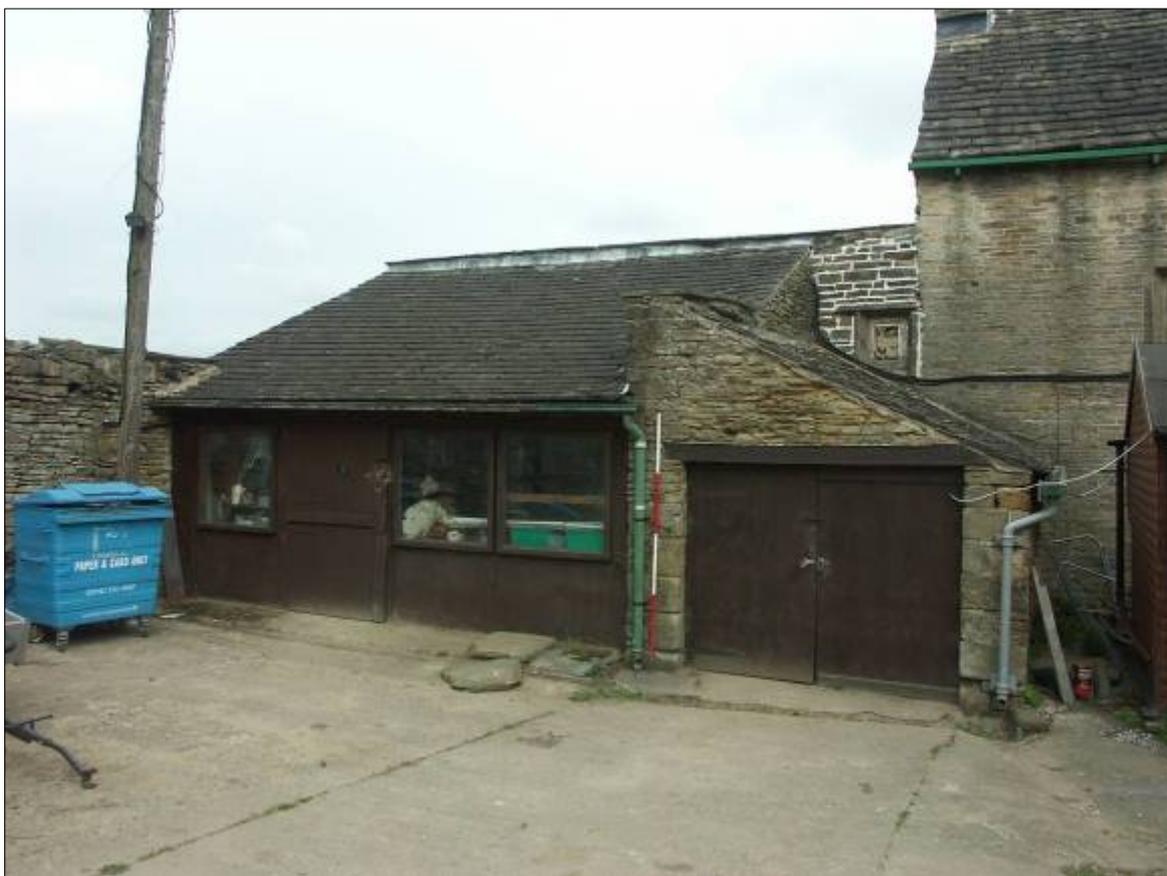
- 4.45 The lean-to structure that is attached directly to Building F contains a blocked, reset window in the west wall (Plate 26). This window almost certainly came from the demolished portion of Building F. The east elevation contains a doorway with a dressed-gritstone lintel (Plate 27). The north elevation has been discussed above as part of Building F. However, it is worth noting here that there are exposed foundation stones on this side of the building, indicating that the present ground level is lower than it was when these structures were erected.

Plate 26. West elevation of Building G.

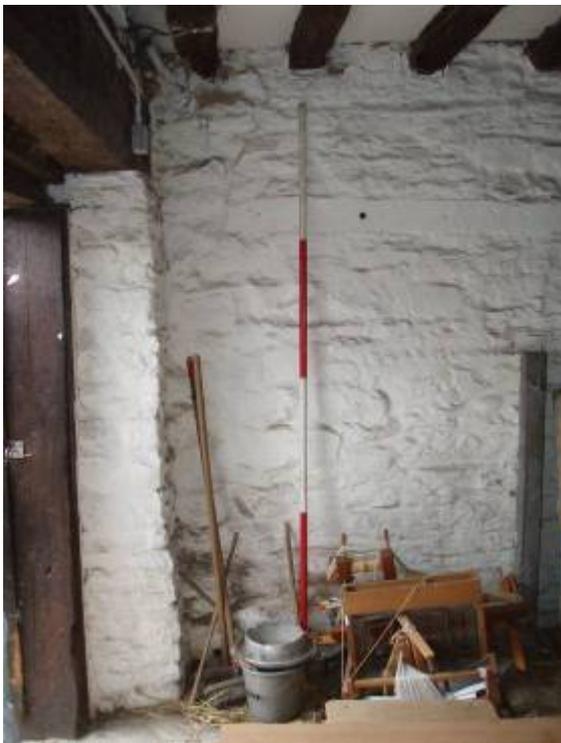
Plate 39. Interior of the western half of Building I showing the scar of a cruck blade in the south west corner.

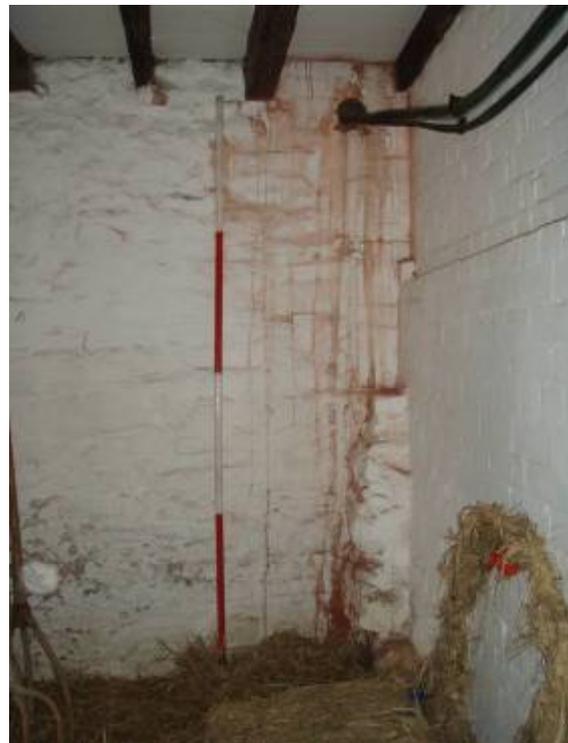
Plate 40. Interior of the western half of Building I showing the scar of a cruck blade in the northwest corner.

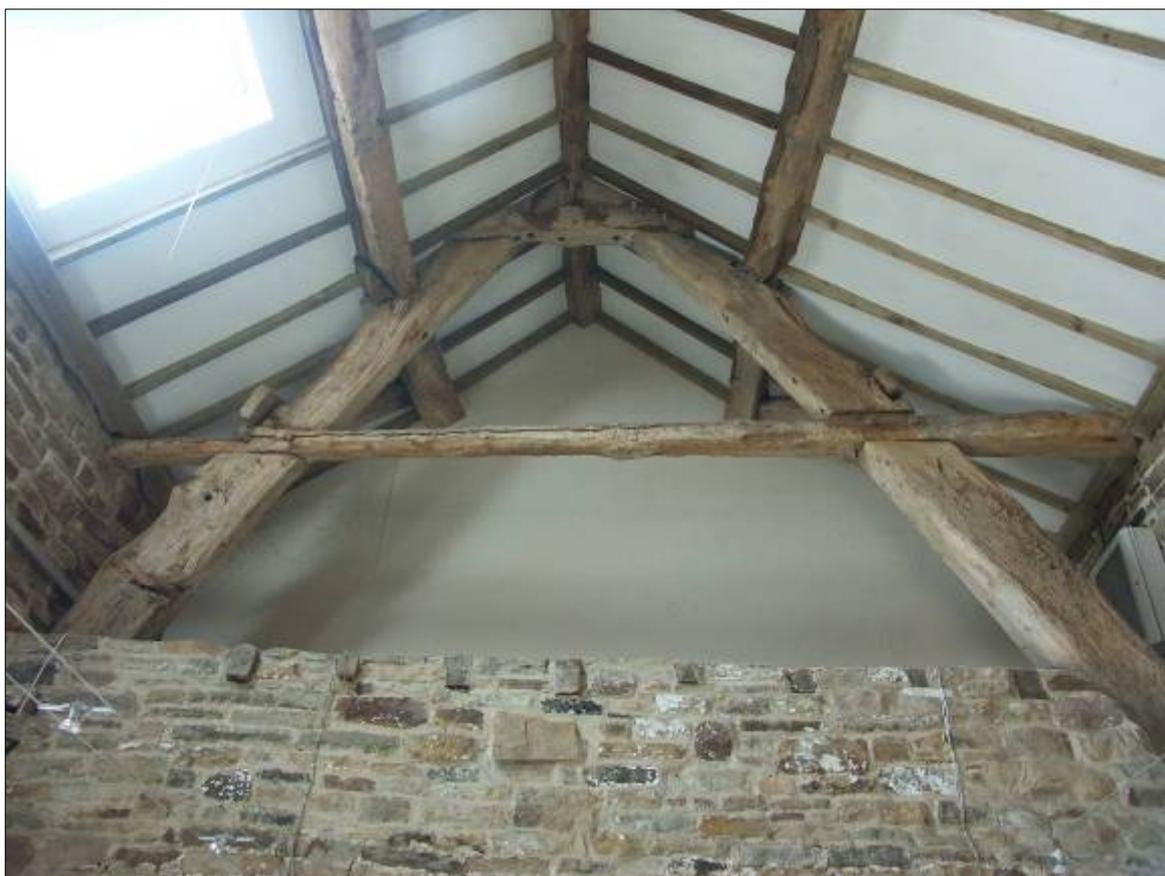
- The surviving frame sits in the centre of Building I and has been encased with stone at a later date and the stresses placed by the frame onto the stone walls have created some cracking. This is evident on the north elevation, at the location of the surviving frame (Plate 36) and on the south elevation where sections of the encasing wall have fallen away to reveal the cruck blade and its stylobate (Plate 37). There is significant cracking above this.

Plate 41. Interior of Building I facing west, showing surviving cruck blades, ridge beam, collar and tie beam encased in a later stone partition wall.

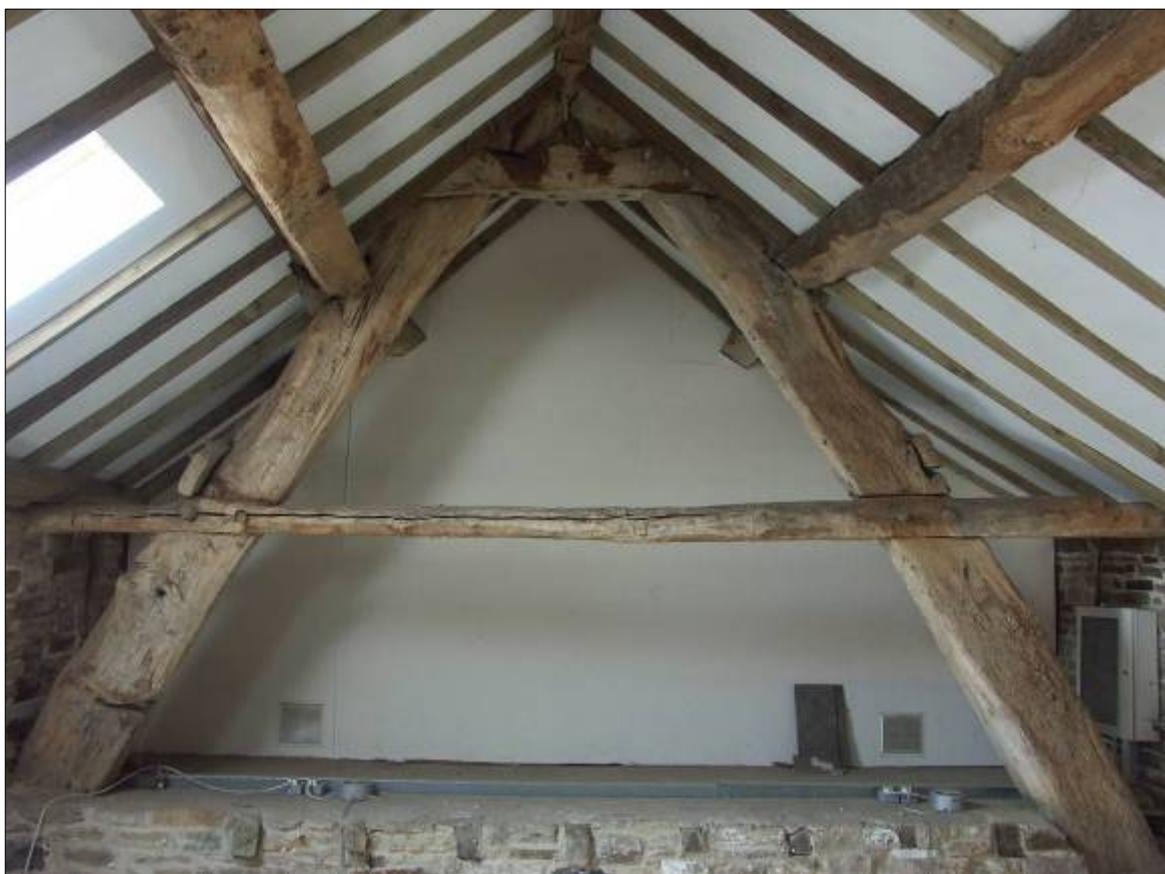
Plate 42. Detail of surviving cruck frame. Interior of Building I.

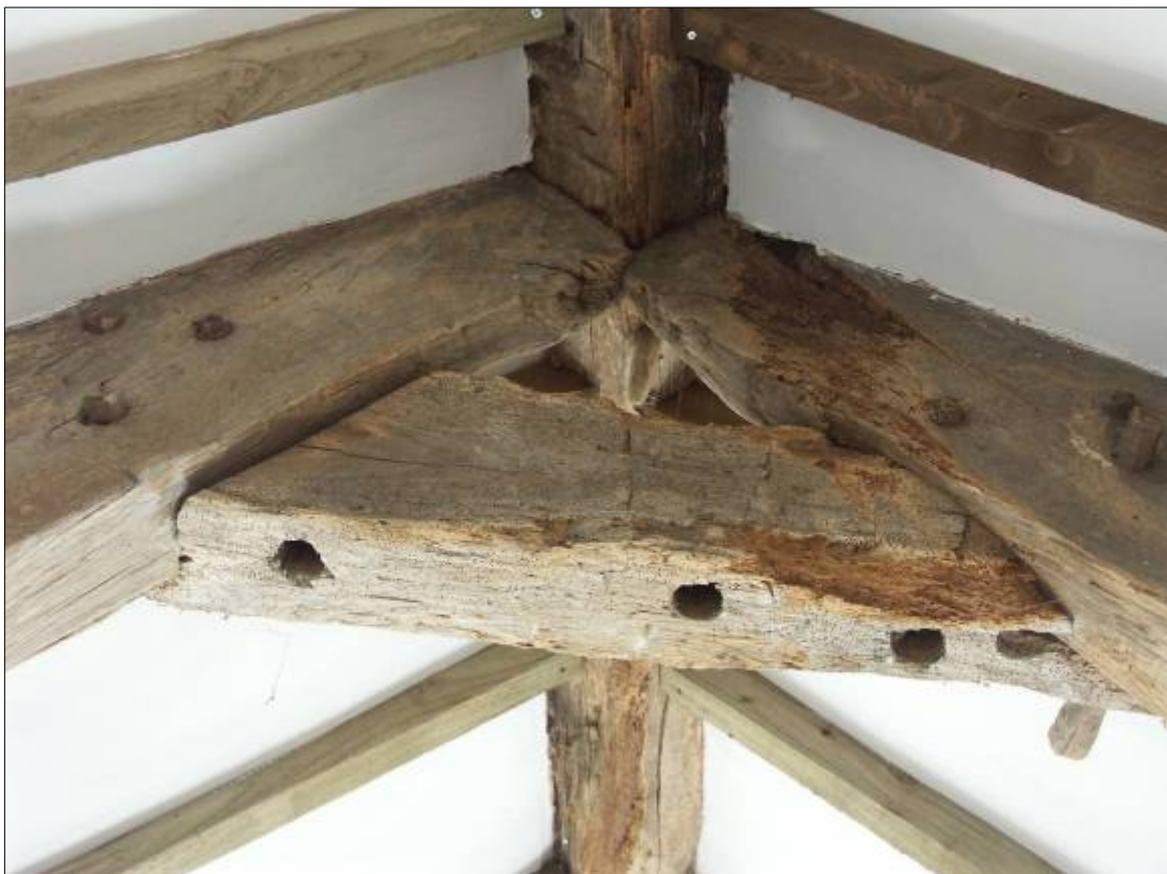
Plate 43. Detail of the apex arrangement of the surviving cruck frame.

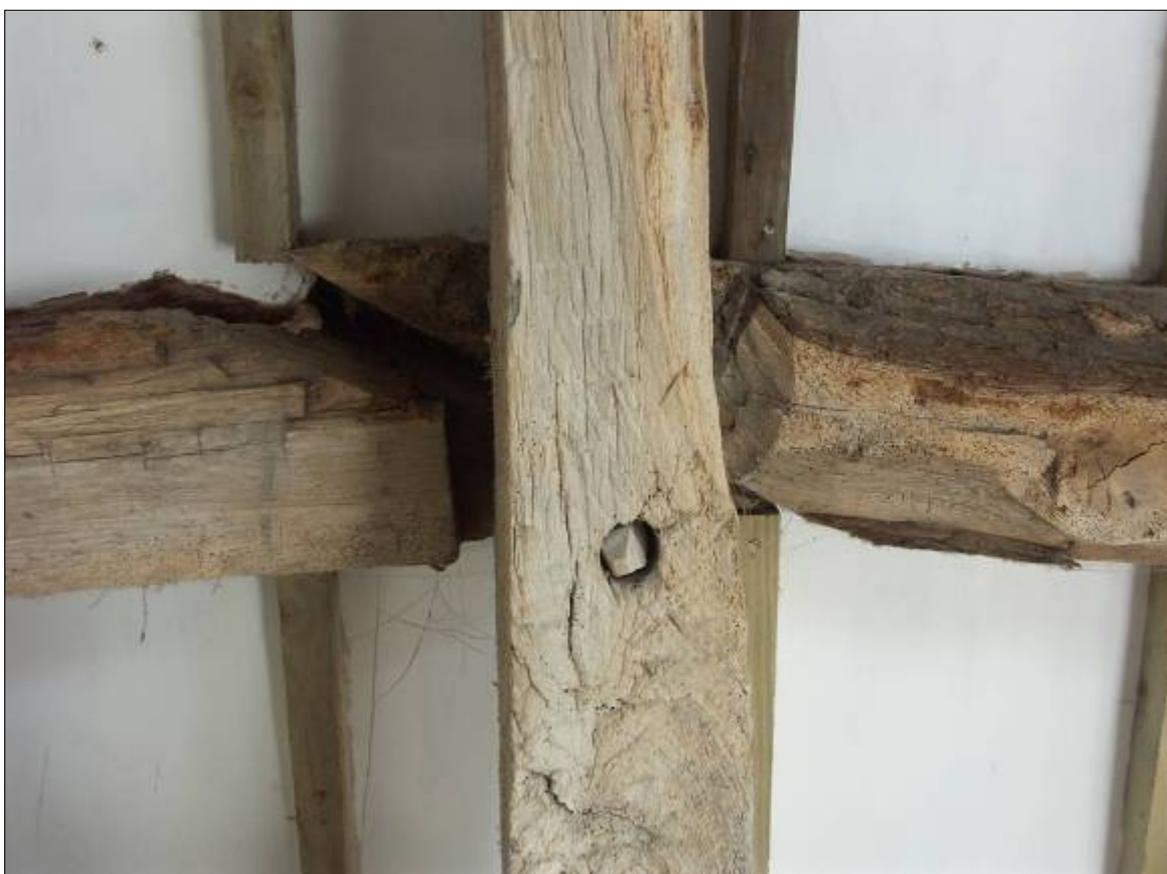
Plate 44. Detail of the joint for the side purlins in the surviving cruck frame

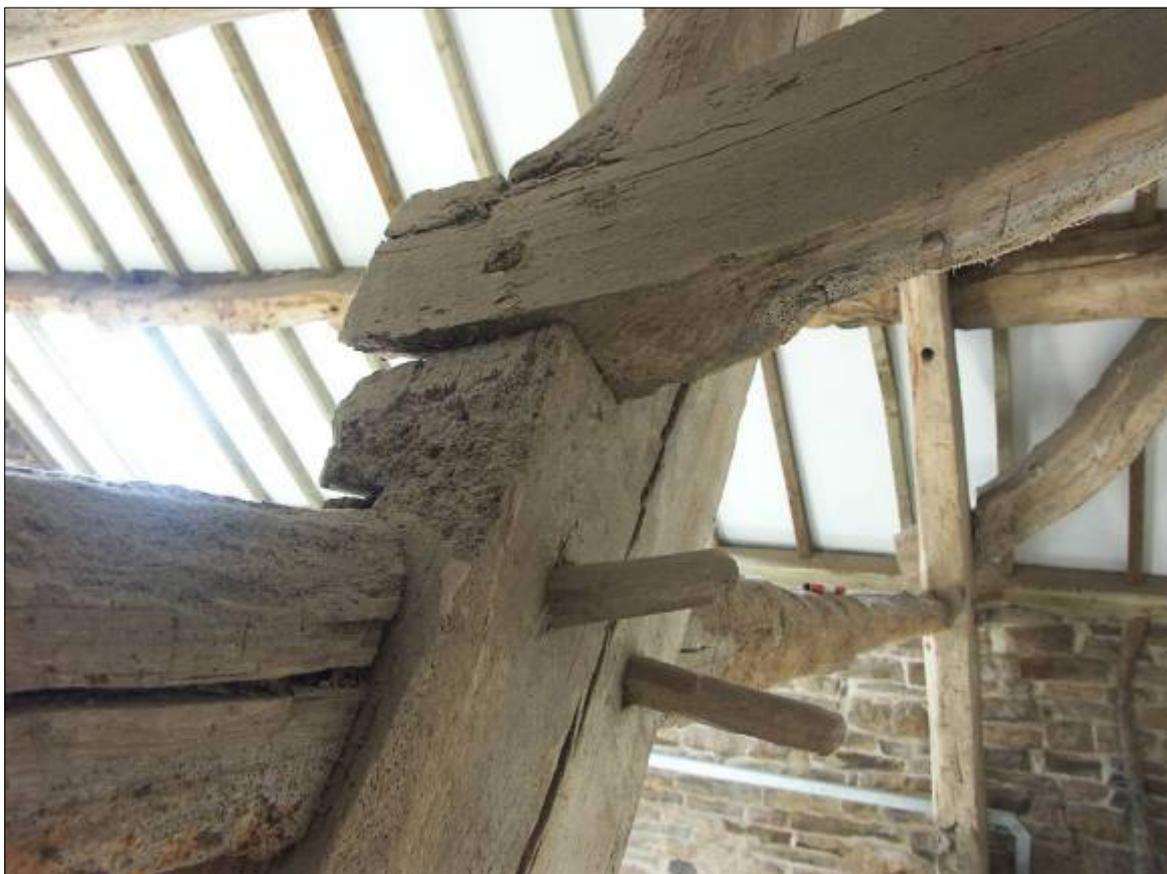
Plate 45. Detail of the halved joint for the tie-beam with tusk pegs.

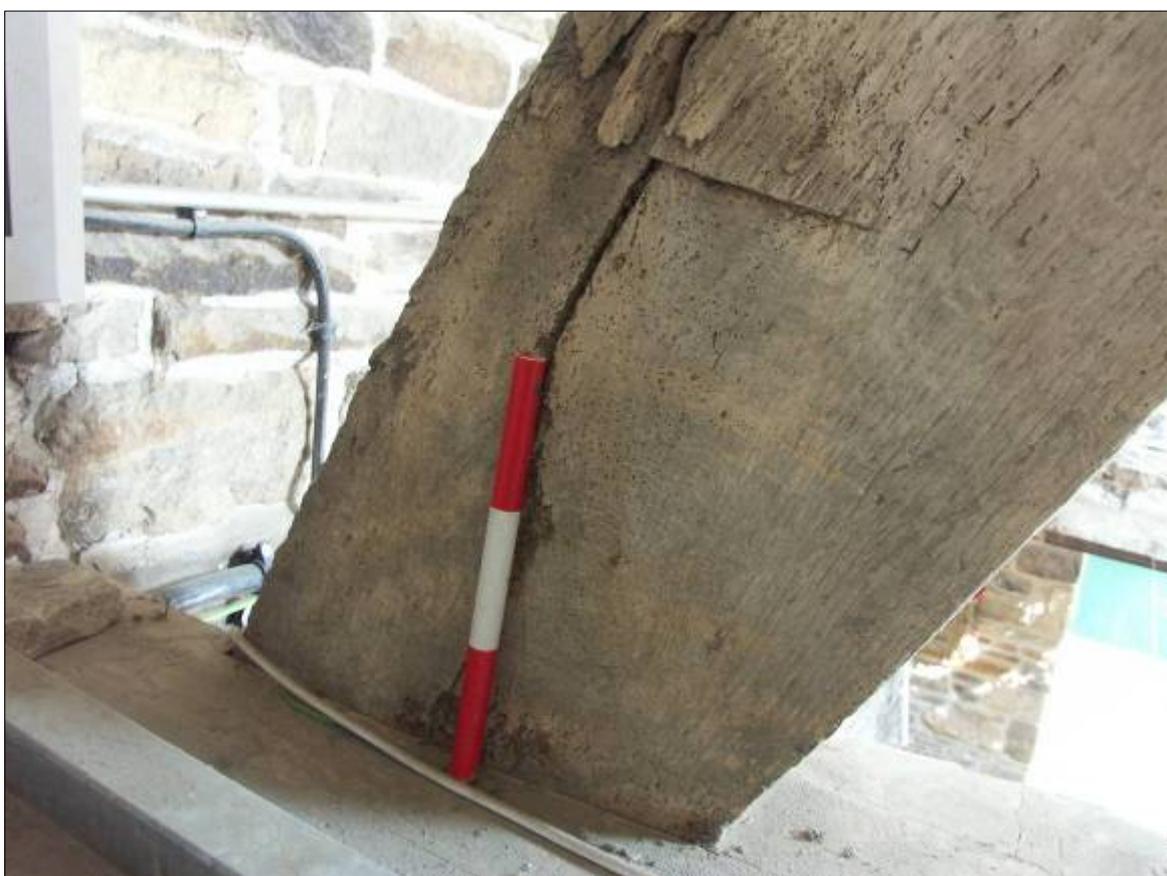
Plate 46. Pit-saw mark on the north blade of the cruck frame.

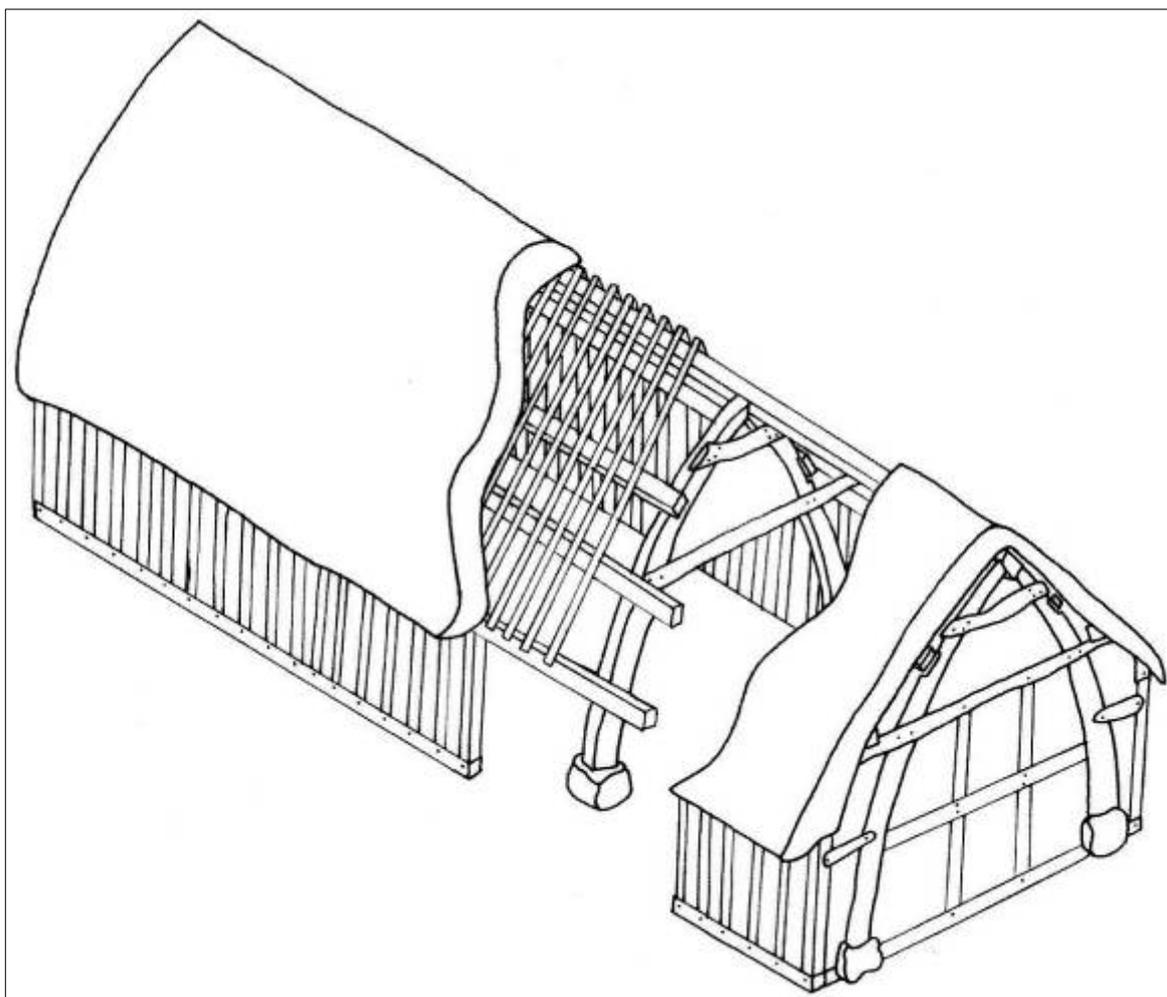
Figure 7. Reconstruction drawing of Building I (Drawn by the author)

- 4.65 All of this surviving evidence can allow us to recreate the original appearance of the cruck barn. Cruck barns generally had timber-framed walls in this region, which would have been infilled with wattle and daub. The barn may have looked something like Figure 7, which has been sketched to illustrate its original form.

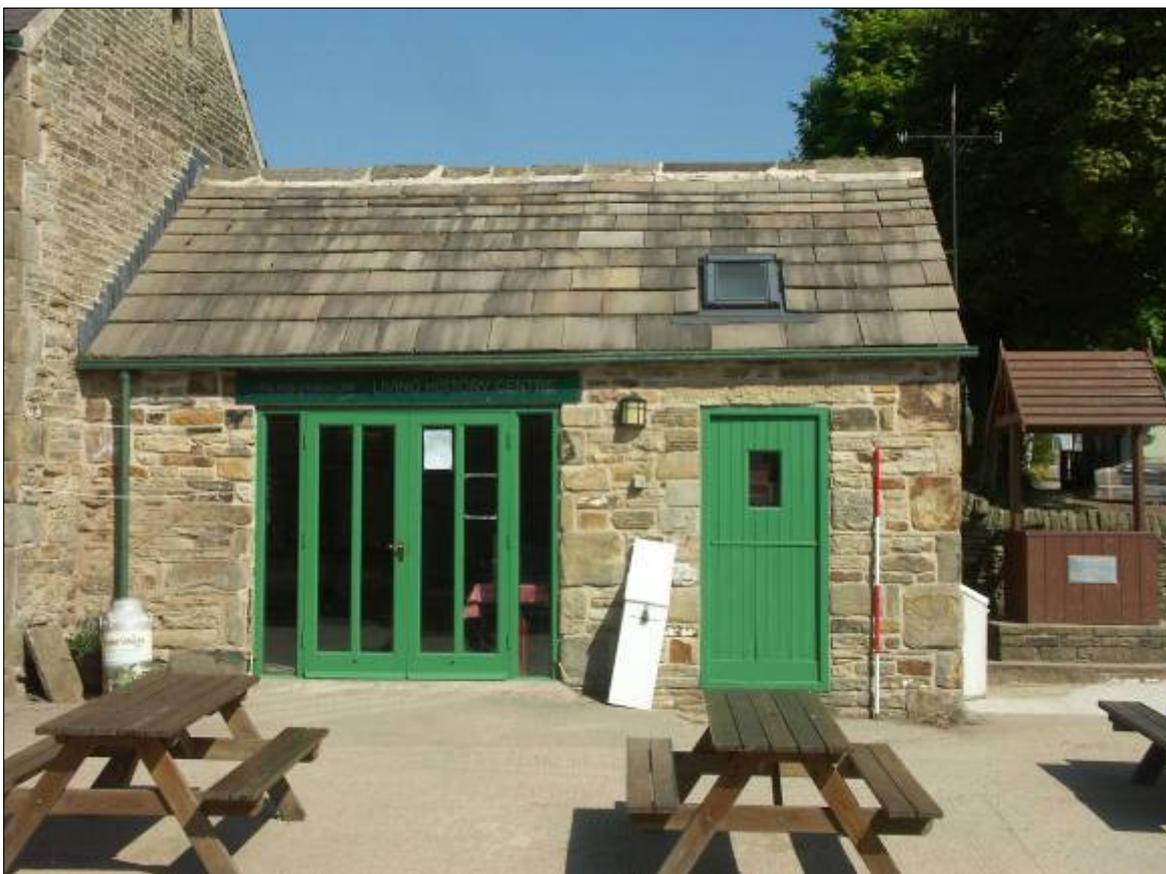
Plate 47. South elevation of Building J.

- 4.68 The south elevation contains wide double doors to the west, which currently give access to the lobby area leading to Building I. This doorway has a textured RSJ lintel. On the east side there is a smaller stable-style door; this has a small skylight above (Plate 47). There is also a small skylight on the north side of the building (Plate 50).

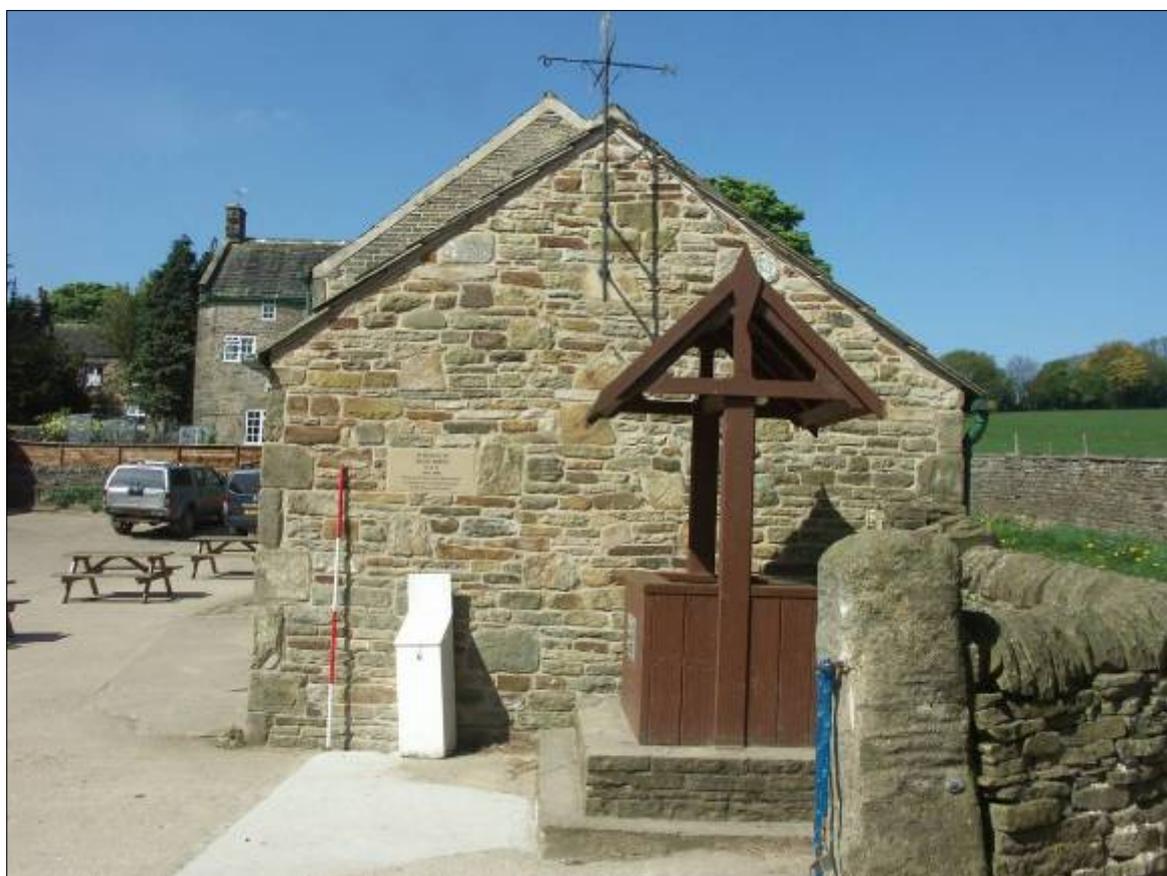
Plate 48. East elevation of Building J.

- 4.69 The east elevation contains a date stone of 2002, which may date the repairs to the structure (Plate 48-49). The earliest depiction of this building is on the Ordnance Survey map of 1893 (Sheppy 2011, 31); it does not appear on the 1850 map.

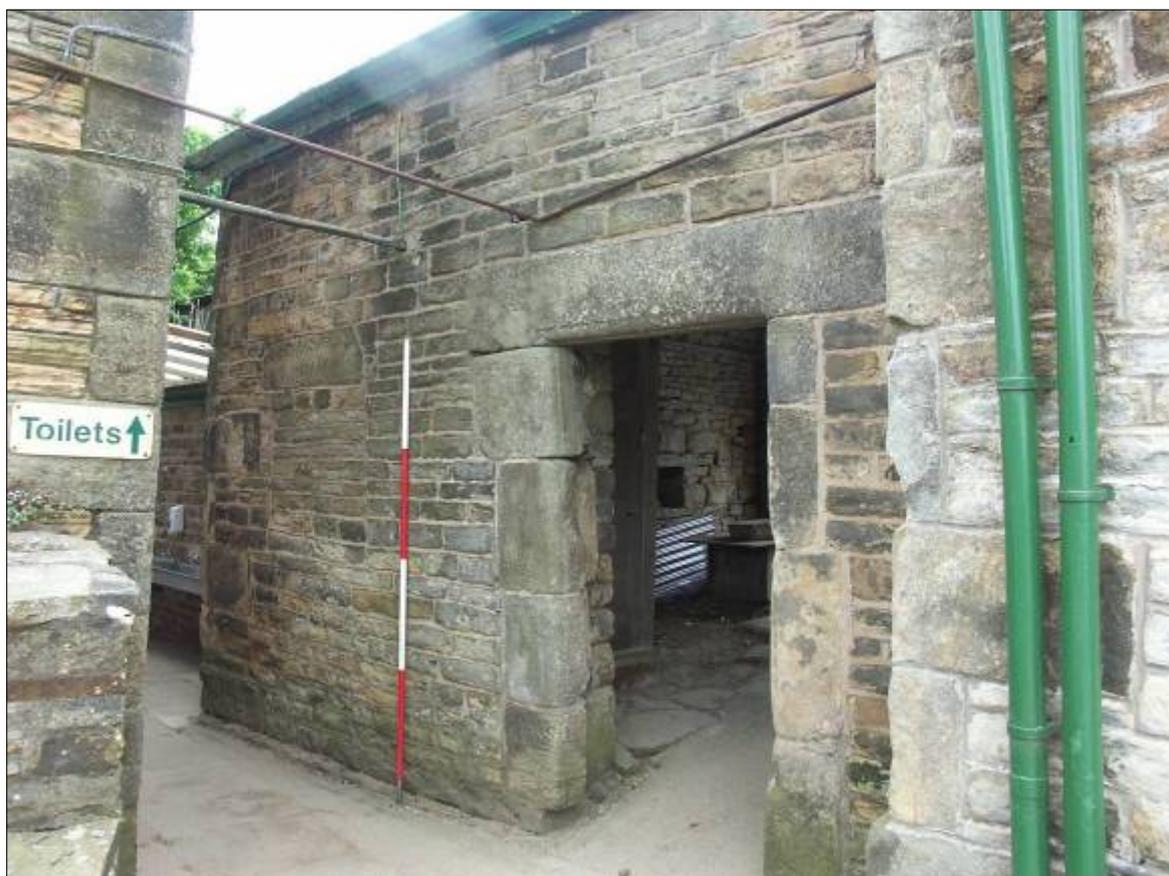
Plate 62. East elevation of Building N

- 4.81 The east elevation contains a doorway with a finely-dressed gritstone surround with roll moulding (Plate 62). This is clearly a reused feature as certain elements of it are incorrect, such as the two uppermost stones on the north side and the uppermost stone on the south side. There is a small, blocked window with stone lintel to the south.

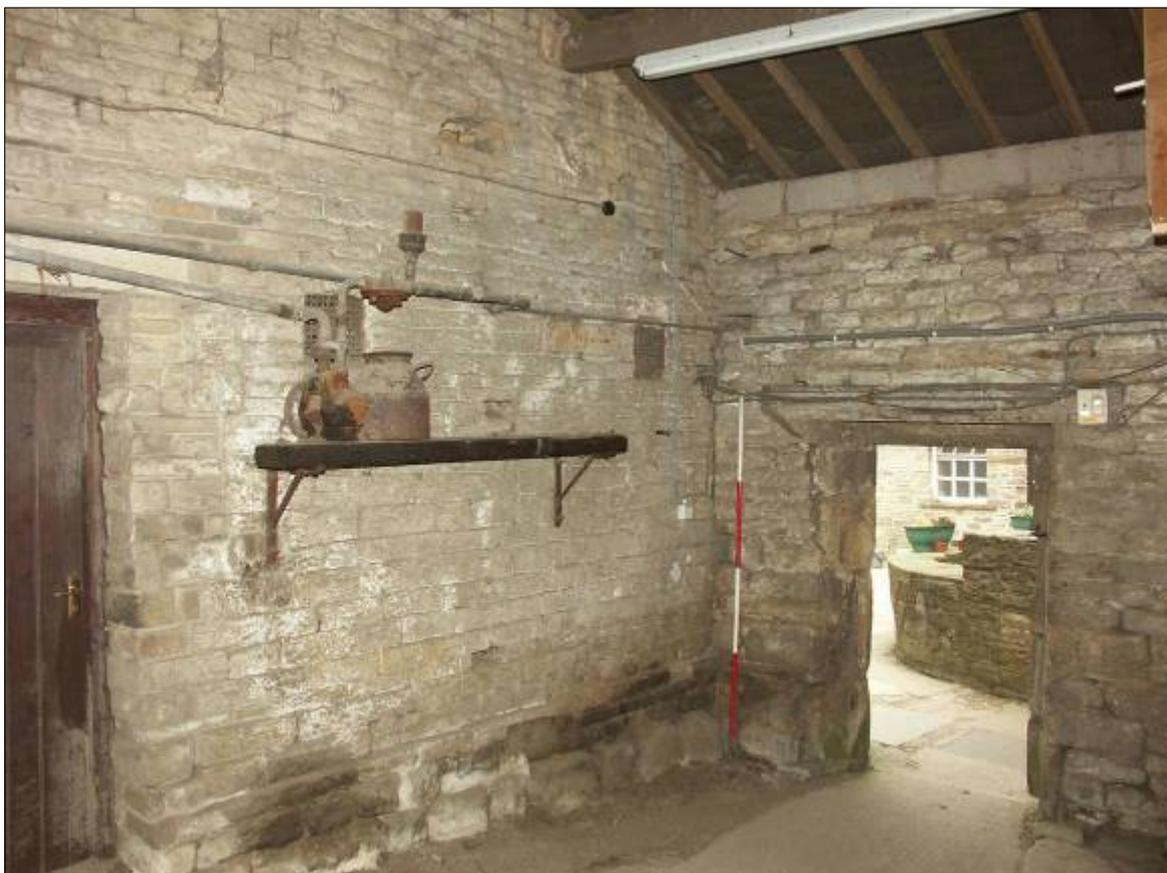
- 4.82 The west elevation contains a wide opening in the wall with timber cladding above (Plate 63).
- 4.83 Internally there is clear evidence that the current roof of the structure has been rebuilt, as it now rests on a single course of breeze-blocks (Plate 64). There are also exposed foundations inside the structure, indicating that the ground level has been lowered. There is a doorway in the north wall that communicates with the ground floor of Building O.

Plate 64. Interior of Building N facing northeast.

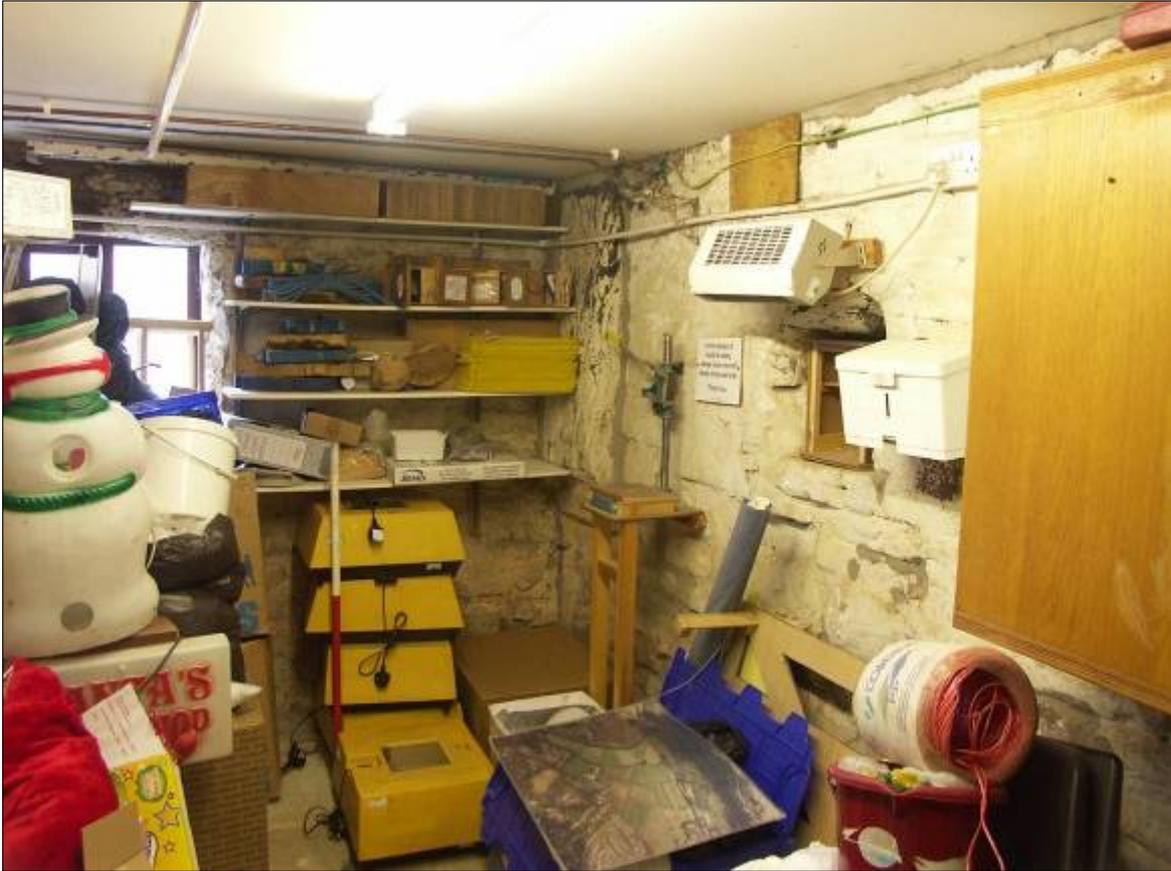
- 4.92 Internally this building incorporates the surviving remains of a cruck frame, making this the second cruck-constructed building. At first floor level in the east side of the south wall there is one surviving blade of a cruck frame which appears to be fire-blackened (Plate 73). It incorporates evidence for two side purlins, which Bunker states is unusual in this region. She also remarks that this cruck building is unusually high (Bunker 1970, 62). There is a noticeable break in the walling on the corresponding west side of the structure where the paired blade should be. At ground floor level the stylobate for the surviving cruck blade is visible, both internally (Plate 74), and externally (Plate 75).

Plate 74. Ground floor of Building O looking east with cruck blade and stylobate in southeast corner (painted).

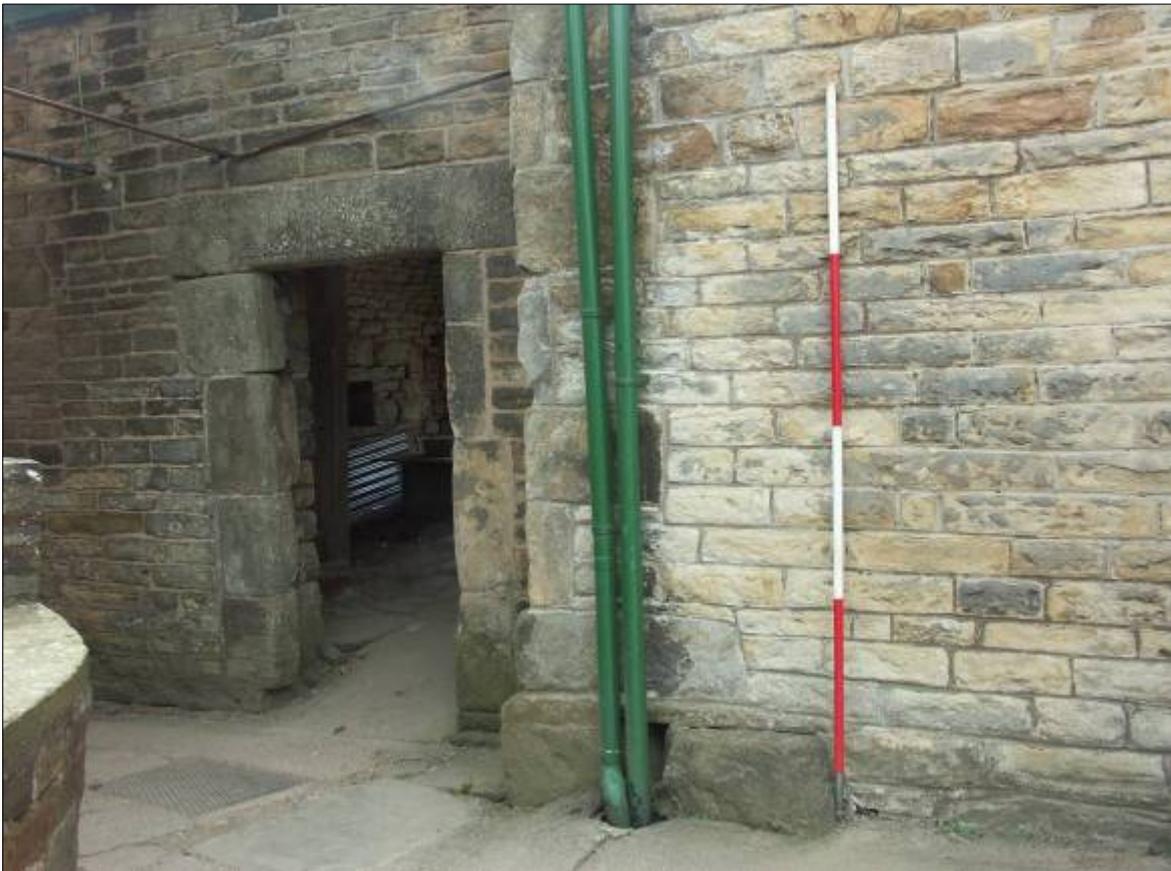
Plate 75. Detail of a stylobate in the southeast corner of Building O.

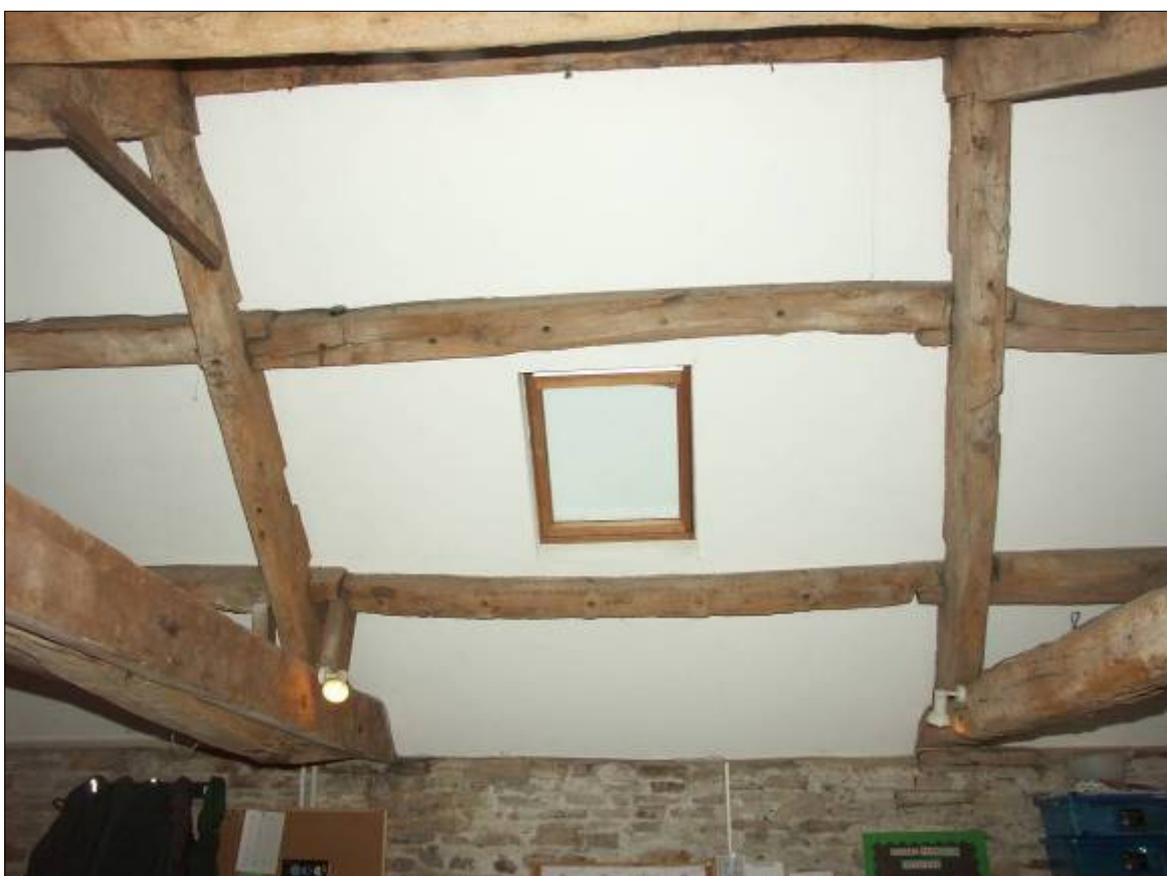
- 4.93 The roof level of this building has been heightened above the original roof line of the cruck building and is now held on a mixture of couple-close trusses (Plate 76) and king post and strut trusses (Plate 78) along its length. The new side purlins are reused timbers that would once have been used as studs or wall-plates. This is shown by the presence of auger holes along their length (Plate 77).

Plate 77. First floor of Building O facing west showing reused timbers with auger holes used as the side purlins.

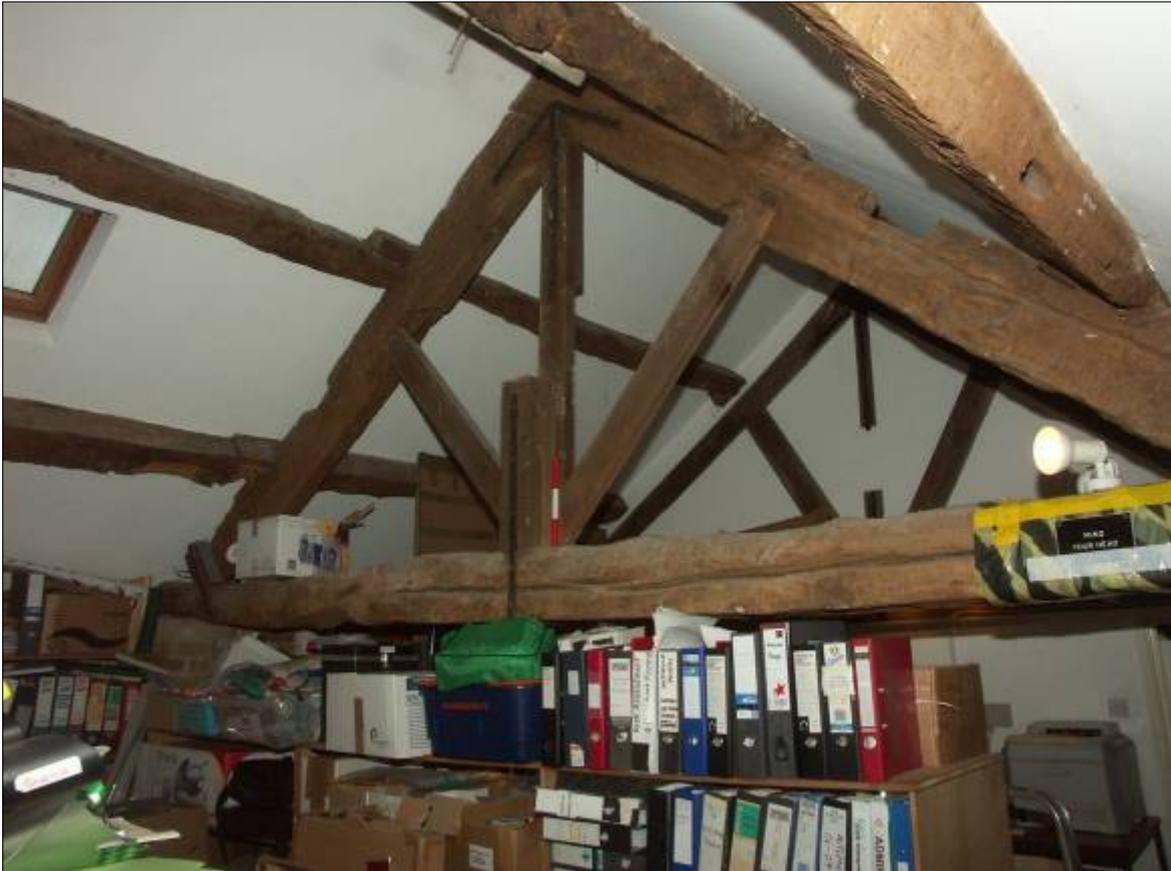
- 4.94 There is evidence of the location of a further cruck-frame in the re-entrant angle of Buildings O and P. This is shown by a surviving stylobate, with scars in the walling above, at this point of the building (Plate 78). If this set of cruck blades is part of the same original building as that on the south wall of building O, then this structure would be longer than the cruck barn in the Lower Yard (see Building I). With the same *c.*5m bay interval this building would have had five sets of crucks, making it four bays or *c.*20m long. The original function of this structure is unclear, but its length and unusual height could certainly have accommodated a longhouse style arrangement with living quarters at one side of the building and animal housing at the other, separated by a small cross-passage (Brunskill 2007, 106-109). Bunker states that the south side of this building was 'evidently the living quarters', but does not state her reasons for making such an assertion (Bunker 1970, 62). There does appear to have been some concern for making the cruck and stylobate sit neatly and as flush as possible at this side of the building (Plate 74). This suggests that this building was more important than a poorly constructed agricultural building.

Plate 78. First floor of Building O facing south. Interior showing king post truss with remodelled side purlins.

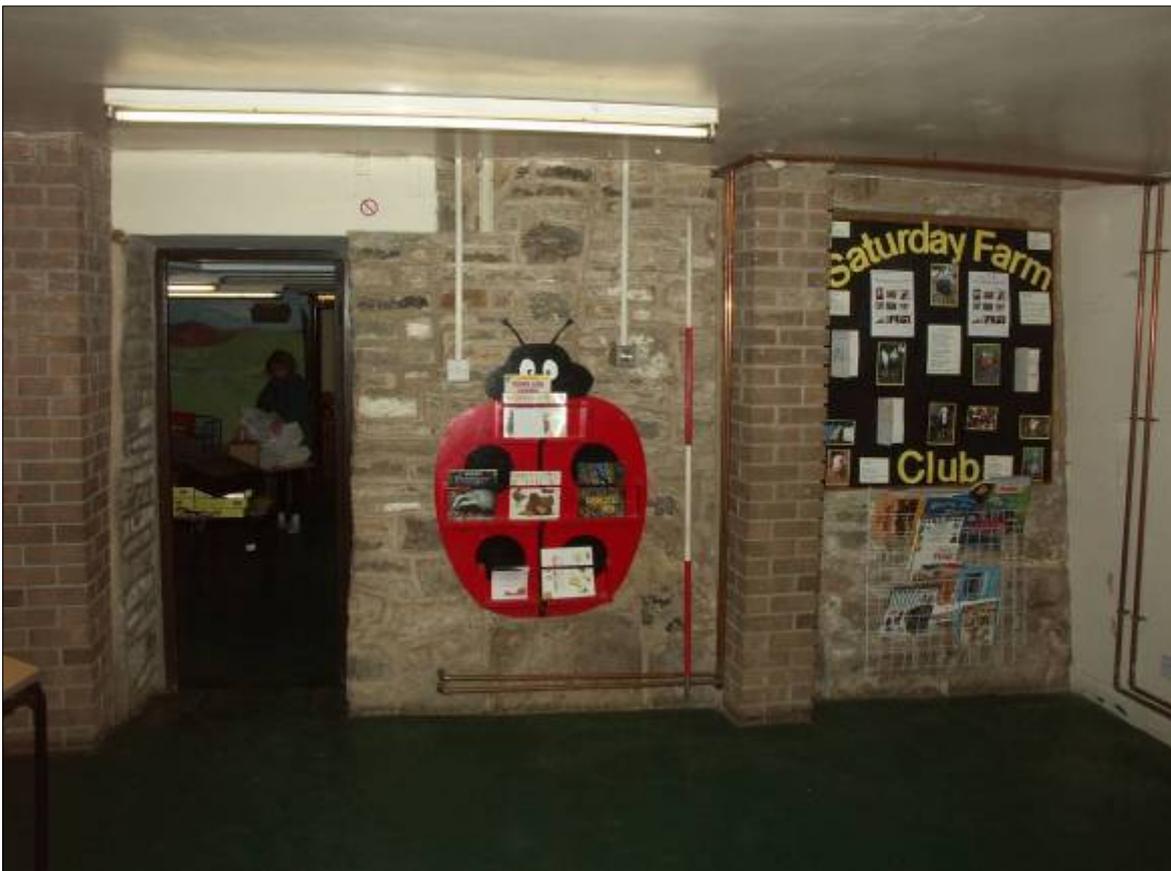
Plate 79. Ground floor of Building O facing east. Interior showing stylobate and scar of a cruck blade.
