An Archaeological Building Recording at Whirlow Hall Farm, Sheffield

ARS Ltd Report 2011/59
May 2011

ARS Ltd Report 2011/59

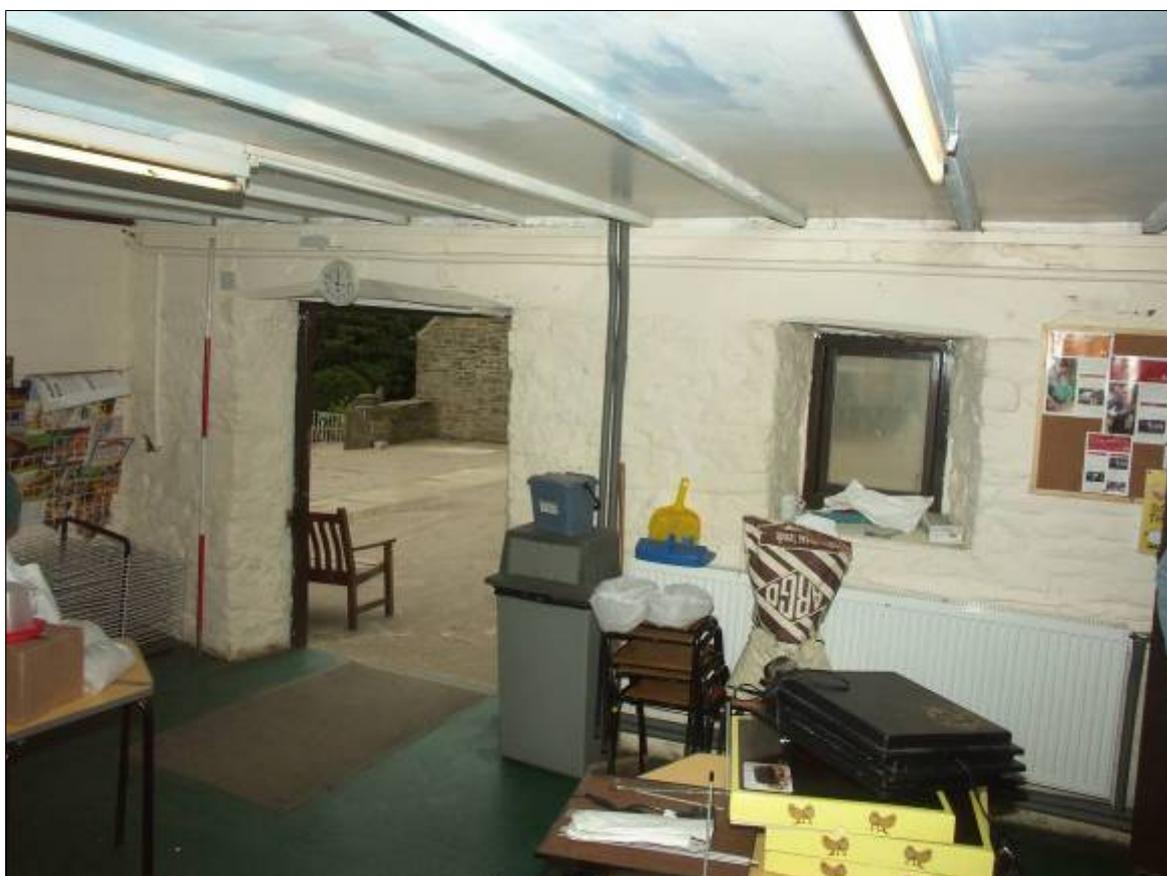
- 4.99 Internally the first-floor chamber has an exposed king post and strut truss with extended tie beam. The ground-floor level has a breeze-blocked partition wall separating this level into two chambers (Plate 82).

Plate 82. Ground floor of Building P facing south showing breeze-blocked partition wall on the left.

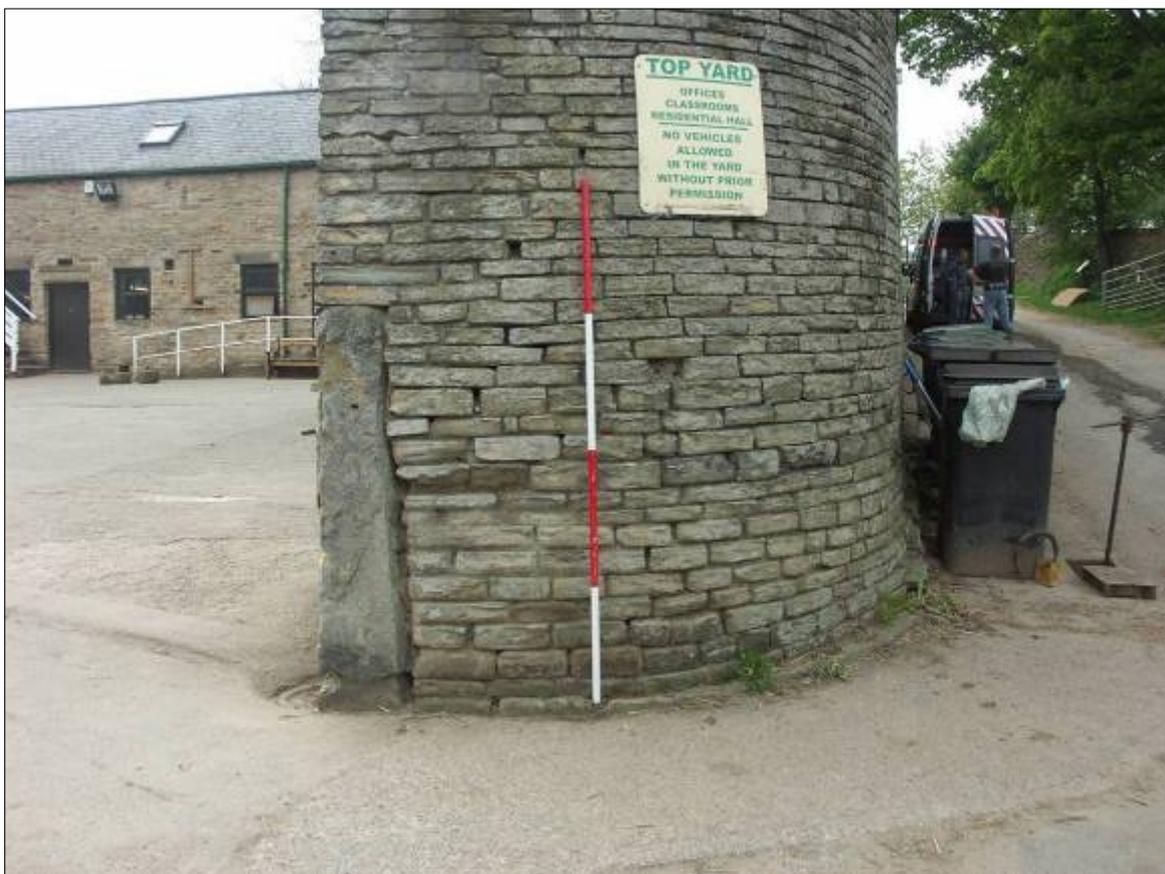
- 4.103 The north elevation of the Top Yard wall contains some features of note at this location. This first is that the current yard wall is built over the original gate-post, meaning that it is a secondary feature of the farm (Plate 84). The second is a doorway of finely-moulded gritstone giving access from Broad Elms Lane into the yard. It is pretentious considering its position adjacent to a pigsty, and the present stone lintel is not part of the original configuration. This suggests that it is not in its original location. The moulding is of hollow and ovolo type which can be dated to the mid-17th century (Alcock and Hall 2002, 54).

Plate 84. East elevation of Building Q showing walling built up over the gate-post.
